# Inspection Report

SURE Pty Ltd

### Pest And Building Inspection

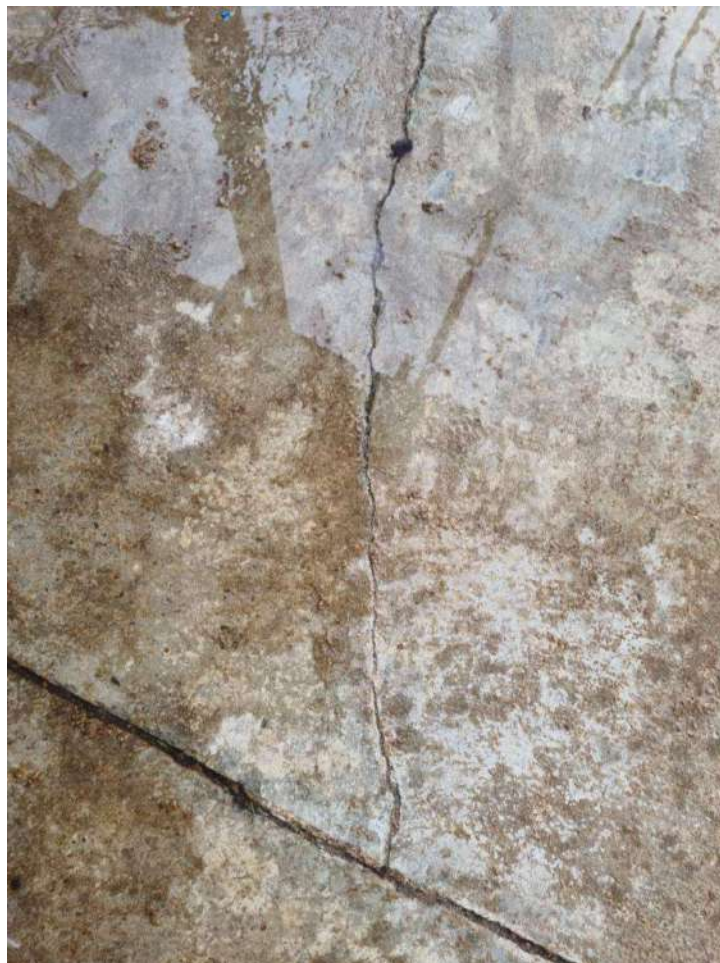
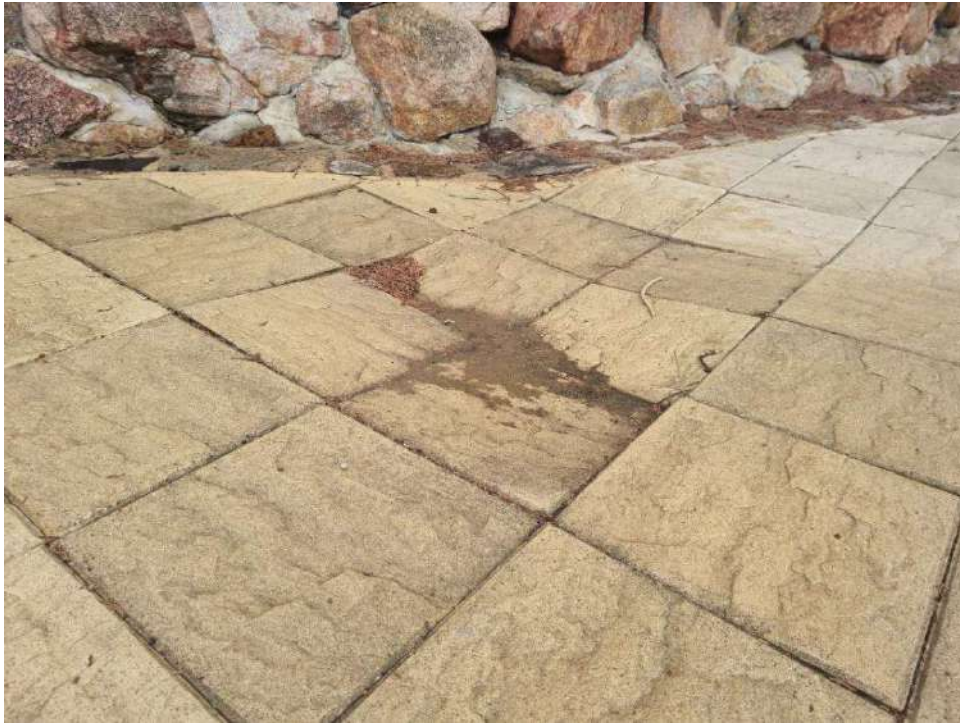
**Maintenance:** Common cracks and settlement was observed on the path area/s.

**Maintenance:** The surface has raised and settled in some areas. This can cause water ponding.

Recommendation: Whilst these cracks appeared to be typical at the time of inspection, we strongly recommend you monitor these cracks and if worsening occurs engage a concreter for further advice and repair.

Recommendation: Engage a landscaper for relay affected sections.

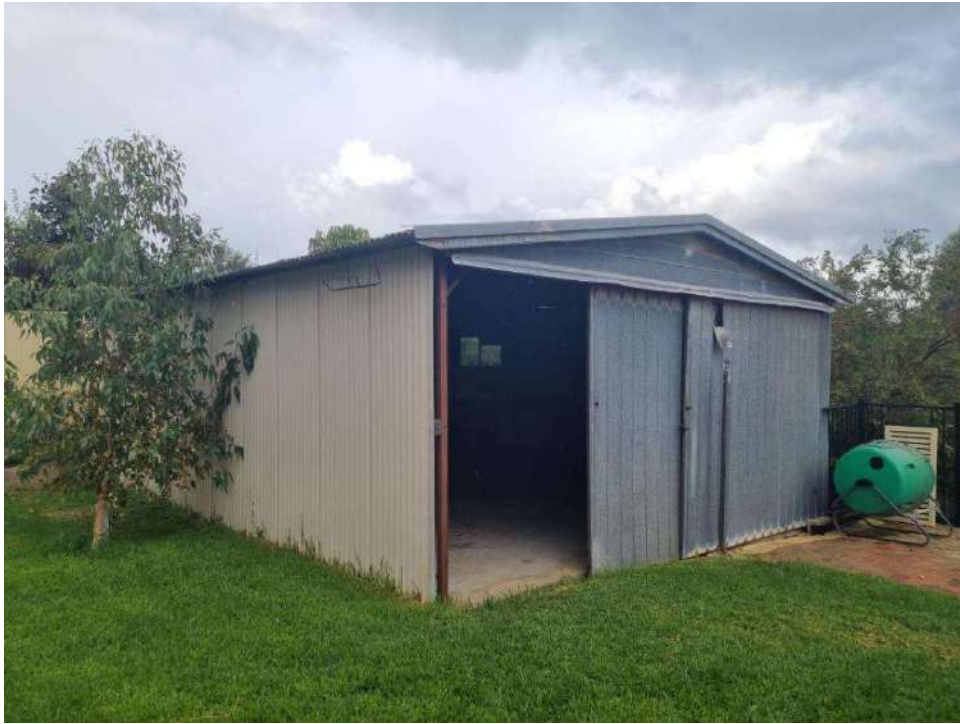
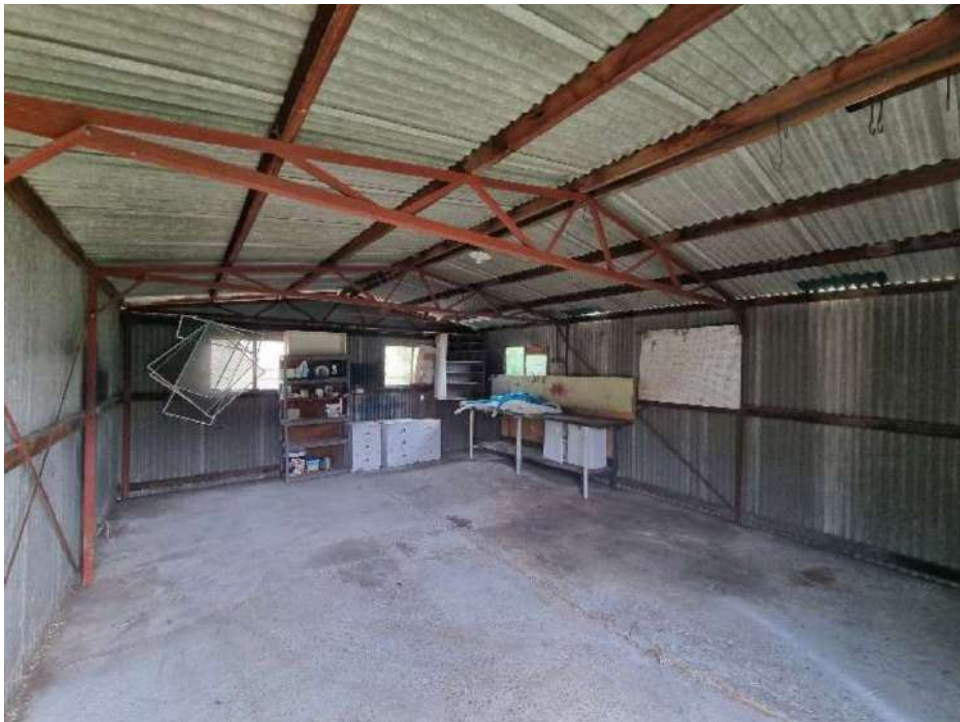
**Health and Safety:** Section of the shed are fibrous cement sheeting. Recommendation: Conduct an asbestos lab test to confirm material. Considered a potential health and safety defect.

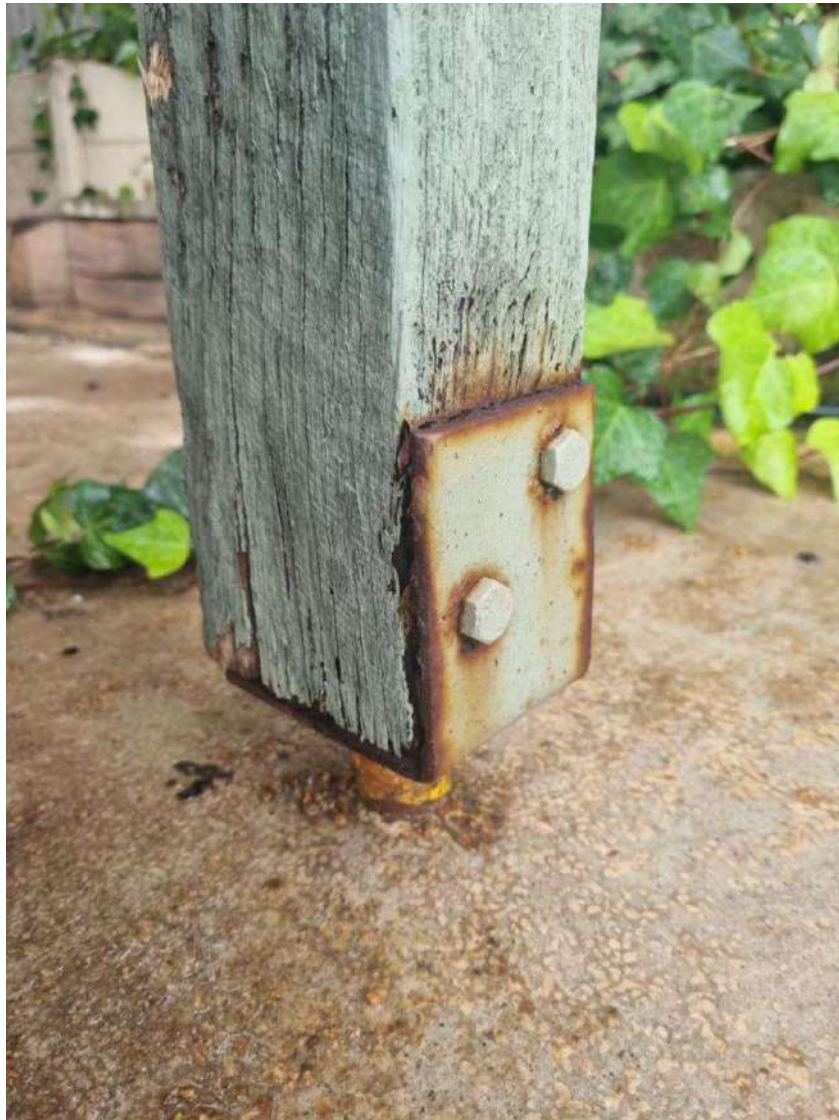
**Structural minor:** Rust observed to pergola post metal stirrups. If left unattended the pergola will become unstable/unsafe. Recommendation: Engage a carpenter to replace.

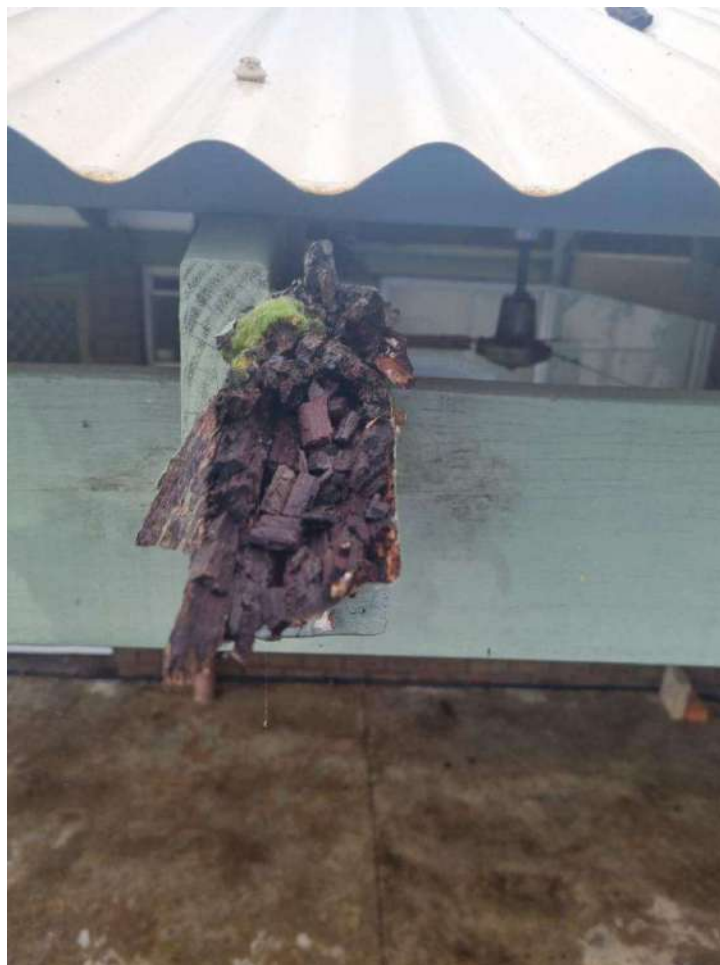
**Structural Minor:** Timber fungal decay observed in sections of bearers or joists. Recommendation: Engage a carpenter for repairs.

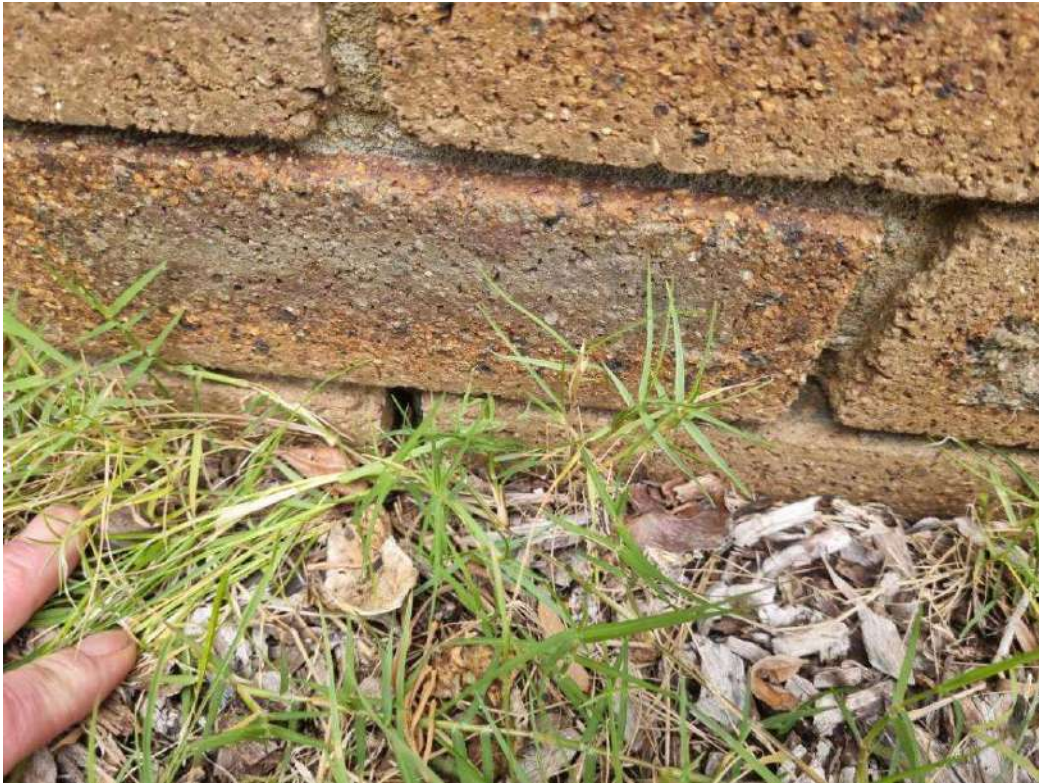
**Maintenance:** Some weep holes are partially blocked by soil. Recommendation: Engage a landscaper to lower finished ground levels to fully expose all weep holes on the lower brick courses around the dwelling.

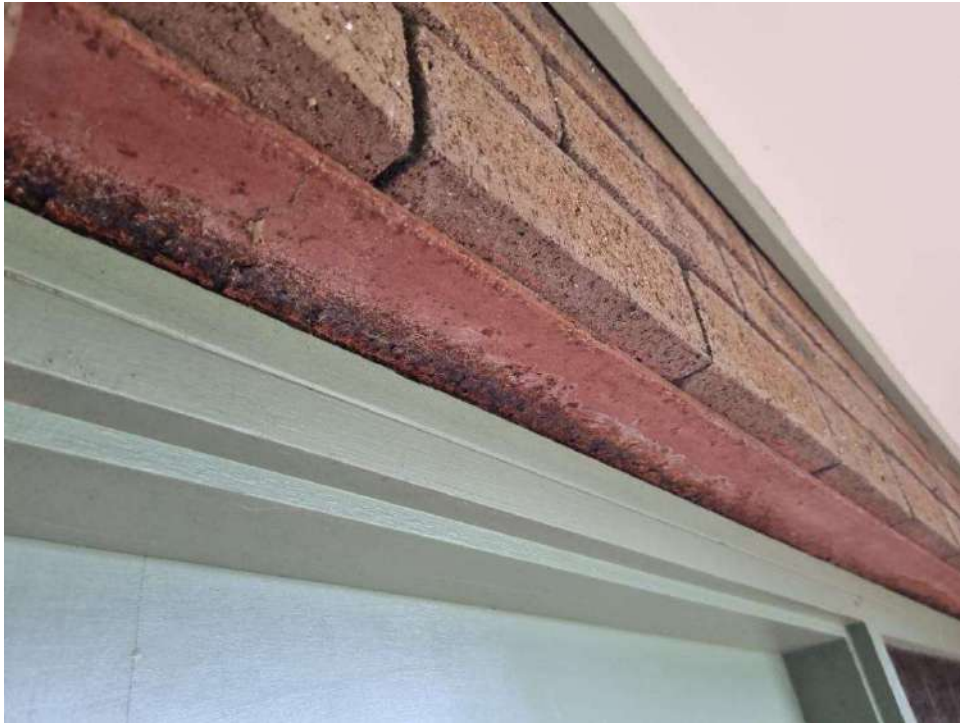
**Maintenance:** General age/damage has occurred to door frame, face or components. Recommendation: Engage a carpenter and/or painter for repairs.

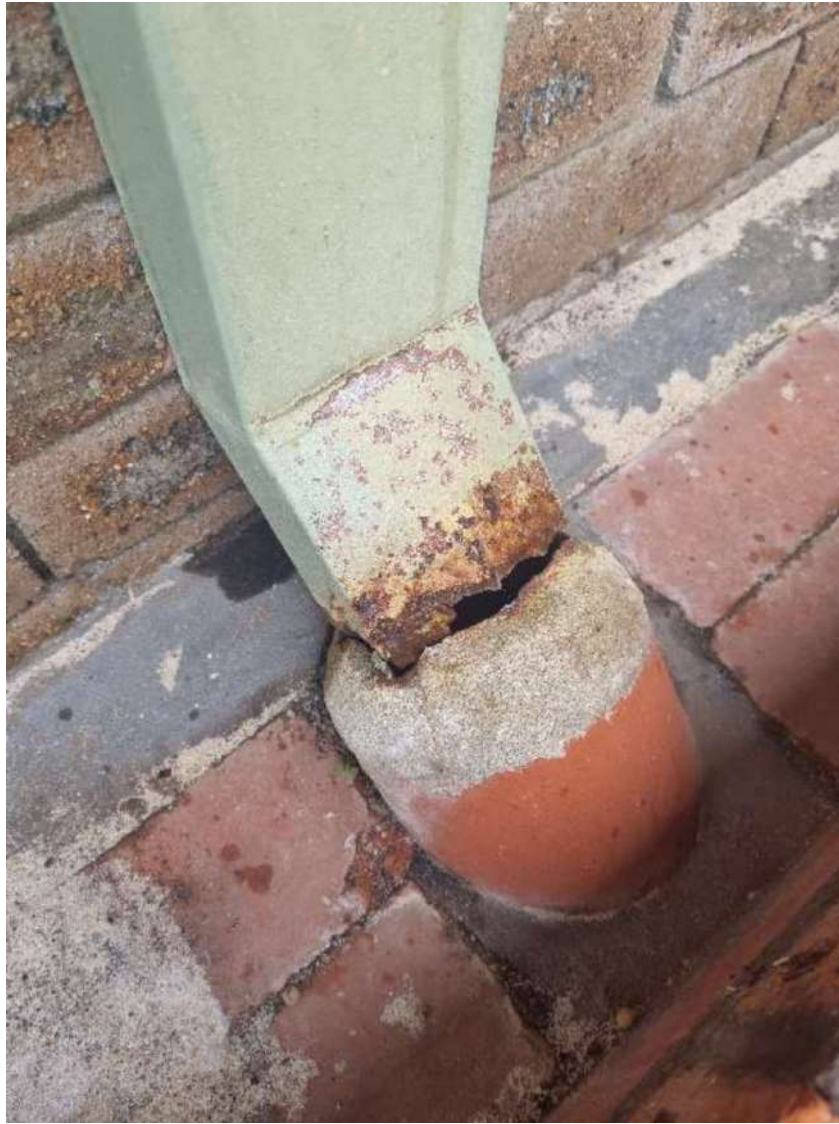
**Maintenance:** Rust penetrations observed to down pipe/s. Recommendation: Engage a roofing contractor to repair or replace affected down pipes.

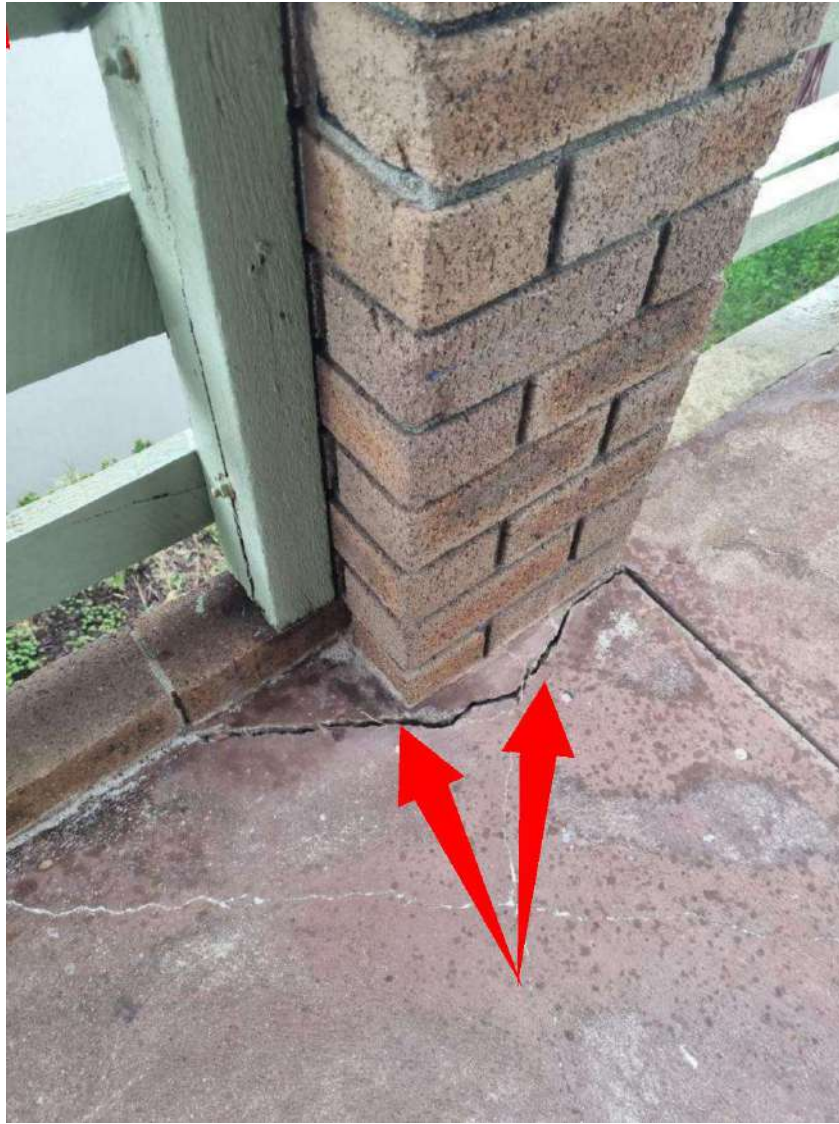
| Section | Location | Name | Comment |
|---|---|---|---|
| GARAGING | Attached Carport | Column or Post Observations | <b>Structural Major:</b> The footings of the brick post have settled with significant ground movement observed. The structural integrity of this supporting post/column has been compromised. In the inspectors opinion the stability of the load bearing post is of concern. Recommendation: Engage a structural engineer for further assessment and advice regarding repairs. |

Recommendation: Engage a structural engineer for further assessment and advice regarding repairs.

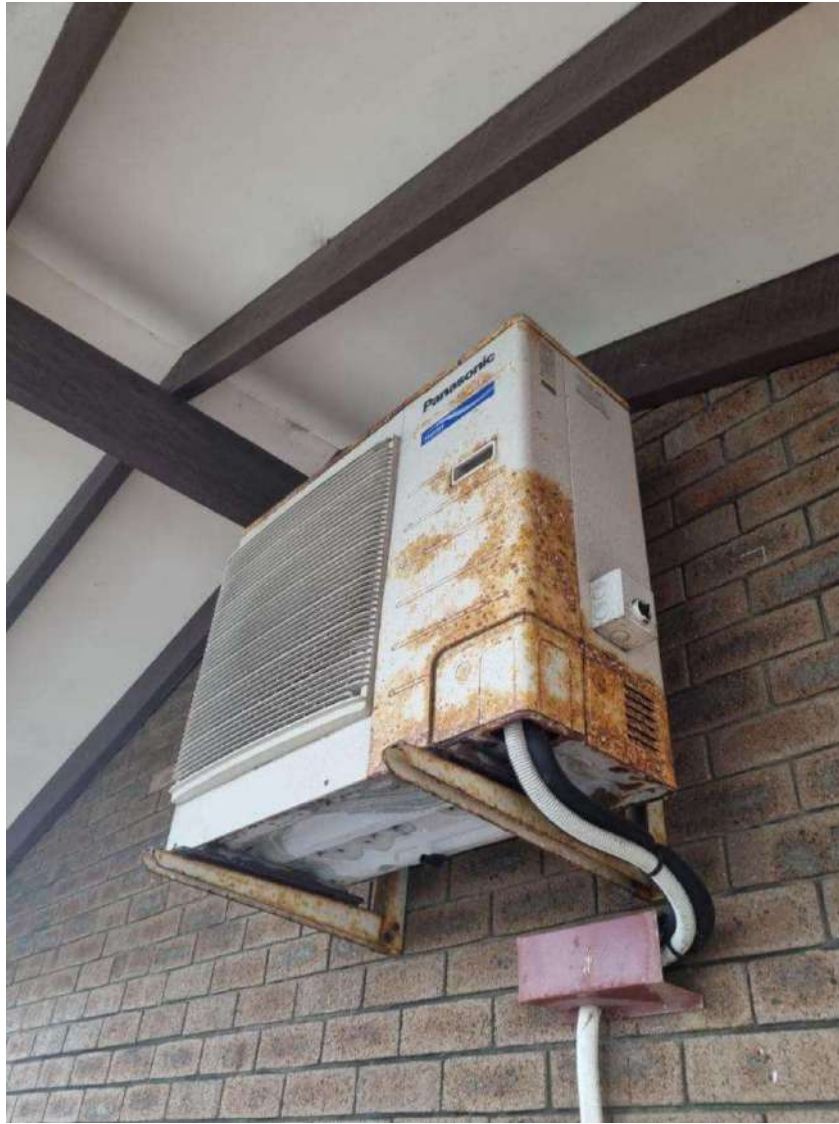
**Maintenance:** Rust noted to external compressor fan unit. Recommendation: Engage a technician for servicing and maintenance.

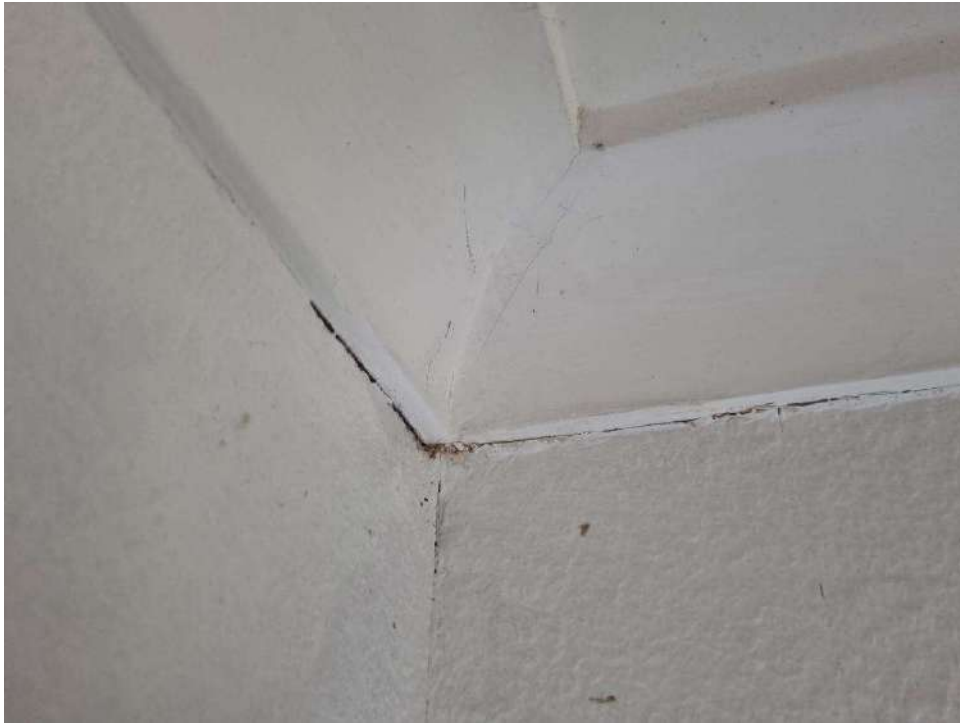
**Maintenance:** Ceiling stains with normal moisture readings obtained. The cause may have been repaired, however, you will need to monitor after a prolonged period of rainfall to confirm. Recommendation: Engage a painter for repairs. *Water damaged plaster has the potential for detachment or collapse, if required engage a plasterer for repairs.*

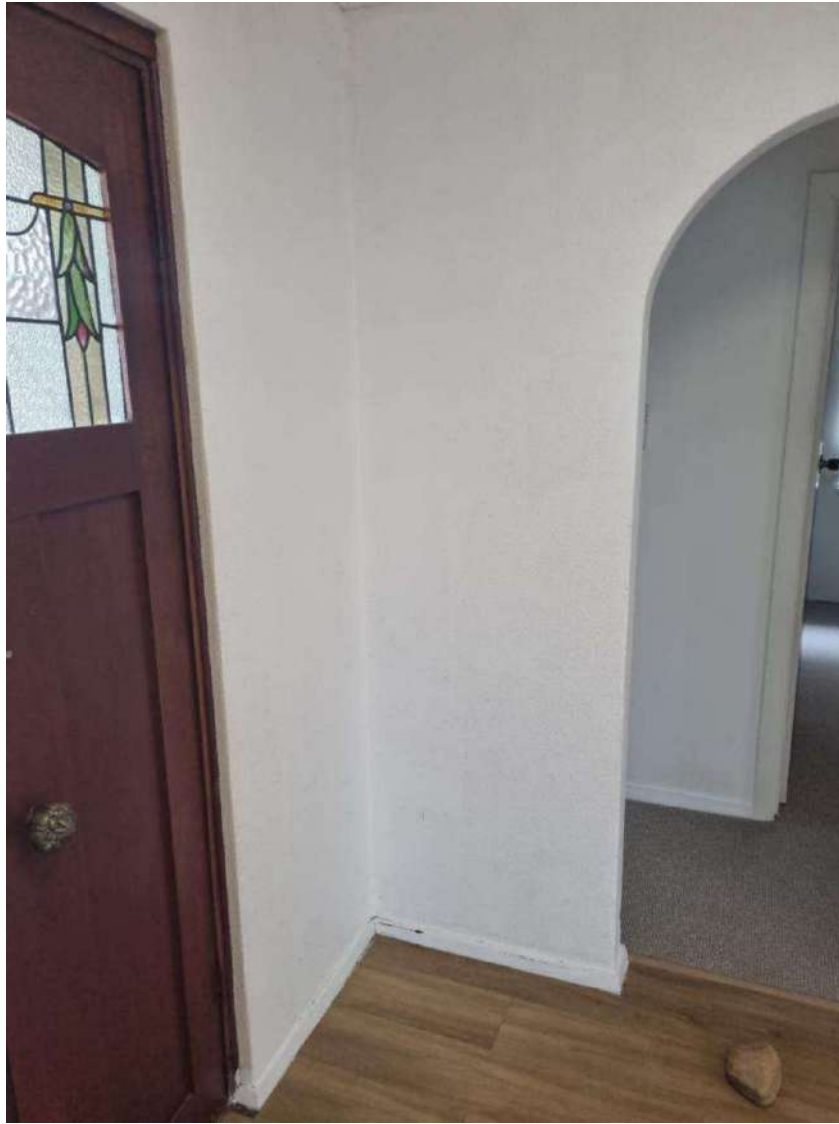
**Maintenance:** General ageing and/or denting and the like is evident on wall linings.  
Recommendation: Engage a painter for repairs.

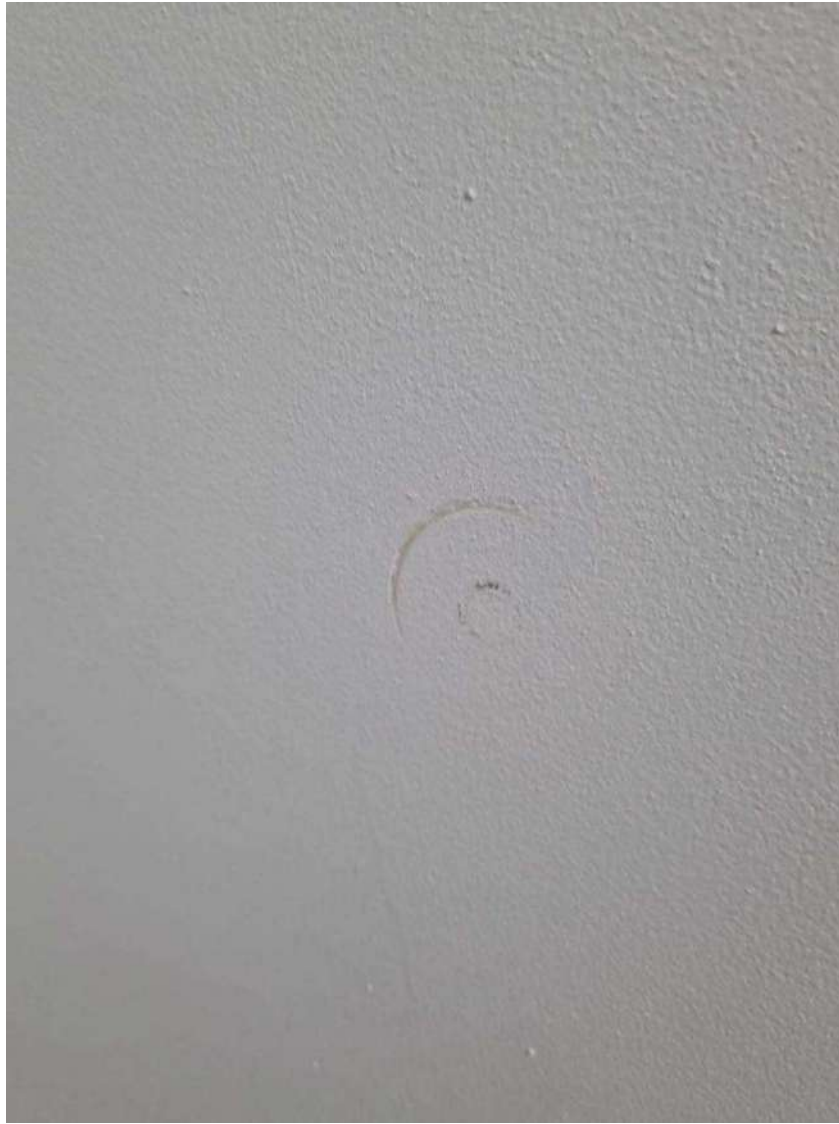
**Maintenance:** Wall damage from door handle impacting wall lining observed. Recommendation: Engage a handyman to install new door stop and touch up paint.

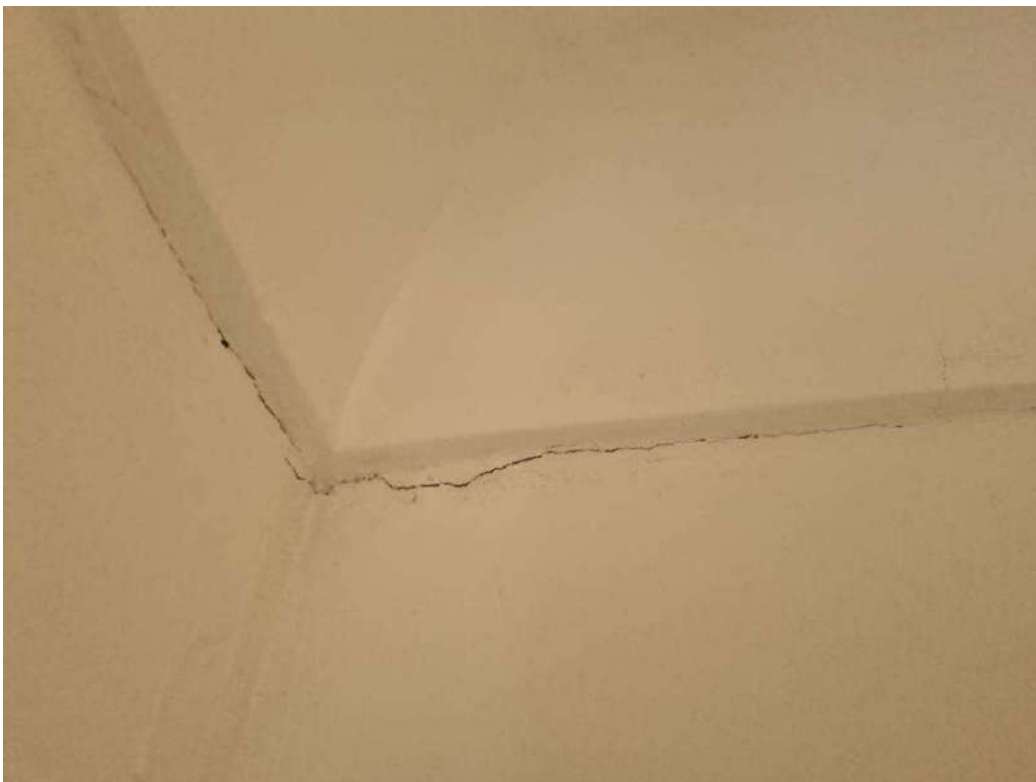
**Maintenance:** Ceiling/cornice join crack/s observed. Recommendation: Engage a painter for repairs.

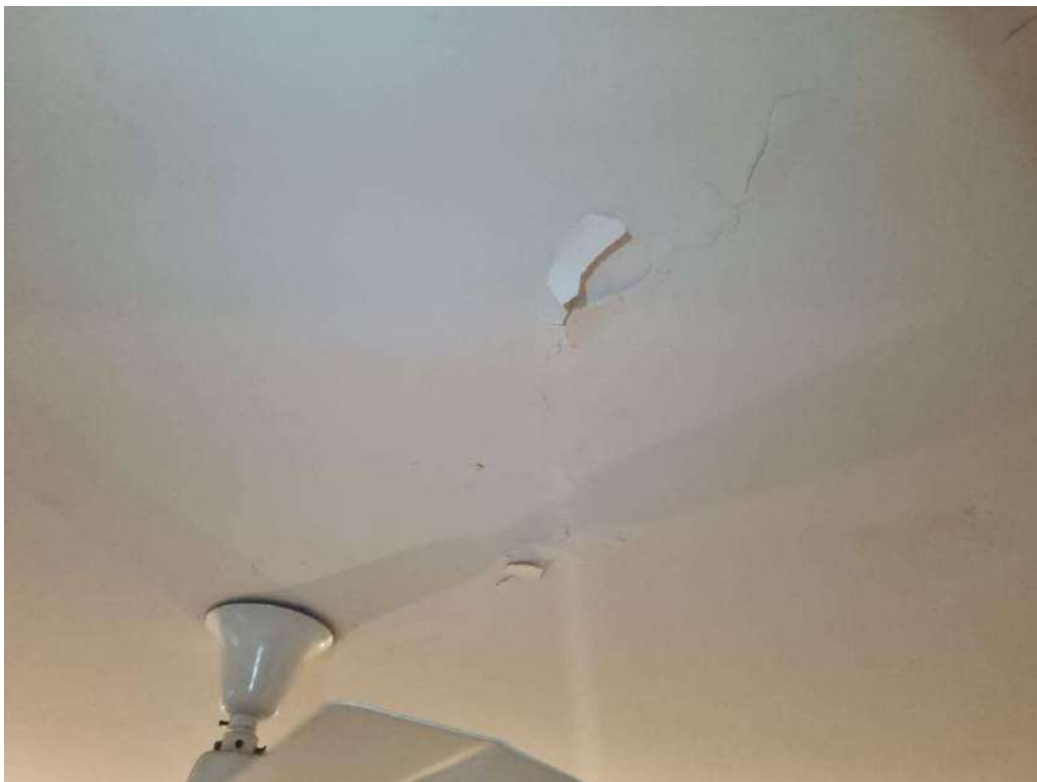
**Maintenance:** Paint deterioration observed. Recommendation: Engage a painter to repair.

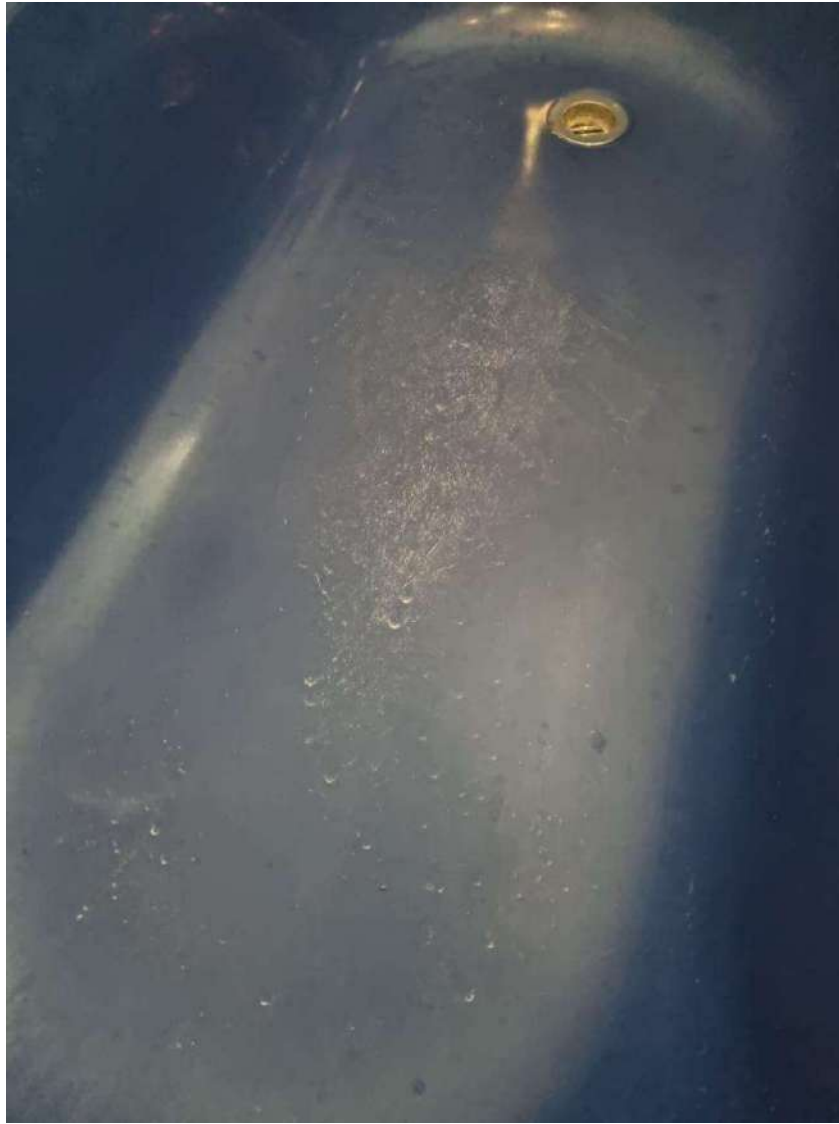
**Maintenance:** General deterioration and wear to bath tub. Recommendation: Engage a plumber to replace if desired.

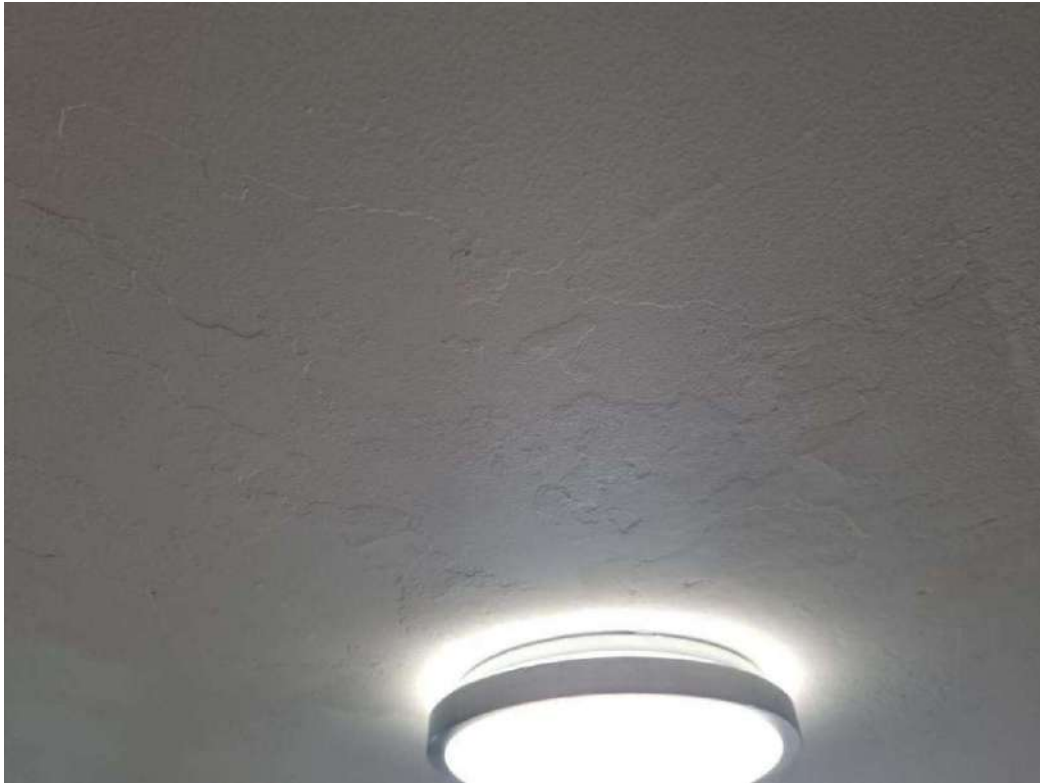
**Maintenance:** Paint deterioration observed. Recommendation: Engage a painter to repair.

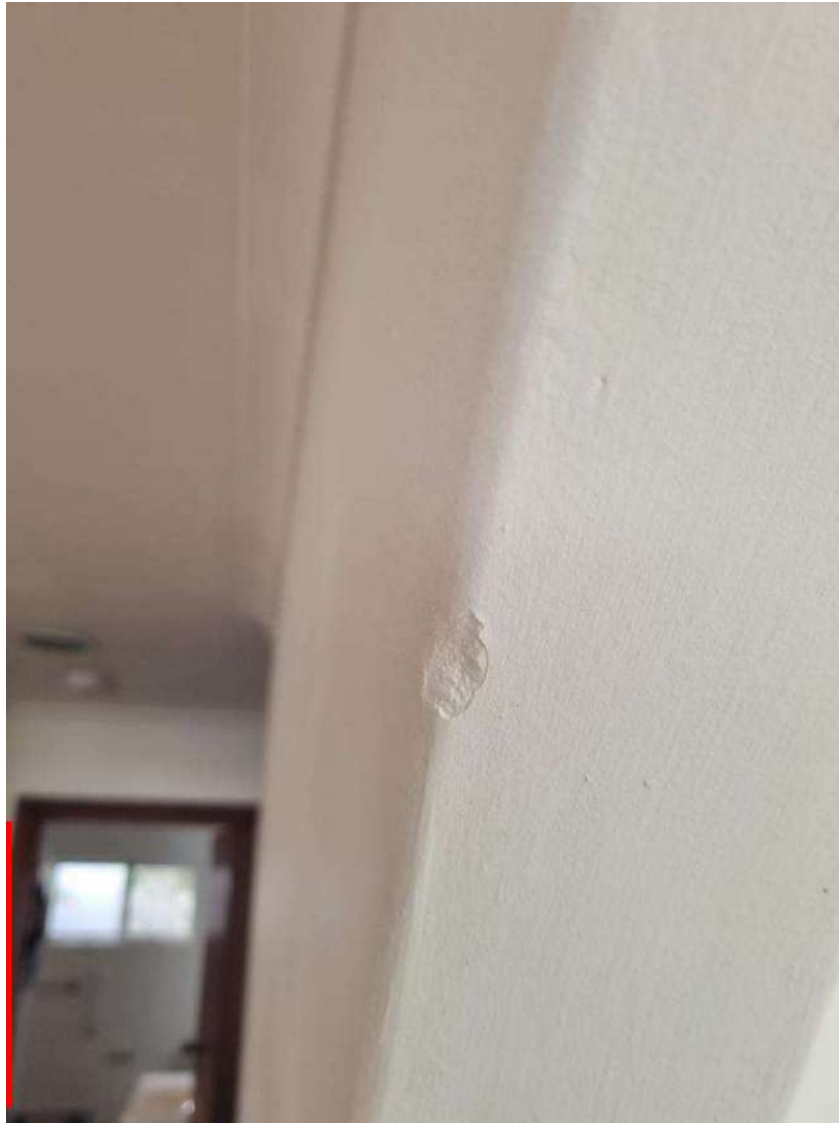
**Maintenance:** Minor impact damage observed. Recommendation: Engage a painter for repairs.

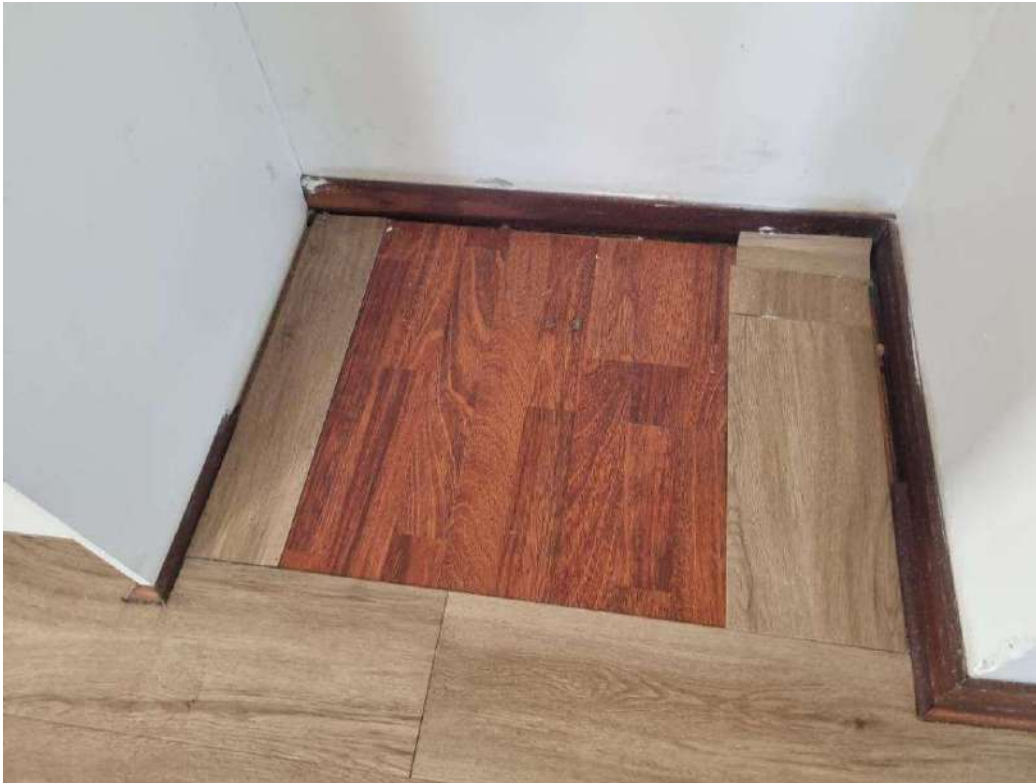
**Maintenance:** The floor covering is aged with wear/repairs noted. Recommendation: Engage a flooring specialist for advice and recommendations.

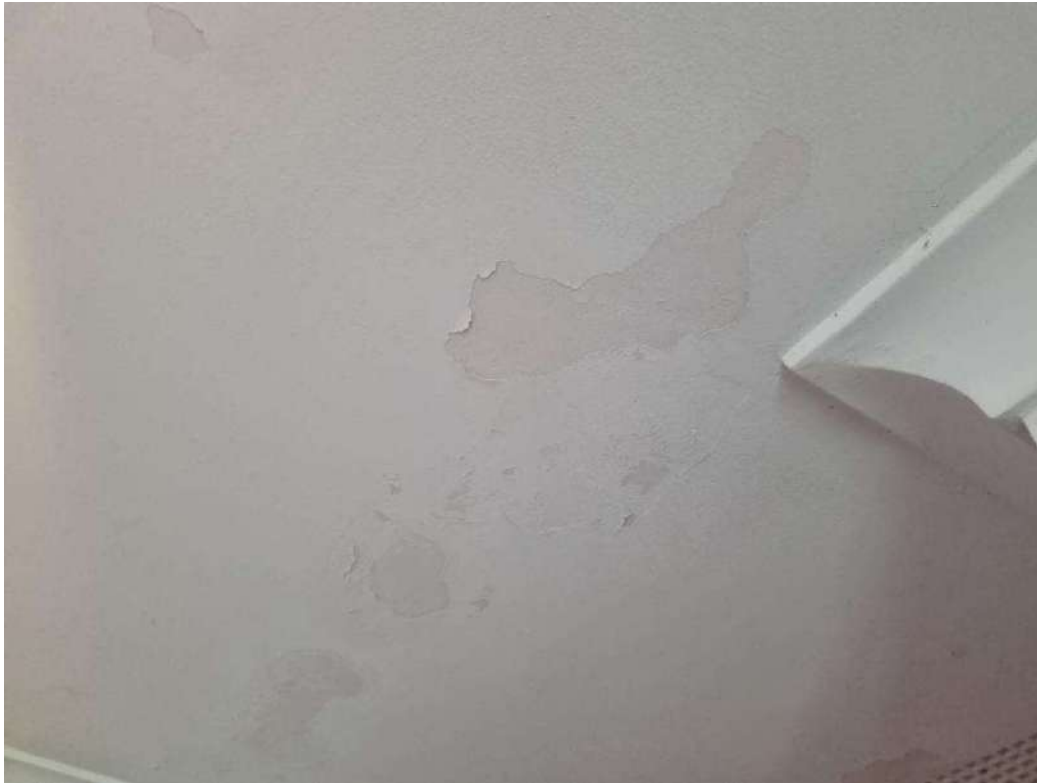
**Maintenance:** Paint deterioration observed. Recommendation: Engage a painter to repair.

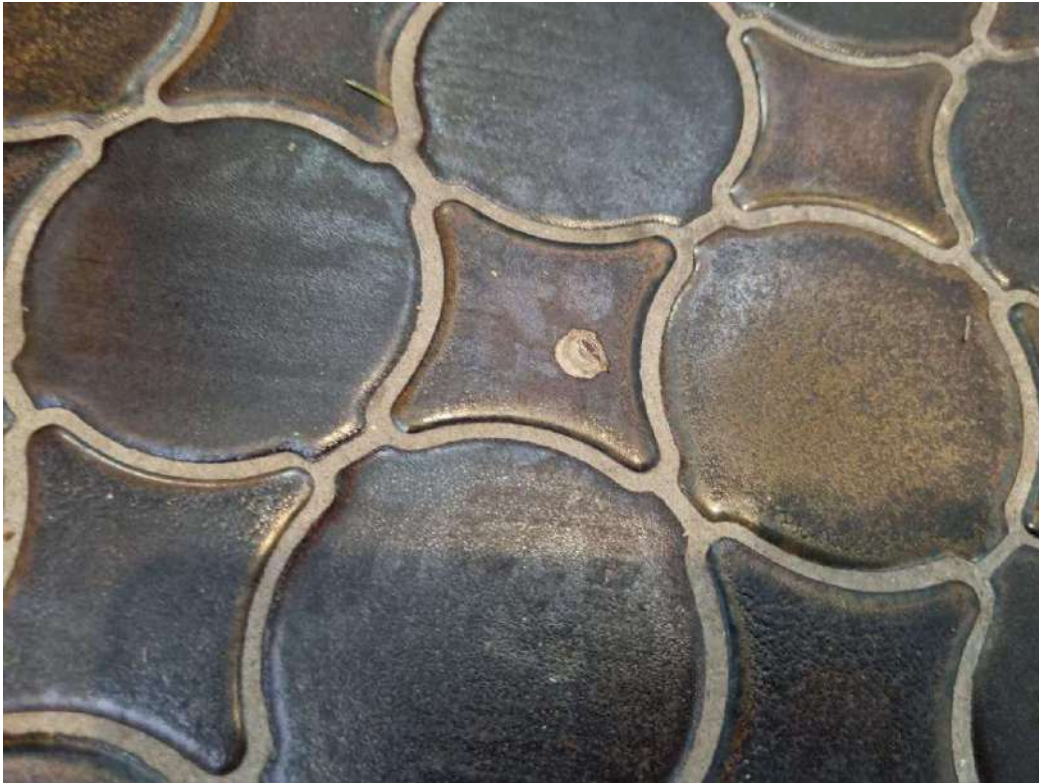
**Maintenance:** Some chipped and damaged tiled were noted. Recommendation: Engage a tiler for repairs.

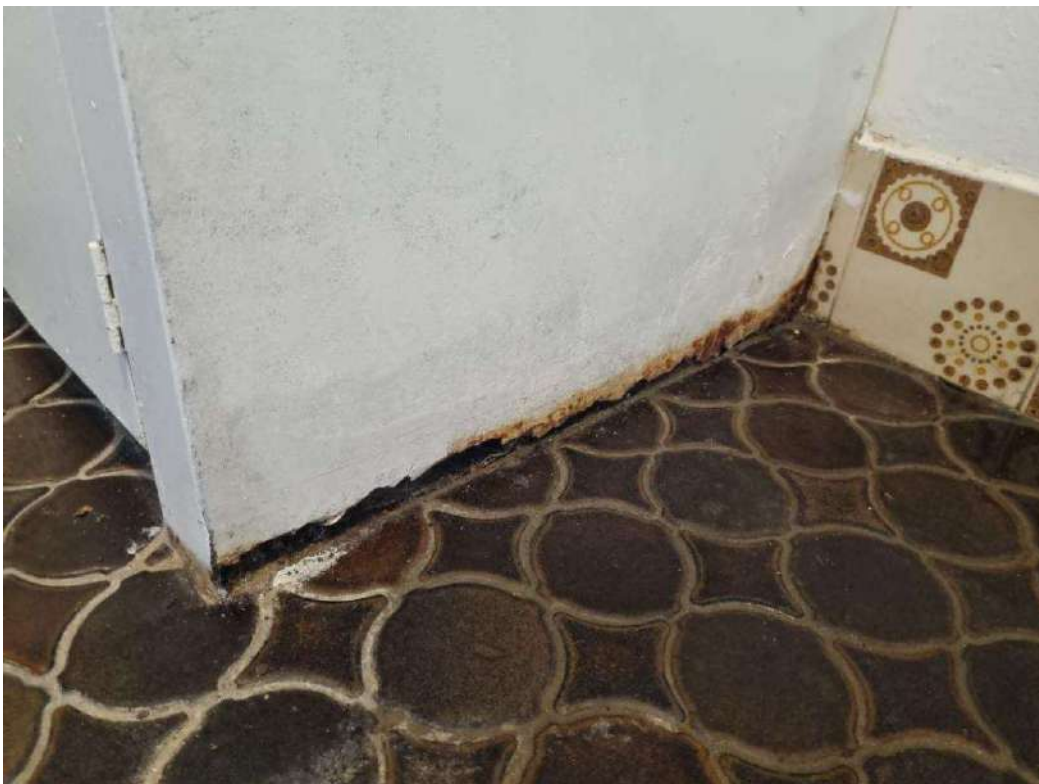
**Maintenance:** General deterioration and wear to sink, cupboards and benches. Recommendation: Engage a cabinet maker for refurbishment if desired.

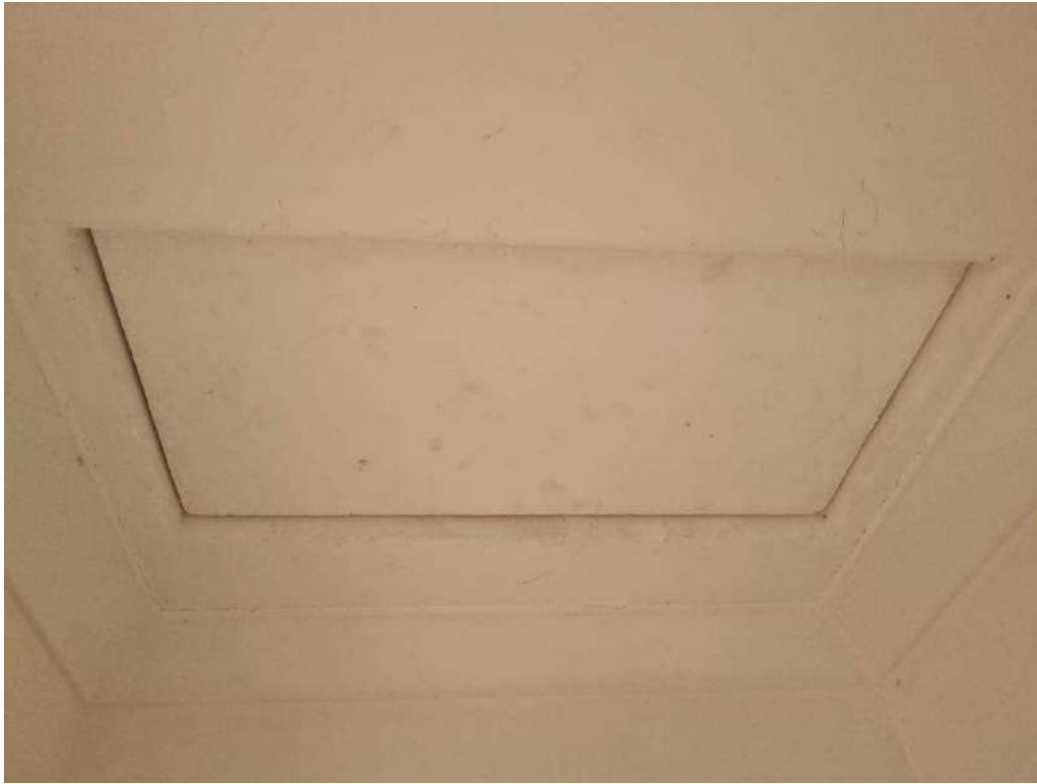
**Maintenance:** General scuffs and marks to manhole cover. Recommendation: Engage a painter for repairs.
