Inspection Report

SURE Pty Ltd

Pest And Building Inspection

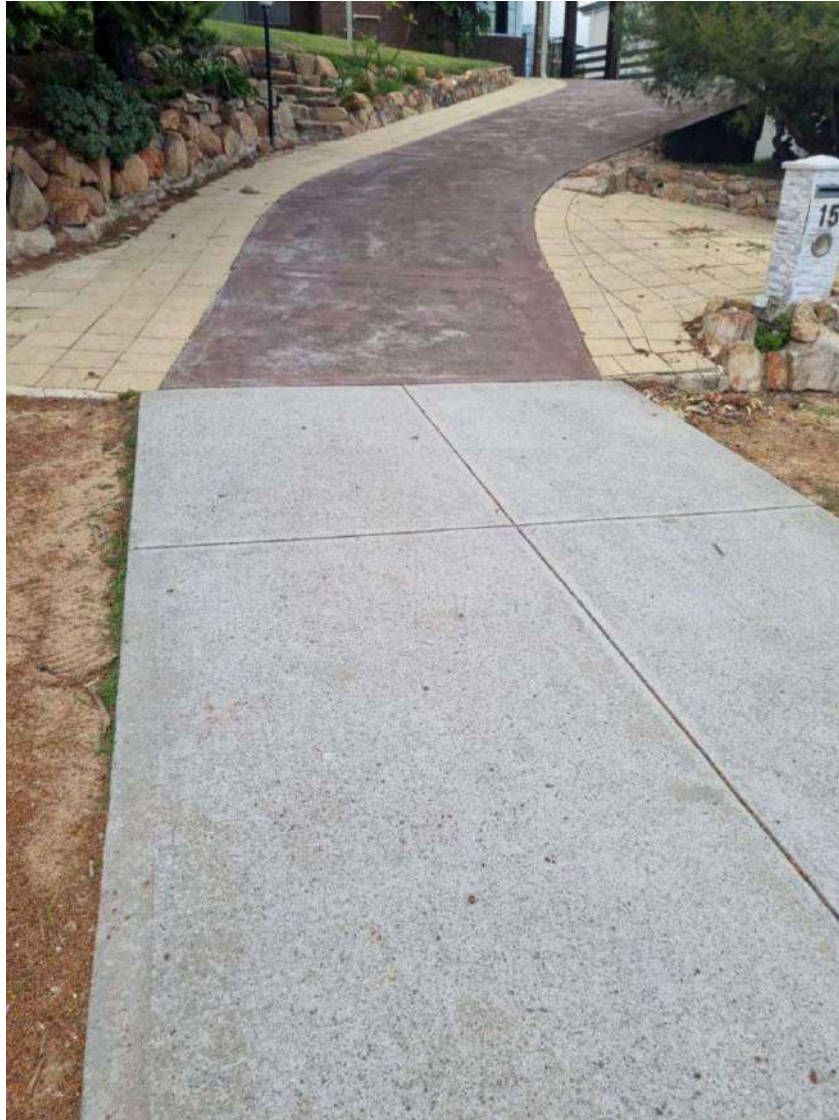
Maintenance: Common cracks and settlement was observed on the driveway. Recommendation: Whilst these cracks appeared to be typical at the time of inspection, we strongly recommend you monitor these cracks and if worsening occurs engage a concreter for further advice and repair.

Maintenance: Sections of the driveway are in poor condition and replacement is recommended. Recommendation: Engage a qualified concreter for a repair.

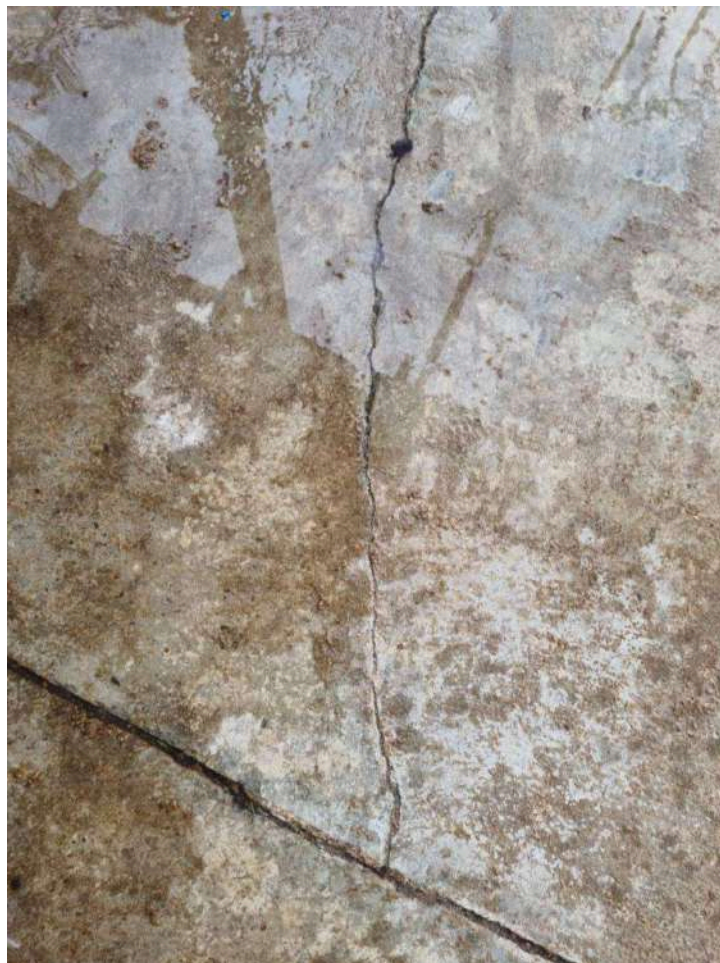
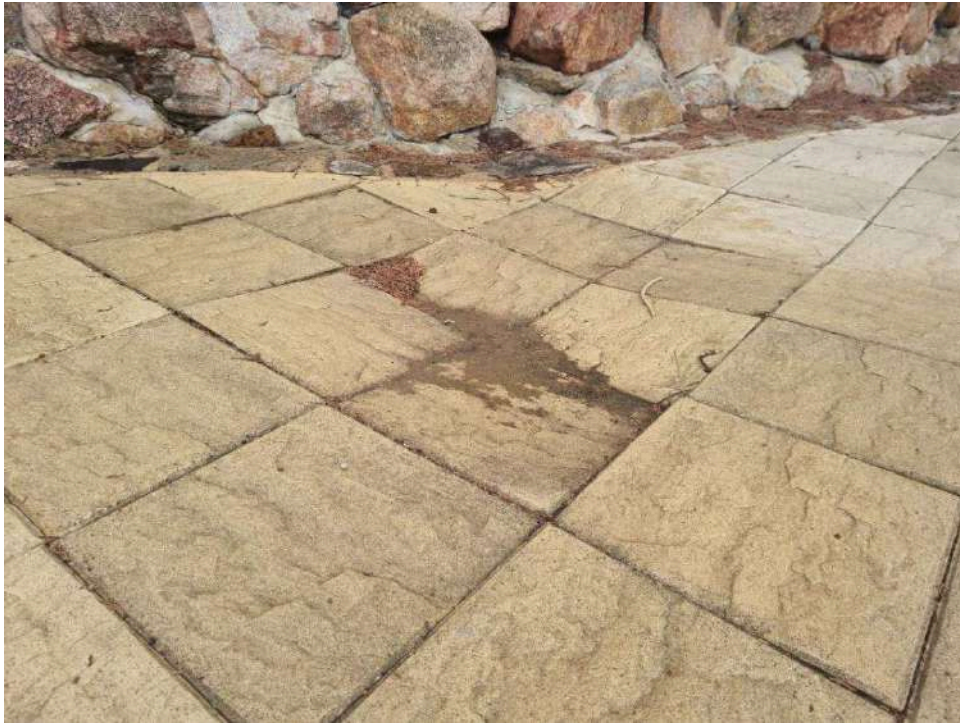
Maintenance: Common cracks and settlement was observed on the path area/s.

Maintenance: The surface has raised and settled in some areas. This can cause water ponding.

Recommendation: Whilst these cracks appeared to be typical at the time of inspection, we strongly recommend you monitor these cracks and if worsening occurs engage a concreter for further advice and repair.

Recommendation: Engage a landscaper for relay affected sections.

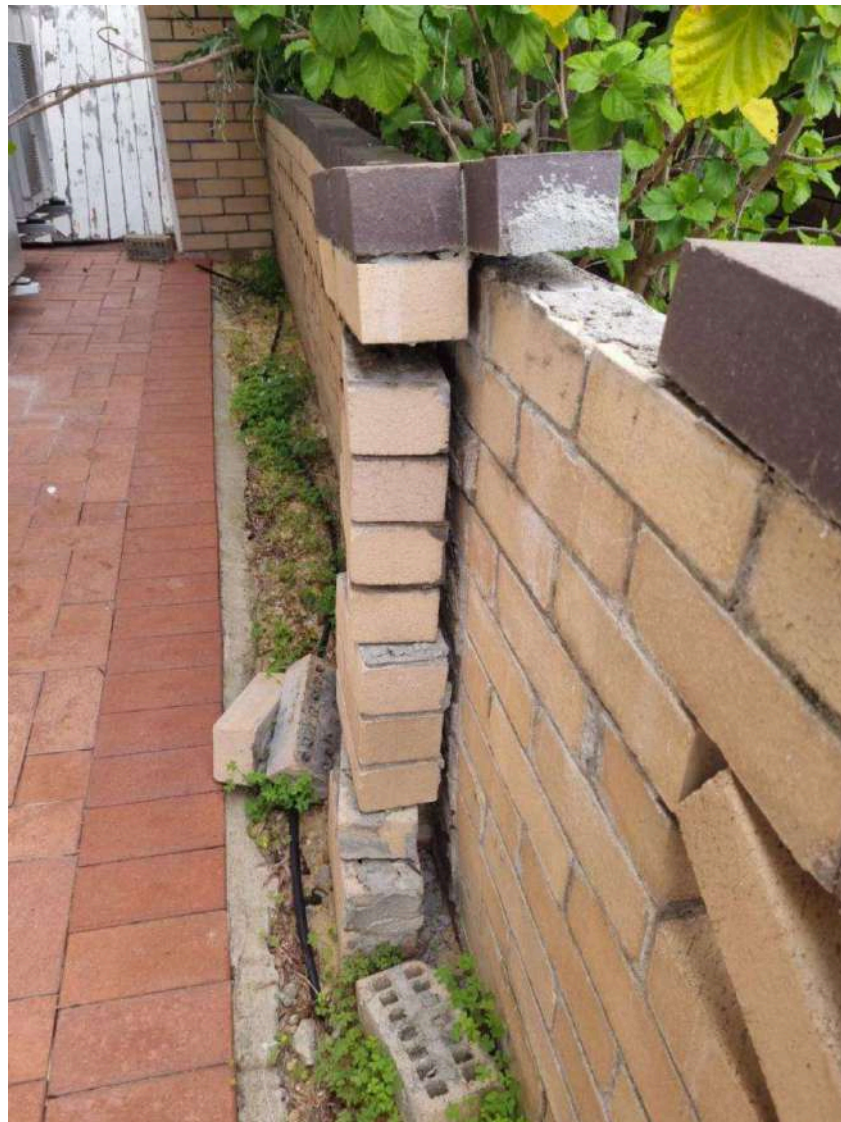
Health and Safety: The brick fence can be rocked by hand and is unstable. This is a safety hazard. Recommendation: Engage a qualified bricklayer for advice and repair.

Health and Safety: Section of the fence are fibrous cement sheeting. Recommendation: Conduct an asbestos lab test to confirm material. Considered a potential health and safety defect.

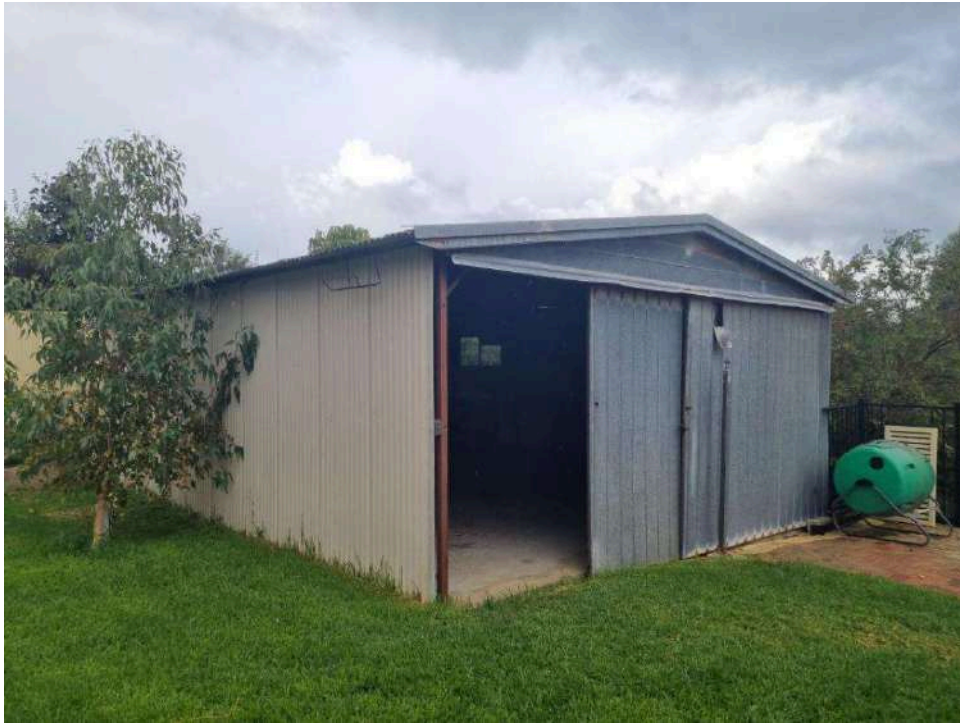
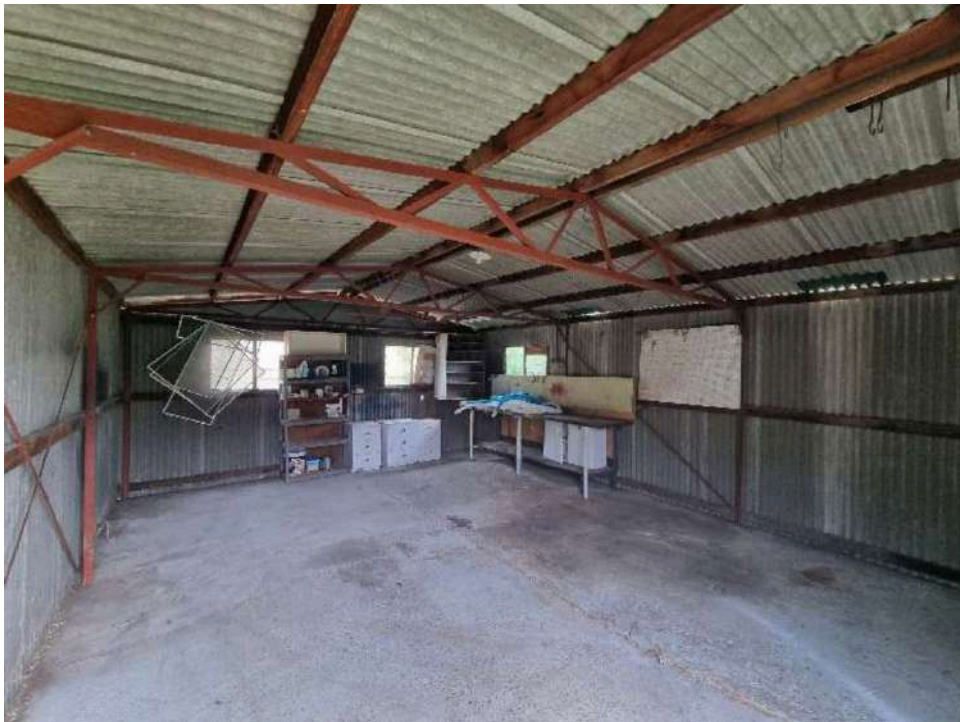
Health and Safety: Section of the shed are fibrous cement sheeting. Recommendation: Conduct an asbestos lab test to confirm material. Considered a potential health and safety defect.

Maintenance: Rust noted to be developing on cladding. Recommendation: Engage a handyman to complete repairs to restrict rust or replace affected sections if desired.

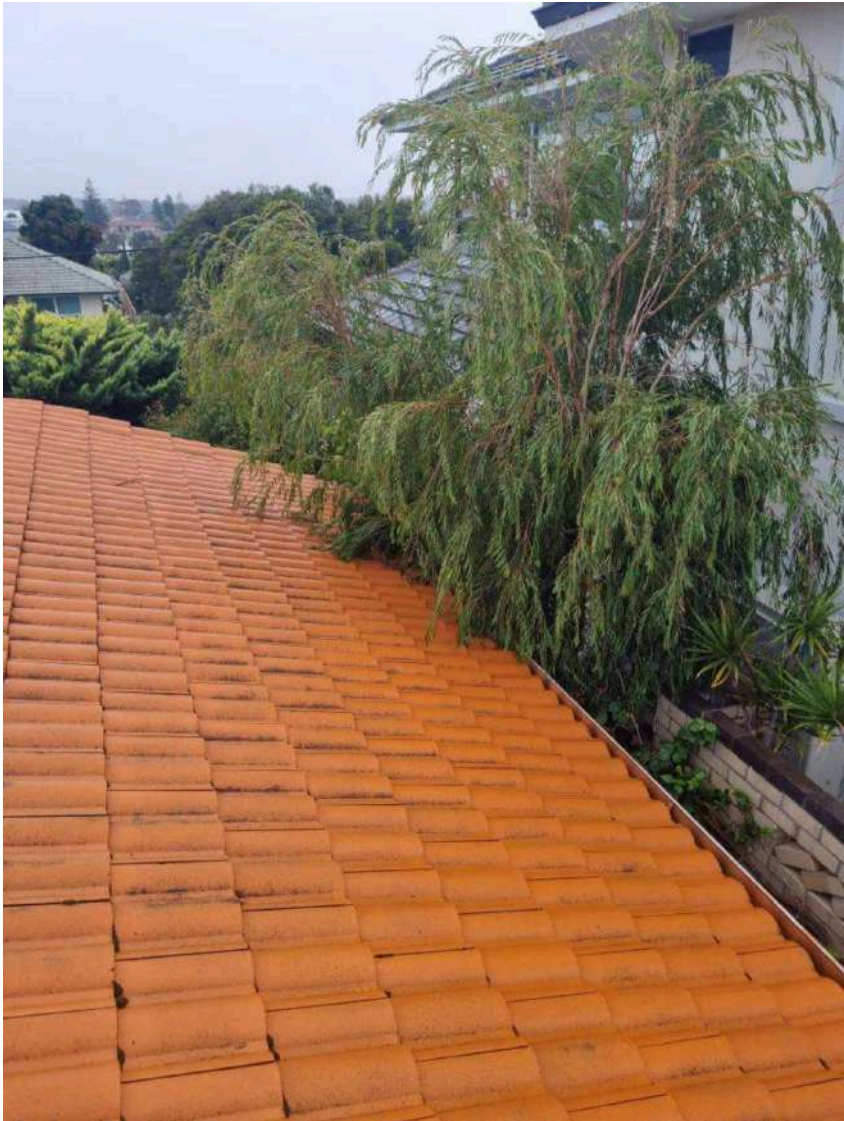
Maintenance: Trees are overhanging roof areas. Recommendation: Engage a tree lopper or arborist to cut back away from the roof line and gutters.

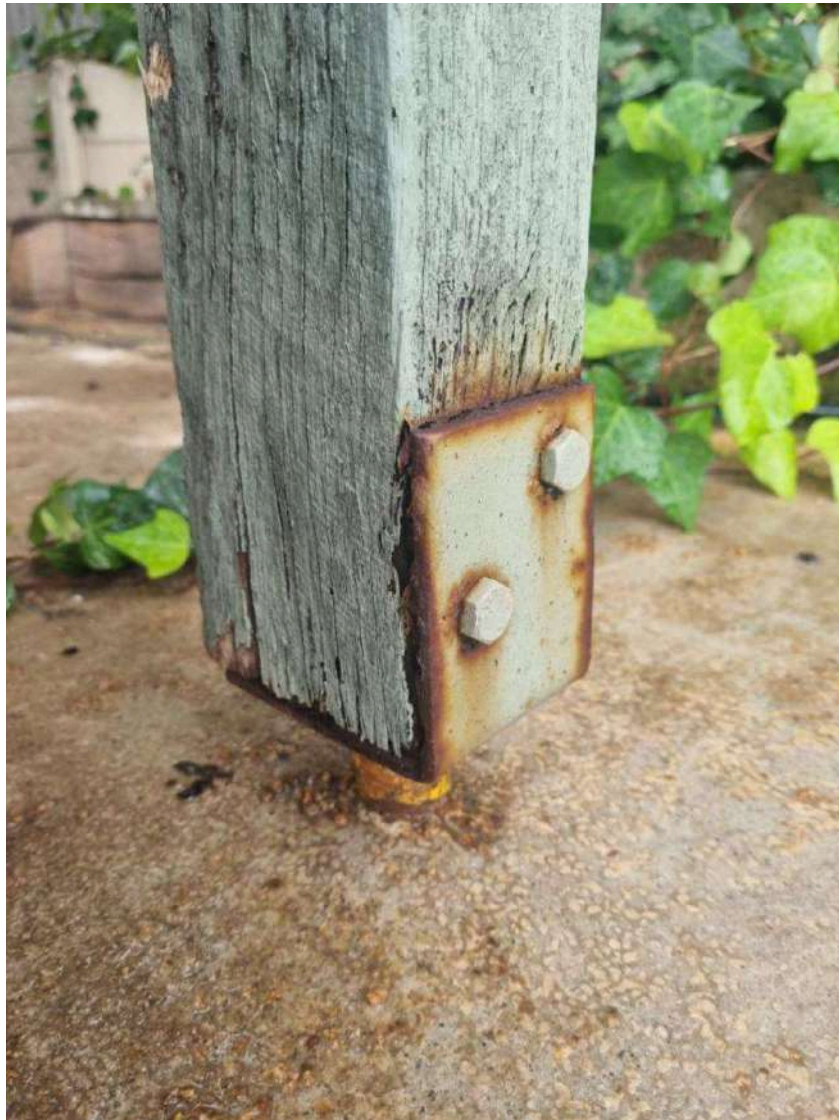
Structural minor: Rust observed to pergola post metal stirrups. If left unattended the pergola will become unstable/unsafe. Recommendation: Engage a carpenter to replace.

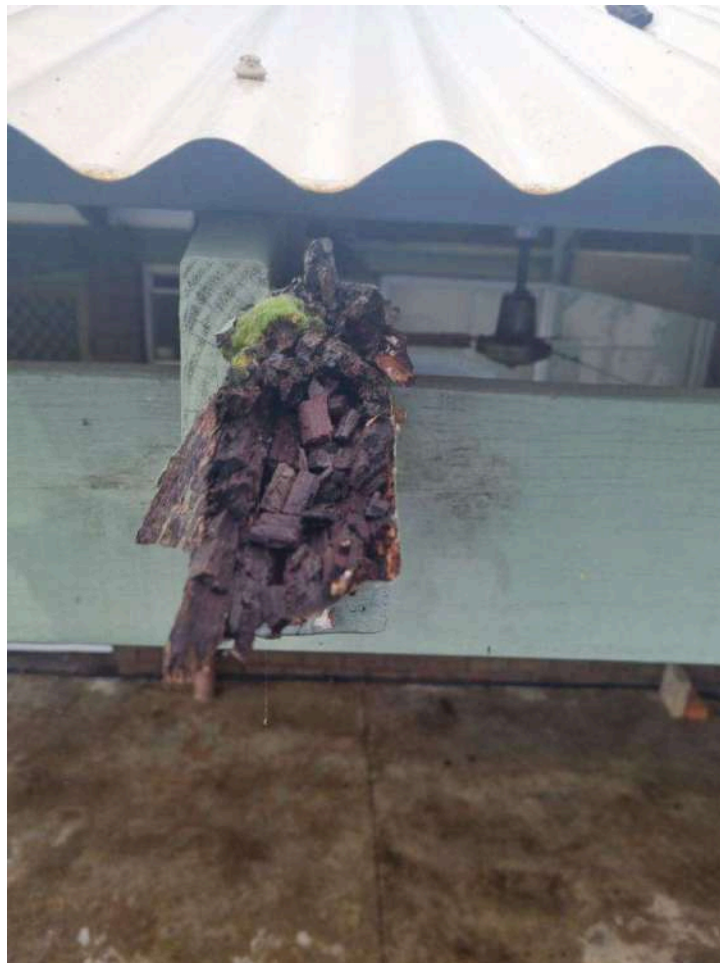
Structural Minor: Timber fungal decay observed in sections of bearers or joists. Recommendation: Engage a carpenter for repairs.

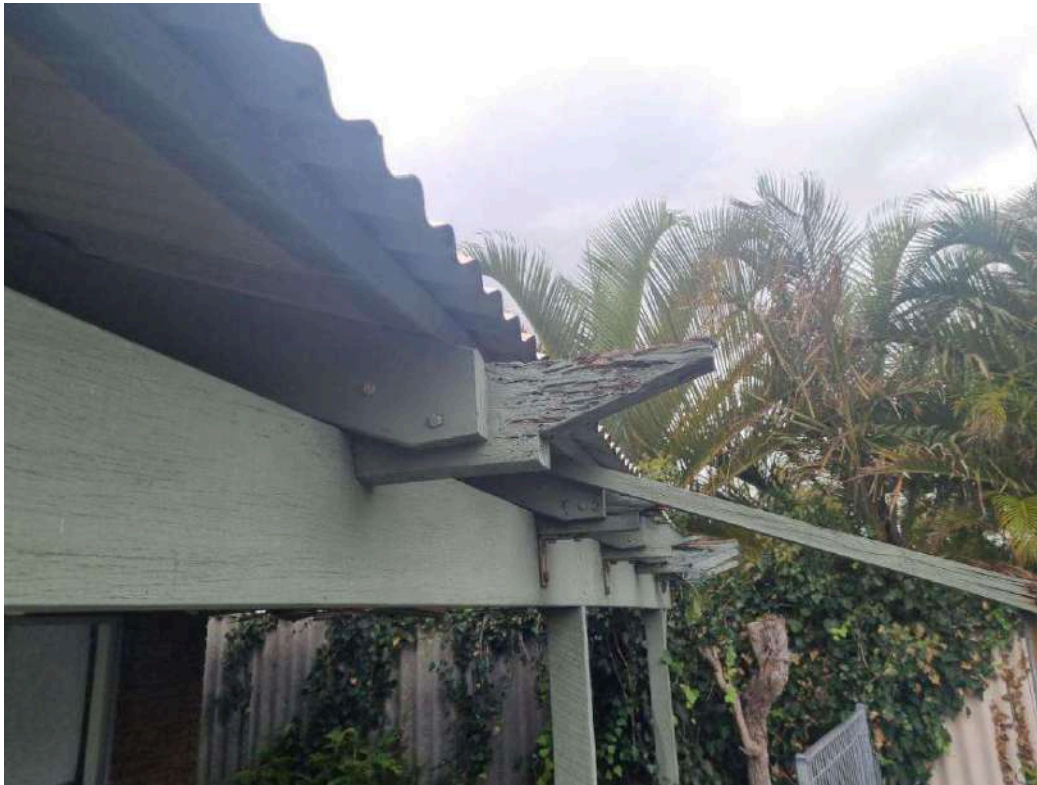
Maintenance: Gutters not fitted and not connected to storm water discharge. Water discharge not

connected to storm water has the potential to cause differential settlement to the footings, cause rising damp and is also conducive to termite infestation. Recommendation: Engage a roofing contractor for repairs.

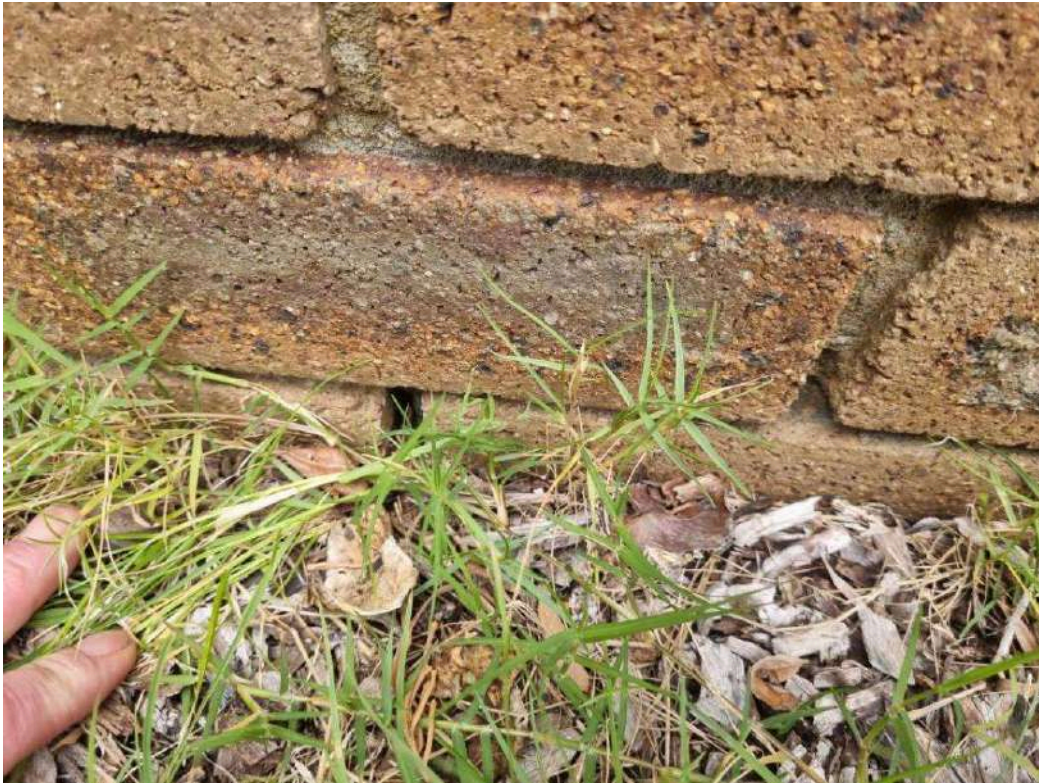
Maintenance: Some weep holes are partially blocked by soil. Recommendation: Engage a landscaper to lower finished ground levels to fully expose all weep holes on the lower brick courses around the dwelling.

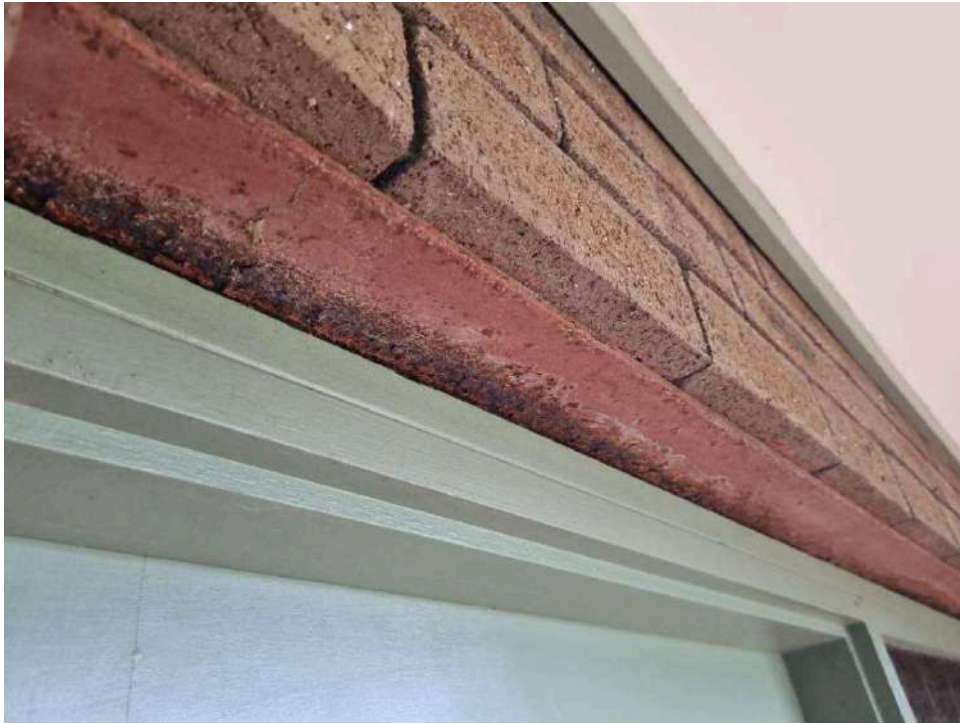
Maintenance: Lintel rust observed above front entry door. Rust in lintels can cause cracking in the above brickwork. Recommendation: Engage a painter to polish out the rust and re-coat.

Maintenance: General age/damage has occurred to door frame, face or components. Recommendation: Engage a carpenter and/or painter for repairs.

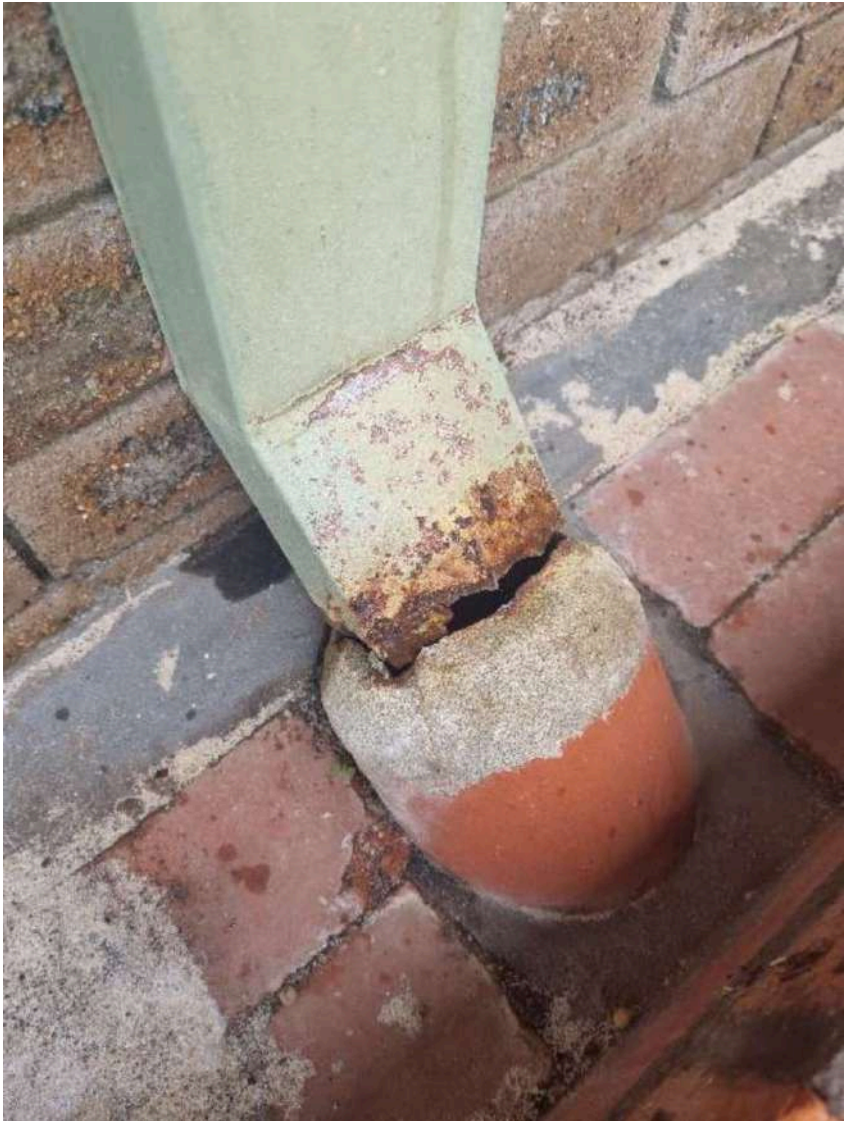
Maintenance: Rust penetrations observed to down pipe/s. Recommendation: Engage a roofing contractor to repair or replace affected down pipes.

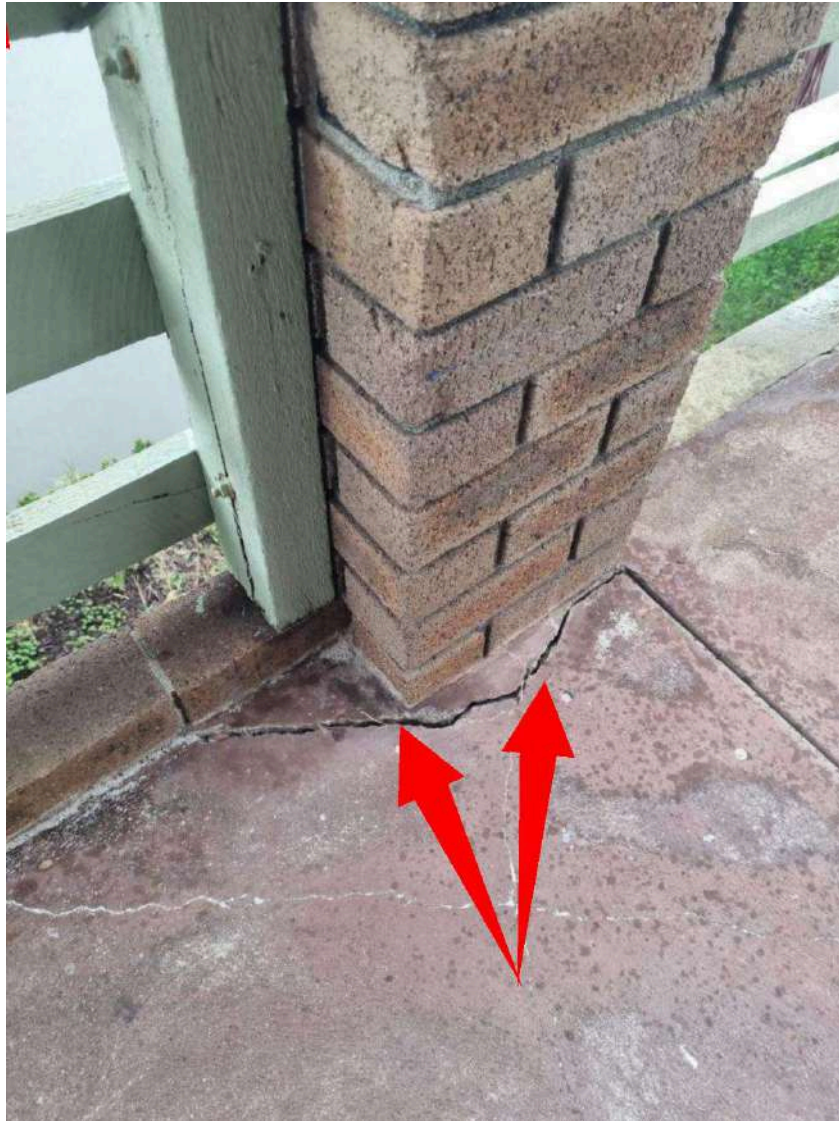
GARAGING	Attached Carport	Floor Observations	Structural Major: Cracks observed in damage Category 3 to 4. Please refer to column/post section of Attached Carport for photo. Possible causes may be foundation movement, support structure deflection, thermal movement, moisture uptake or loss or failure under external loads. Recommendation: Engage a registered builder to complete repair works. A structural engineer should be consulted for further evaluation to determine scope of repair. <i>For clarification on the category of cracks with a damage category of 3 to 4, please refer to Cracking of Building Elements in Section 2D of the Terms and Conditions of this report.</i>
ROOF VOID	Roof Void Findings	Roof Framing Observations	Structural Major: Unevenness in underpurlin - insufficient load support contributing to sagging / unevenness in roof line. Recommendation: Engage a carpenter for installation of additional strut components to adequately support the load of the roof frame/covering.

Recommendation: Engage a structural engineer for further assessment and advice regarding repairs.

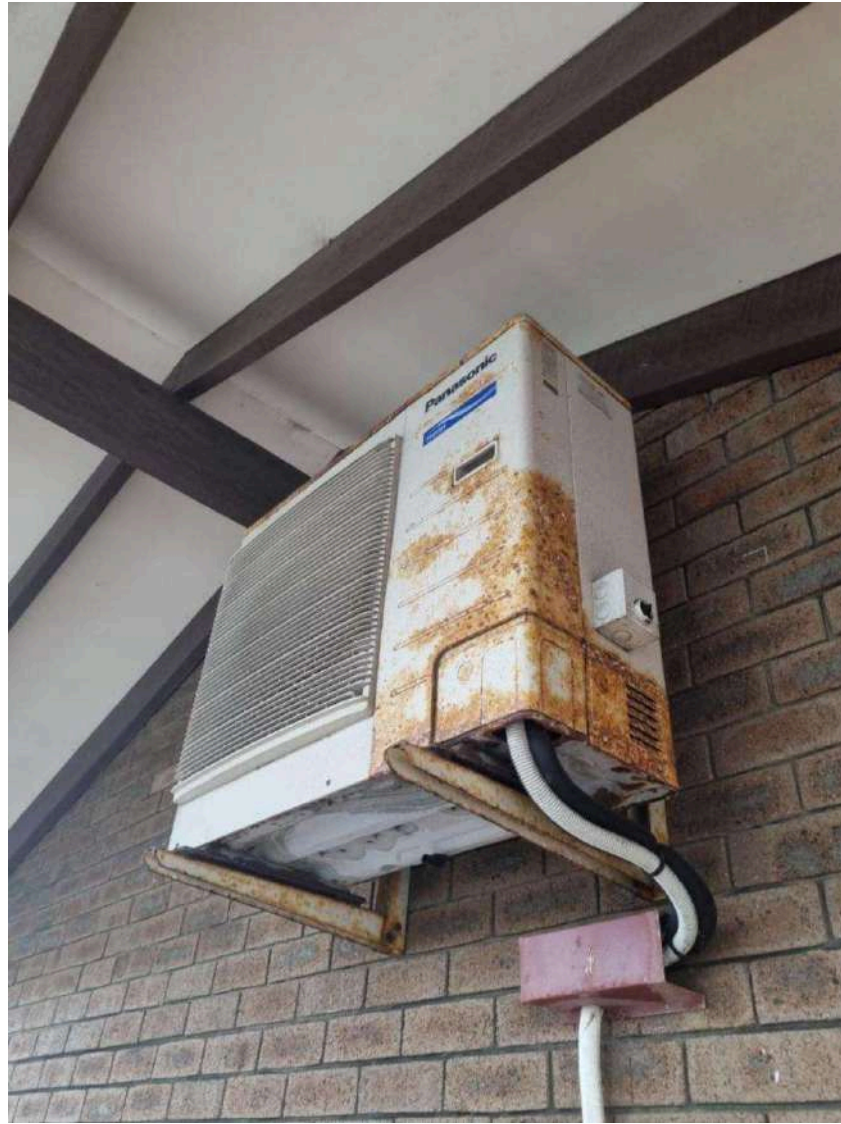
Maintenance: Rust noted to external compressor fan unit. Recommendation: Engage a technician for servicing and maintenance.

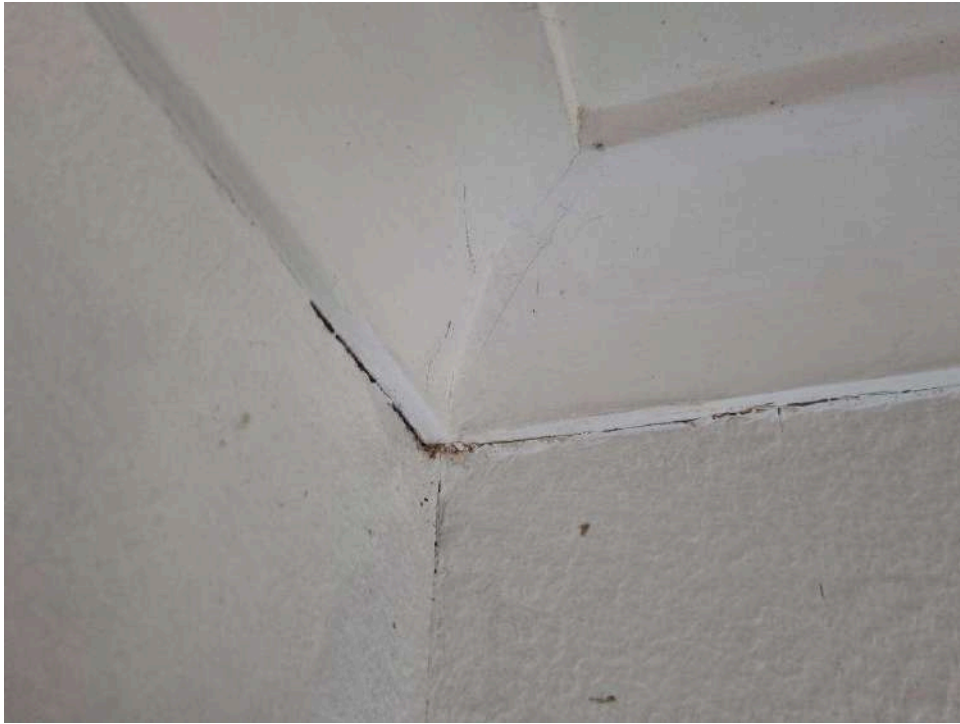
Maintenance: Ceiling stains with normal moisture readings obtained. The cause may have been repaired, however, you will need to monitor after a prolonged period of rainfall to confirm. Recommendation: Engage a painter for repairs. *Water damaged plaster has the potential for detachment or collapse, if required engage a plasterer for repairs.*

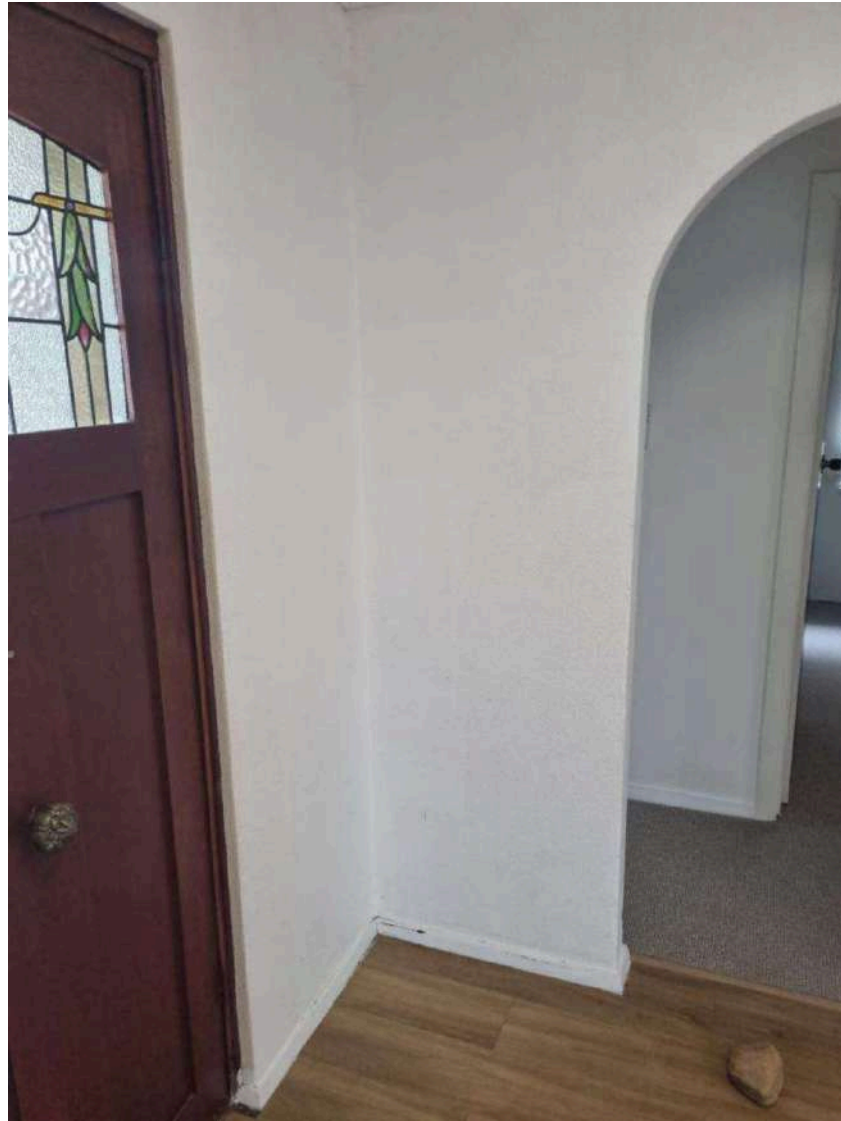
Maintenance: General ageing and/or denting and the like is evident on wall linings.
Recommendation: Engage a painter for repairs.

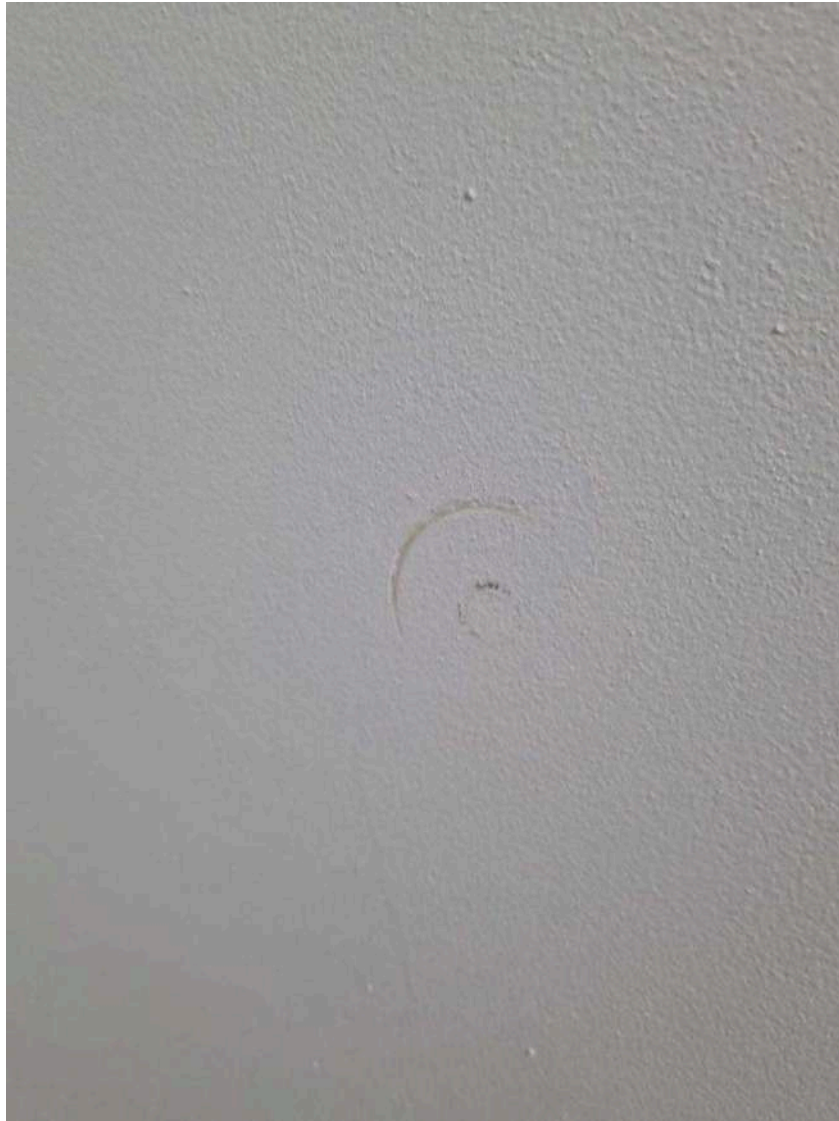
Maintenance: Wall damage from door handle impacting wall lining observed. Recommendation: Engage a handyman to install new door stop and touch up paint.

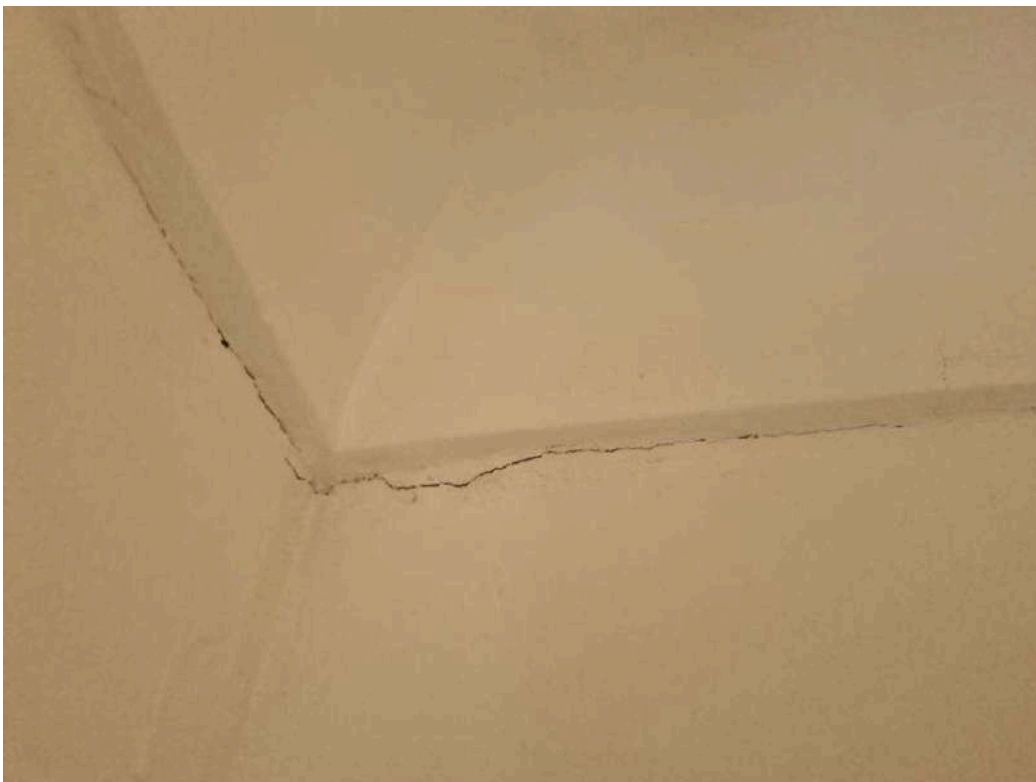
Maintenance: Ceiling/cornice joint crack/s observed. Recommendation: Engage a painter for repairs.

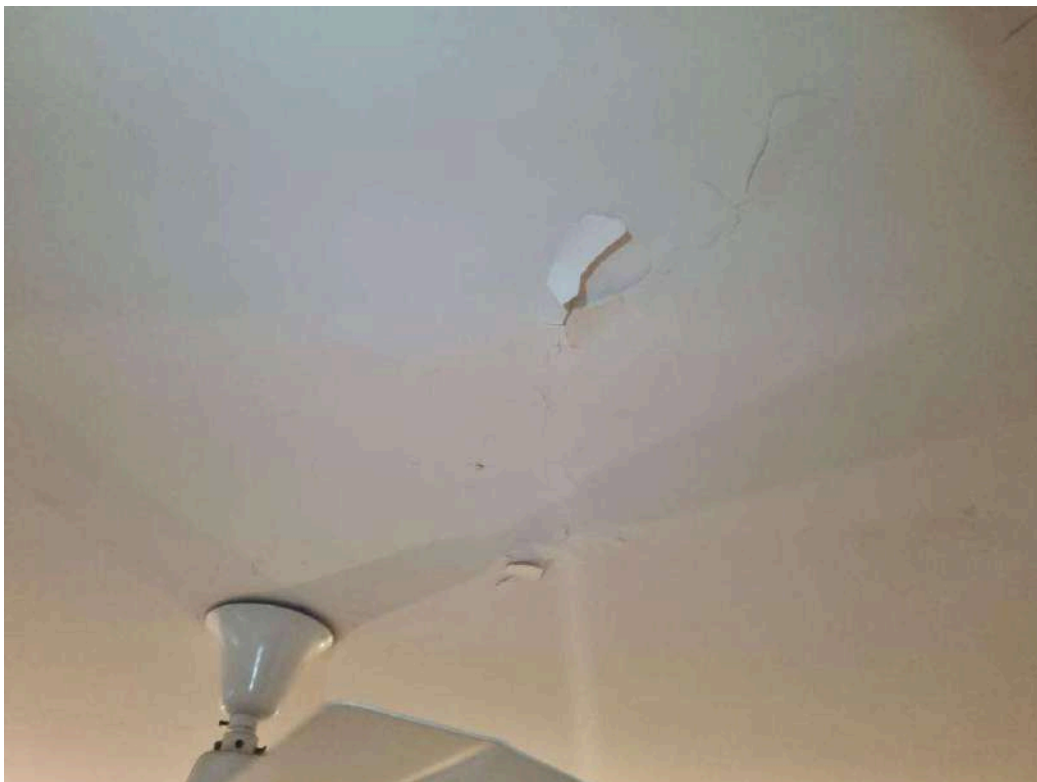
Maintenance: Paint deterioration observed. Recommendation: Engage a painter to repair.

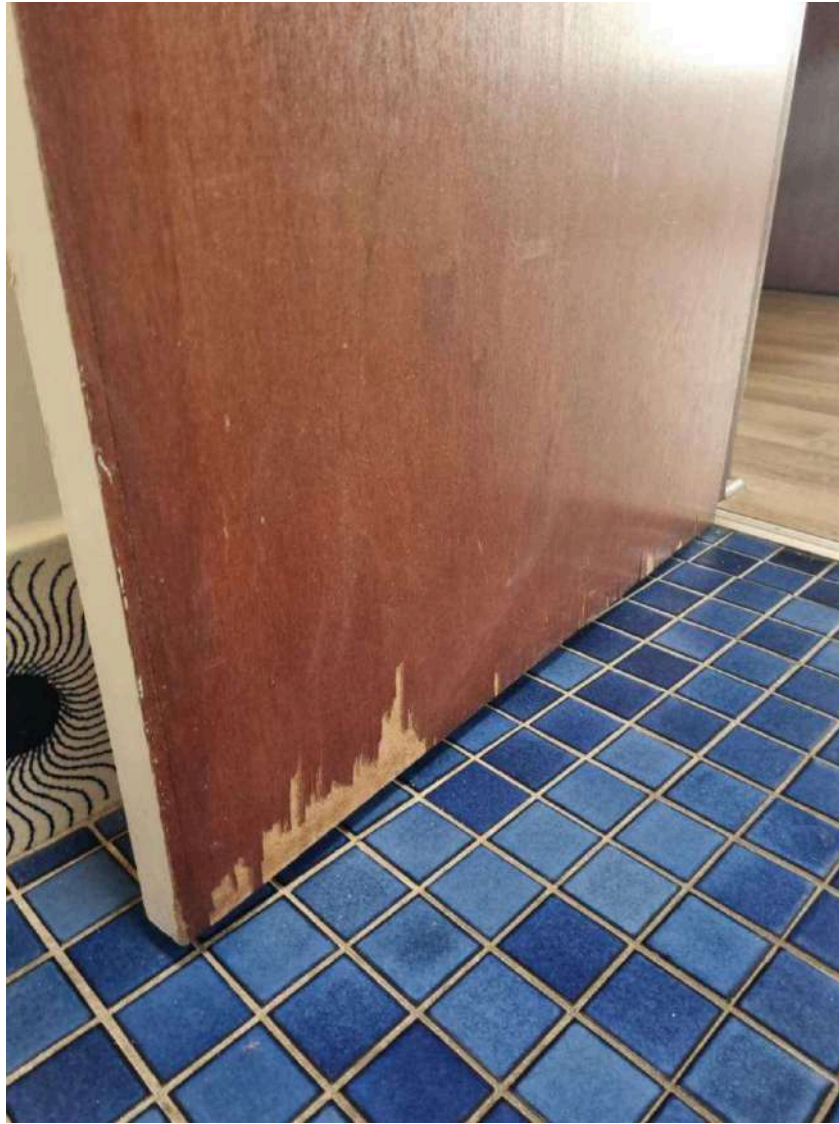
Maintenance: General age/damage has occurred to door frame, face or components.
Recommendation: Engage a carpenter and/or painter for repairs.

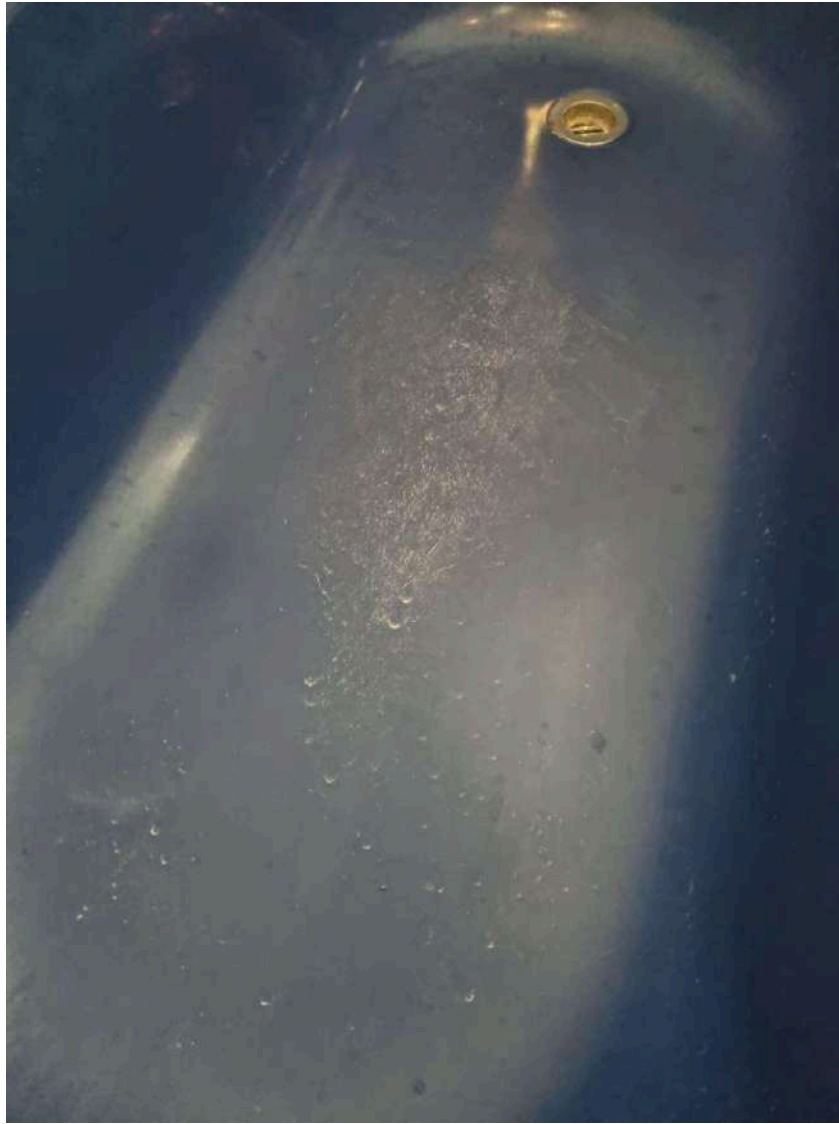
Maintenance: General deterioration and wear to bath tub. Recommendation: Engage a plumber to replace if desired.

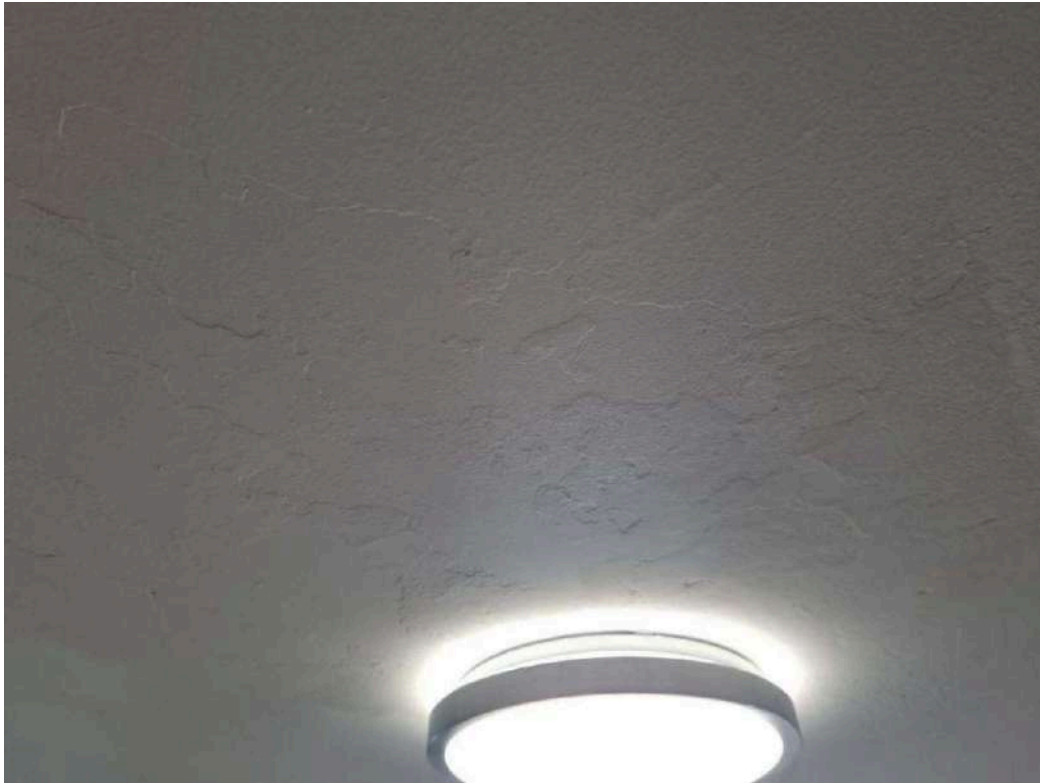
Maintenance: Paint deterioration observed. Recommendation: Engage a painter to repair.

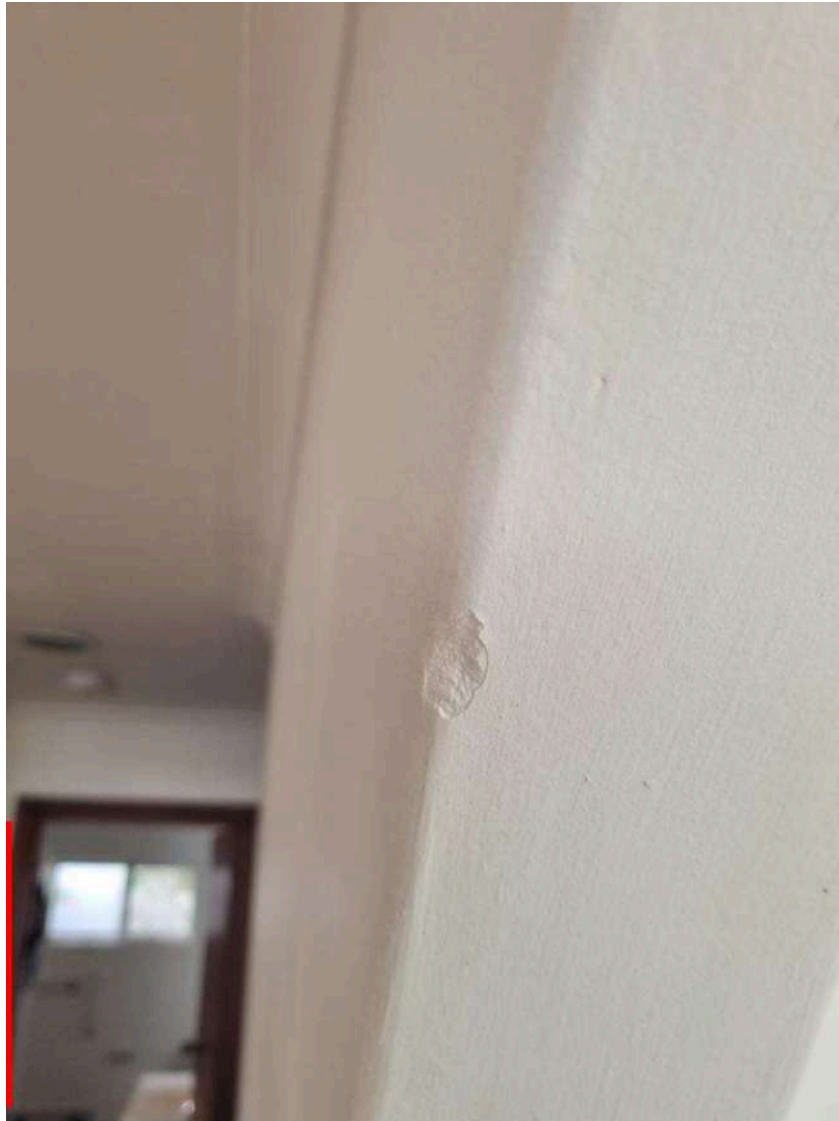
Maintenance: Minor impact damage observed. Recommendation: Engage a painter for repairs.

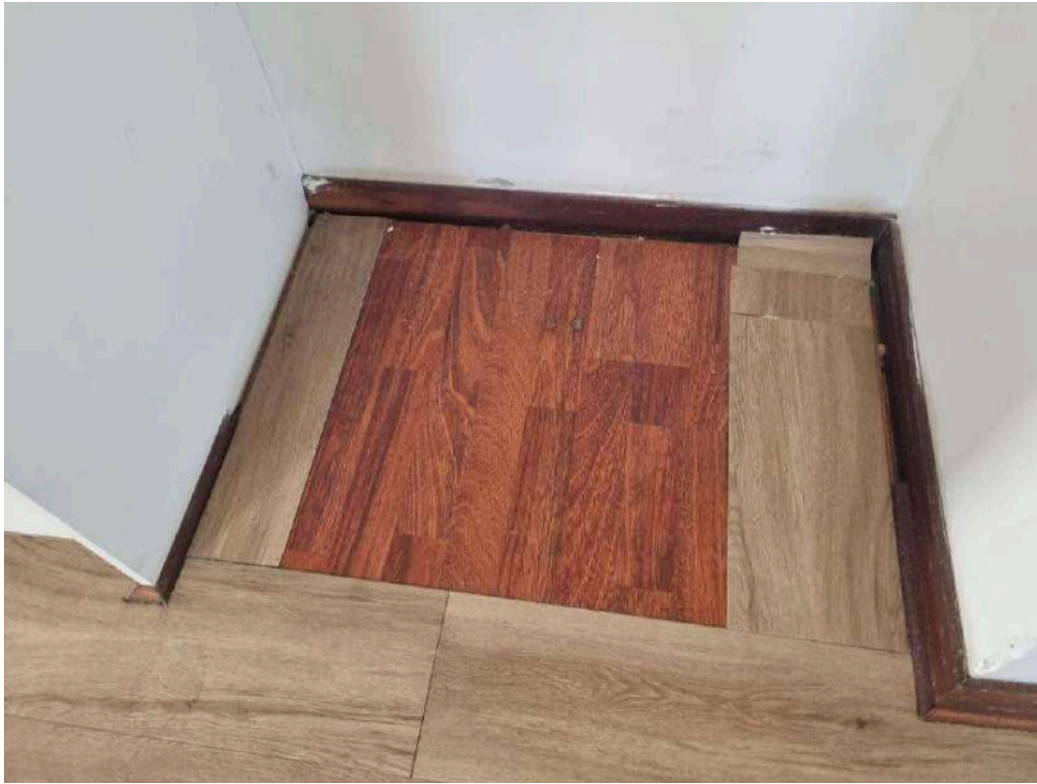
Maintenance: The floor covering is aged with wear/repairs noted. Recommendation: Engage a flooring specialist for advice and recommendations.
