Inspection Report

SURE Pty Ltd

Pest And Building Inspection

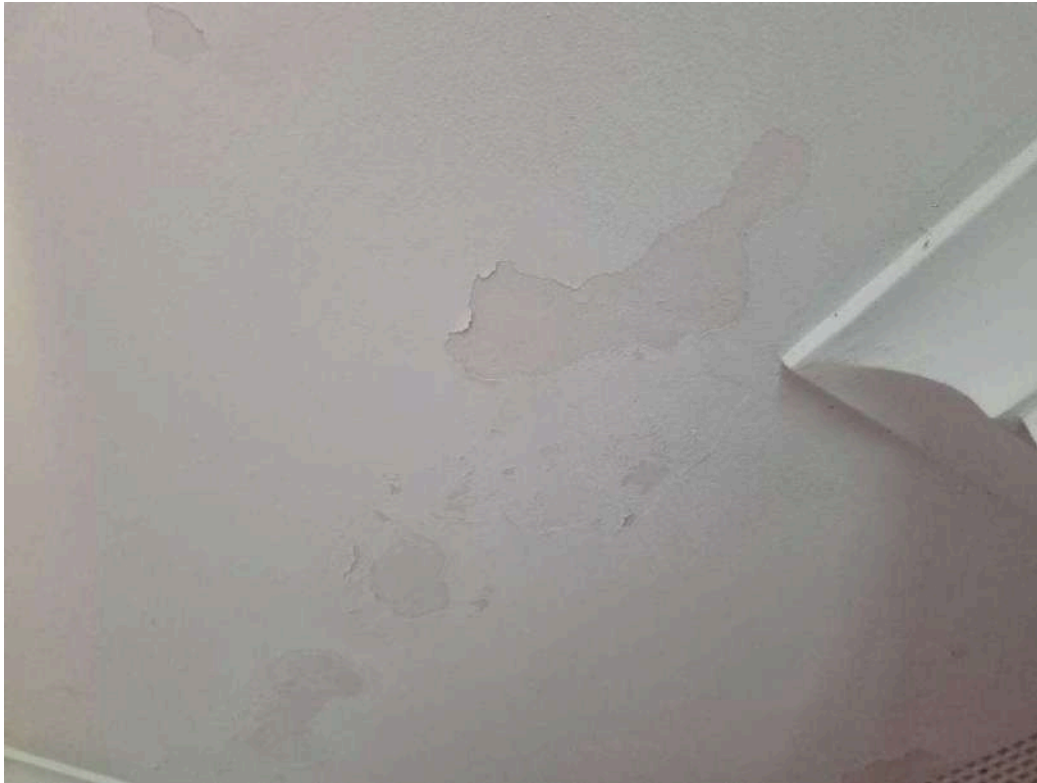
Maintenance: Paint deterioration observed. Recommendation: Engage a painter to repair.

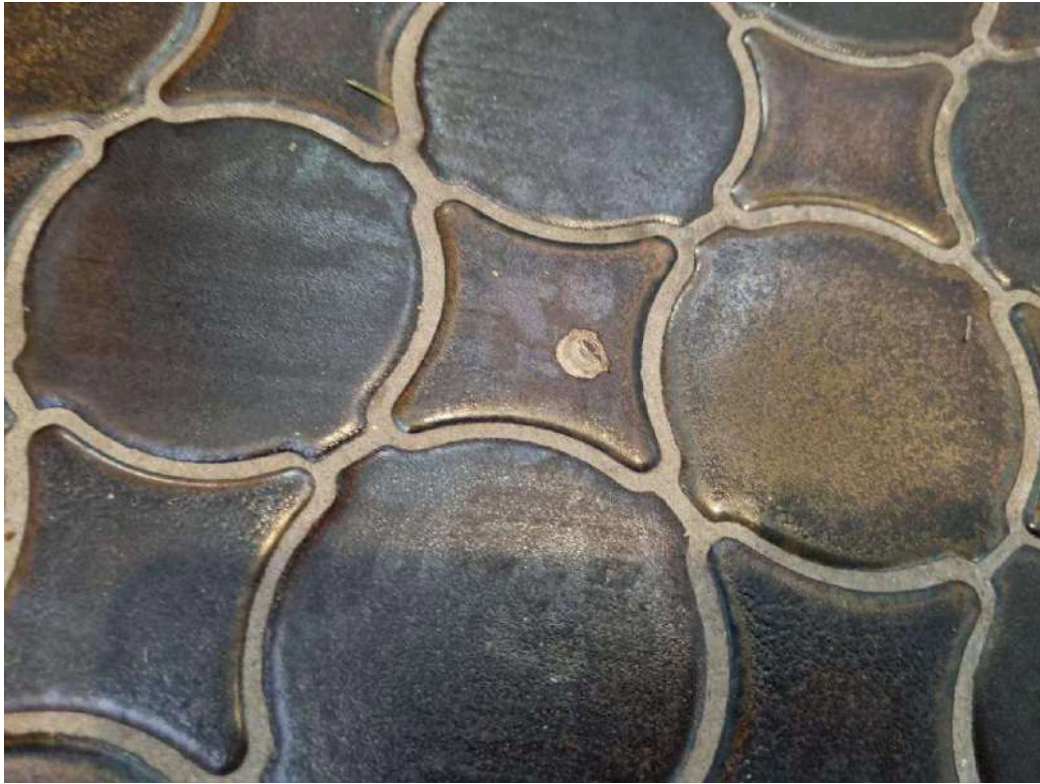
Maintenance: Some chipped and damaged tiled were noted. Recommendation: Engage a tiler for repairs.

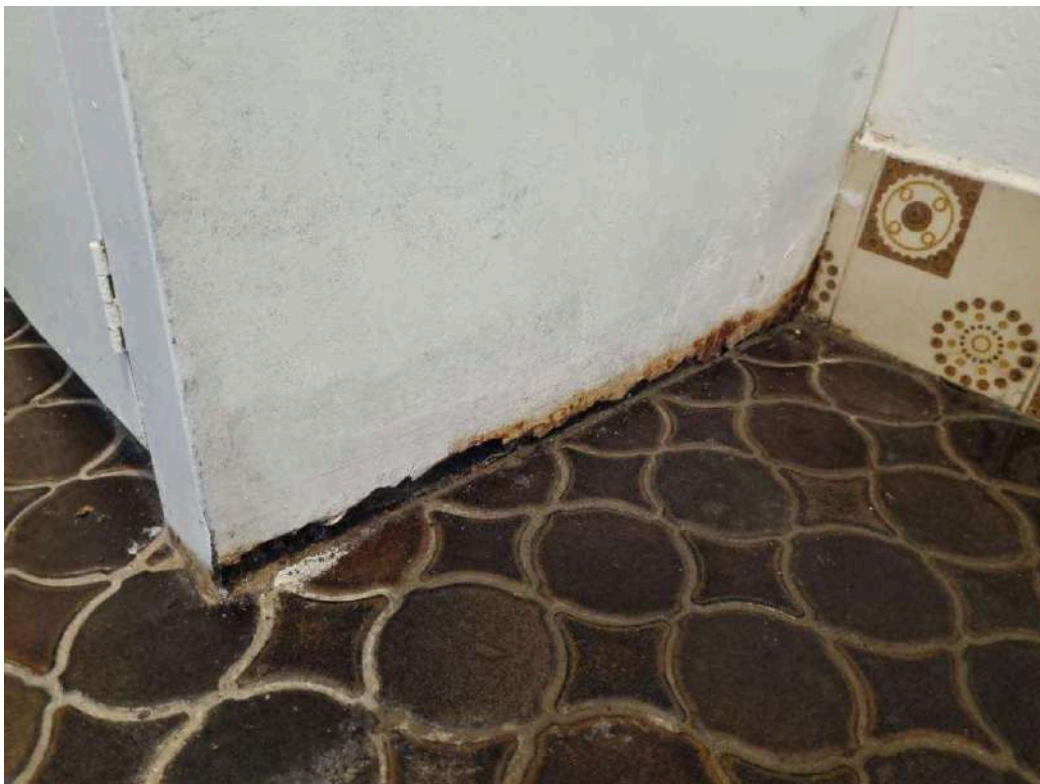
Maintenance: General deterioration and wear to sink, cupboards and benches. Recommendation: Engage a cabinet maker for refurbishment if desired.

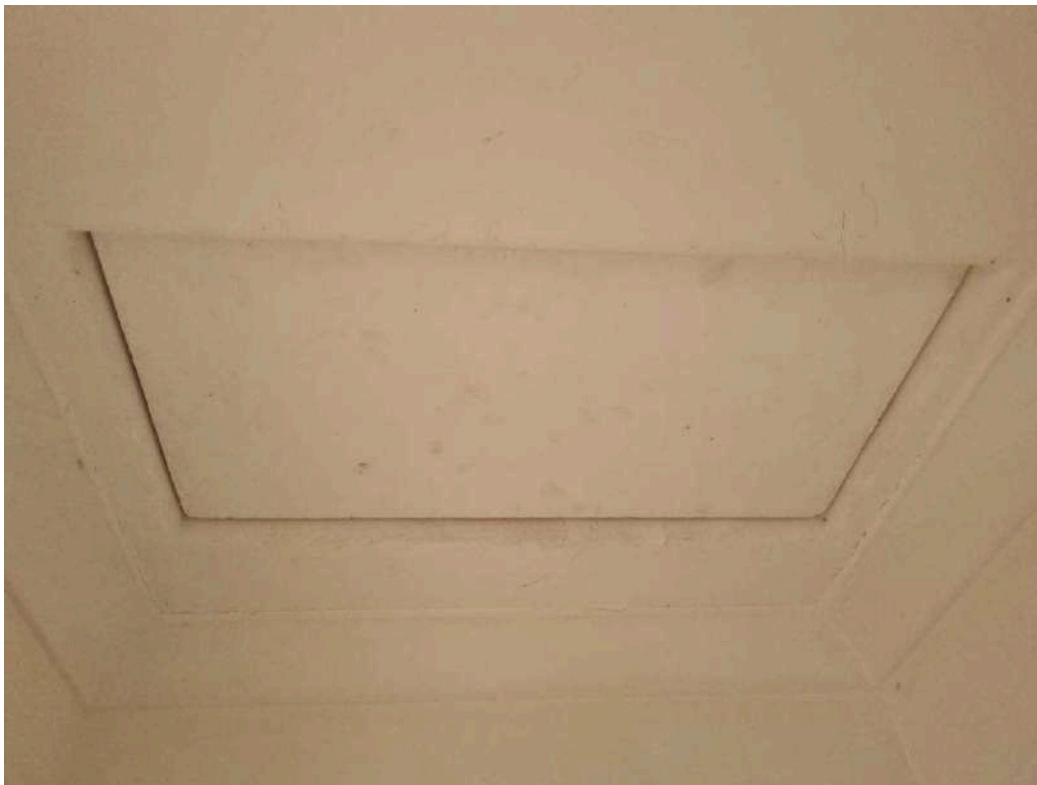
Maintenance: General scuffs and marks to manhole cover. Recommendation: Engage a painter for repairs.

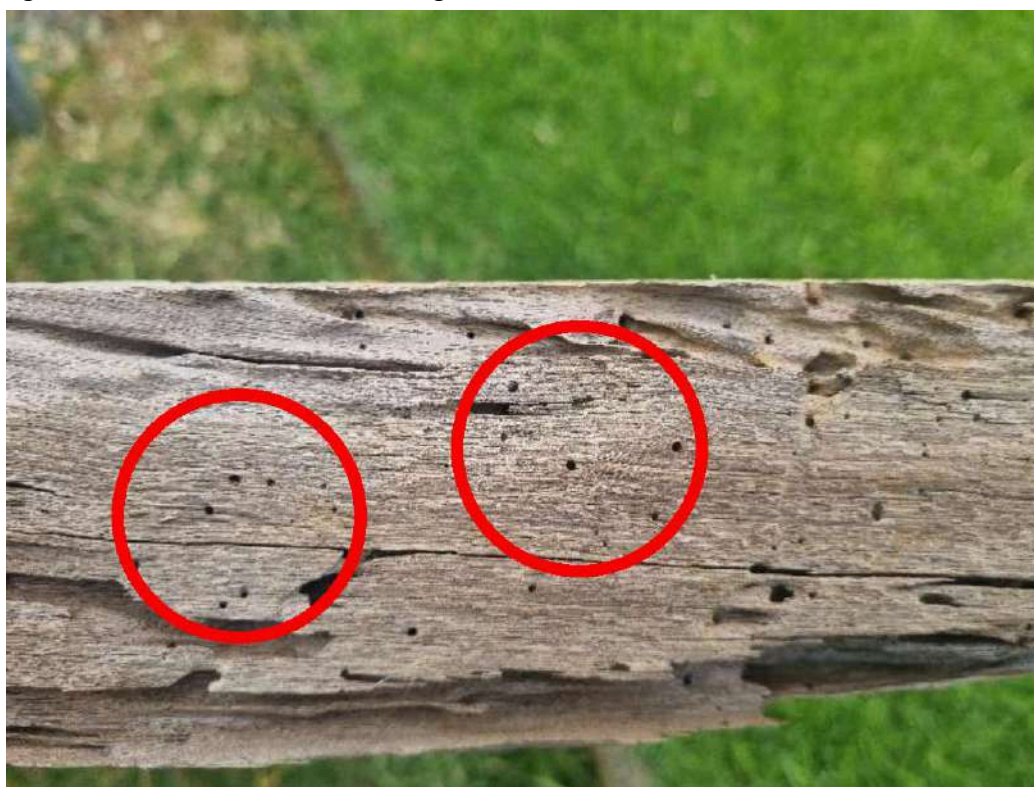
Borer damage was observed to areas of garden timbers.
