Inspection Report

SURE Pty Ltd

PROPERTY AND INSPECTION INFORMATION

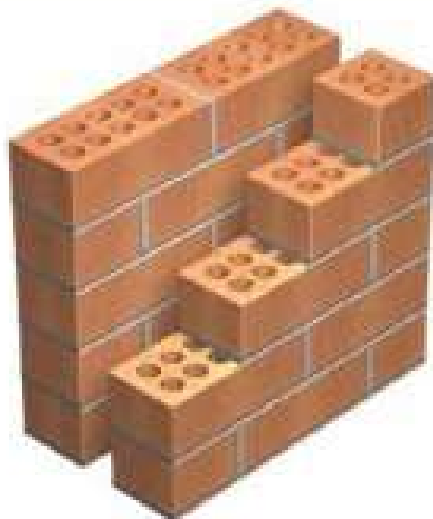
DOUBLE BRICK WALL

The structure is of full (Double) brick construction.

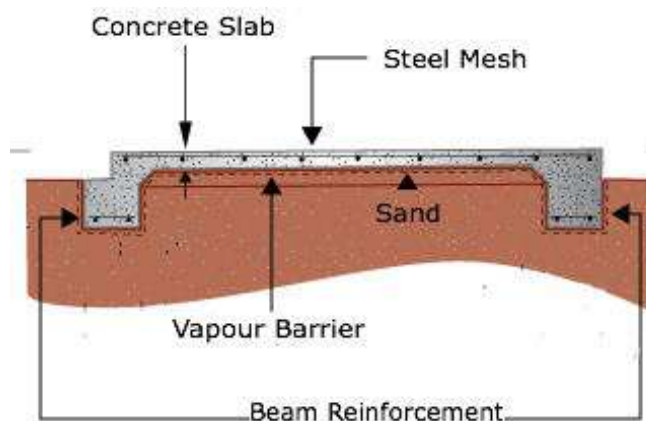
Slab on ground construction.

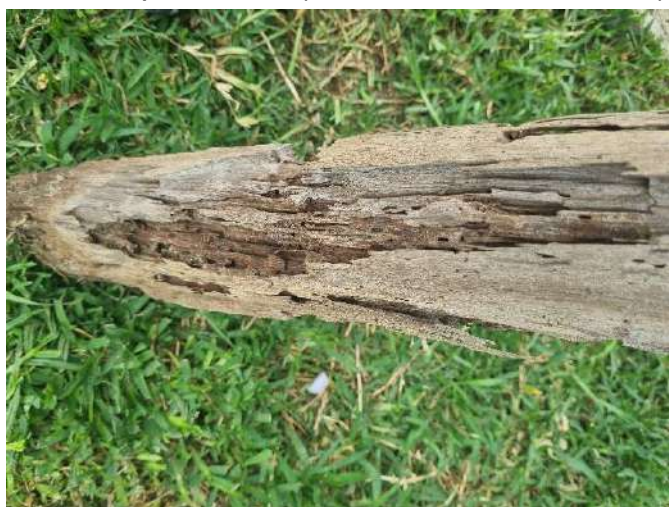
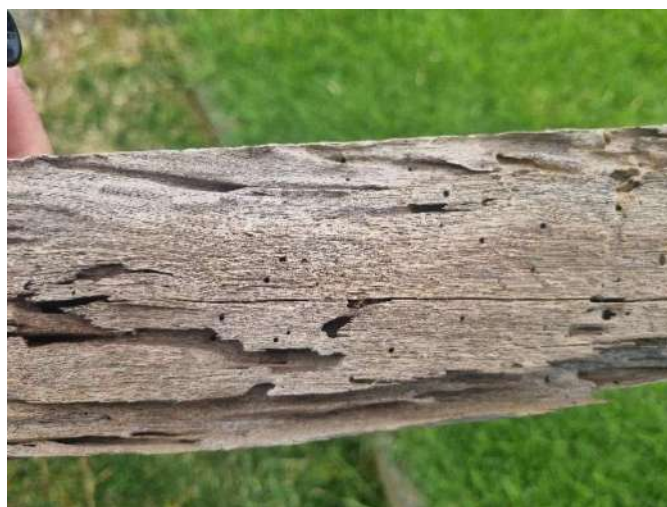
Yes, termite damage was located mainly but not limited to the following.

Garden timbers.

Localised damage.

Where evidence of termite activity was found in the grounds then the risk to buildings is extremely high. A treatment to eradicate the termites and to protect the building(s) should be carried out in the first instance.

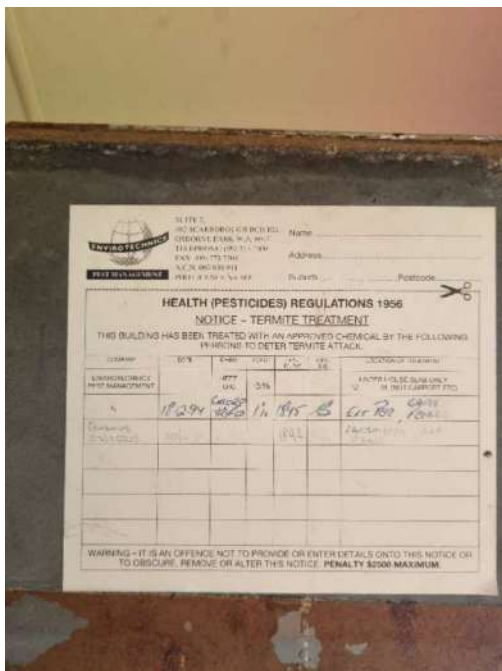
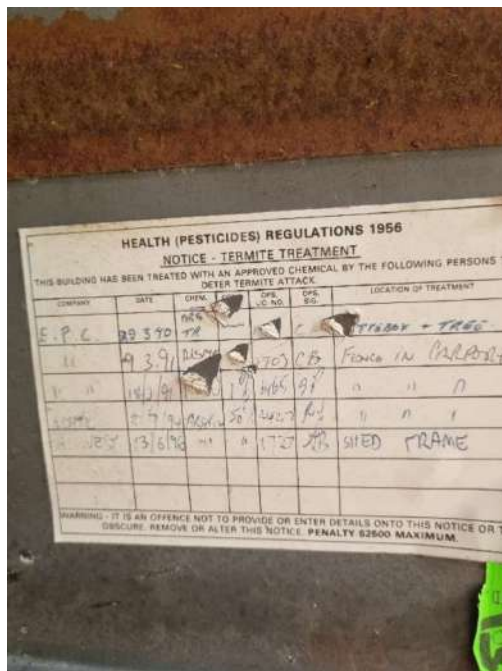
Yes, a durable notice was found in the meter-box during the inspection.

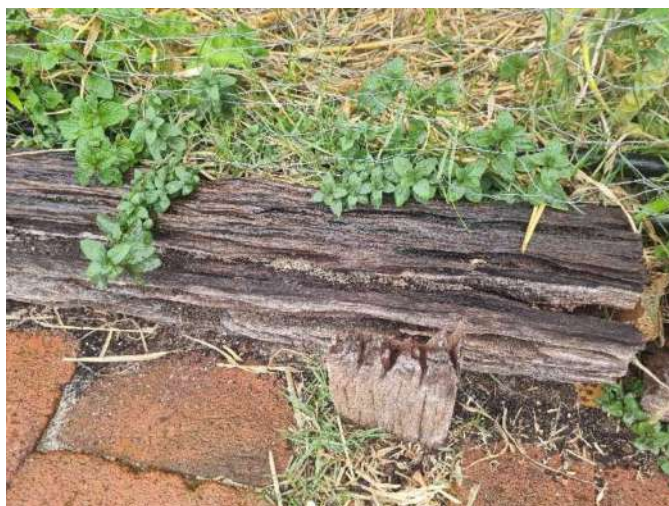
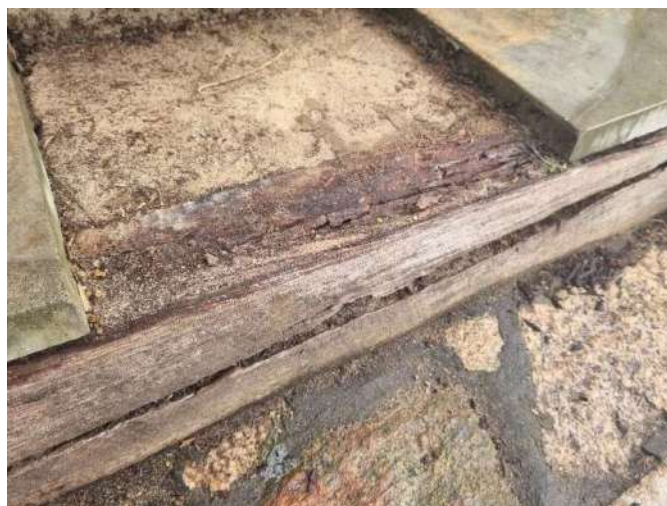
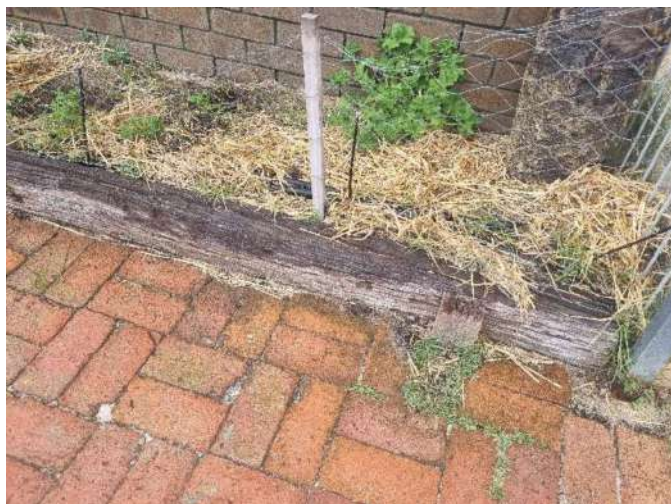
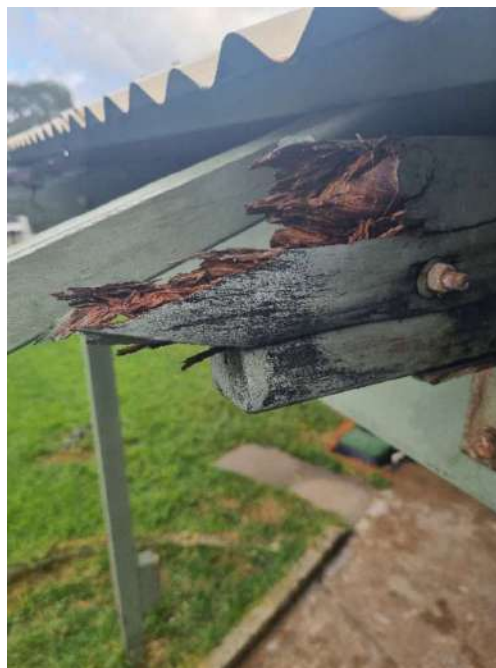
Yes, in the following areas ,
 Garden landscaping sleepers/timbers.
 Pergola framing timbers.

The extent of rot damage is considered to be high.

No, the damage does not present a major safety hazard.

If any evidence of fungal decay or damage is reported you should consult a building expert determine the full extent of damage and the estimated cost of repairs or timber replacement (see terms & limitations).

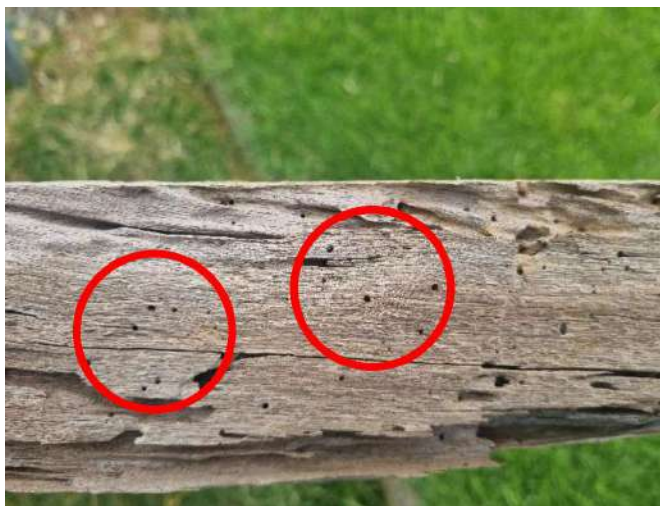
Yes, an undetermined species of borer damage was found.

Moderate Damage was Found in

Borer damage was observed to areas of garden timbers.

Replacement of all susceptible timbers is always preferred since, in the event of selling the property in the future it is probable that an inspector will report the borers as active (see above). A chemical treatment to control and/or protect against furniture beetle and/or queensland pine beetle can be considered as a less effective, lower cost option. Before considering this option you should consult with a builder (see terms & limitations) to determine if the timbers are structurally sound. Following the initial treatment a further inspection is essential in twelve months time to determine if further treatment is needed. Treatments over a number of consecutive years may be required. Note: Only lyctus borer/powder post borer, pin-hole borer and furniture beetle presence is inspected.

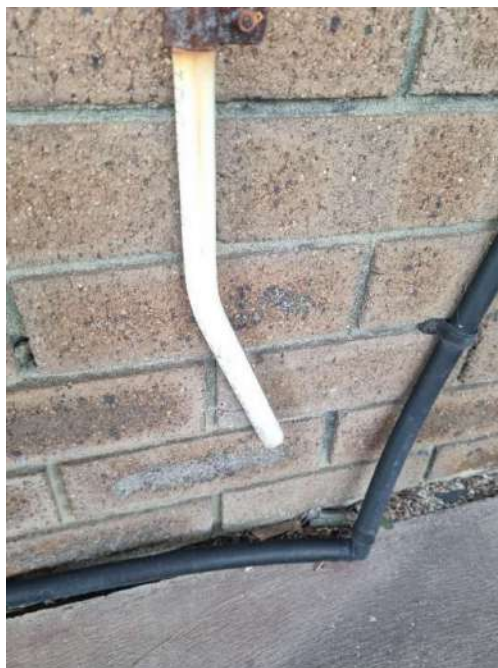
There was water leakage detected during the inspection from the hot water overflow. This should be diverted away from the dwellings walls or into a drain.

Was the Hot Water Overflow Sufficiently Drained

Hot water unit overflow not connected to drain. This provides conducive conditions for termite infestation.

No. Divert hot water overflow away from the building perimeter.

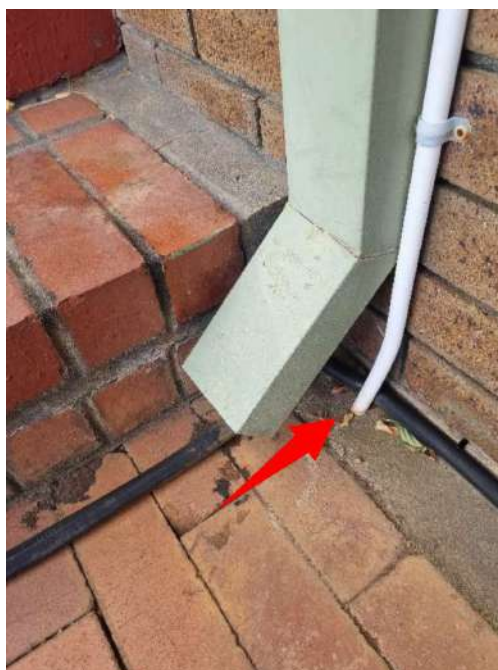
Was the Air Conditioner Sufficiently Drained

Air conditioner overflow requires diverting to drain. This provides conducive conditions for termite infestation.

No - Divert A/C overflow away from the building perimeter.

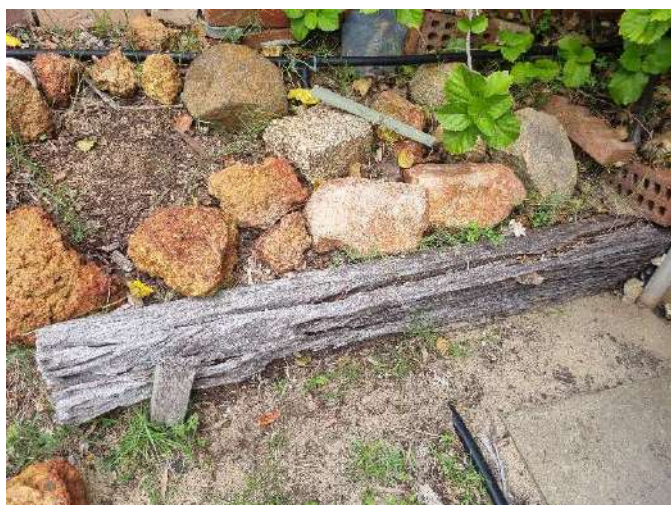
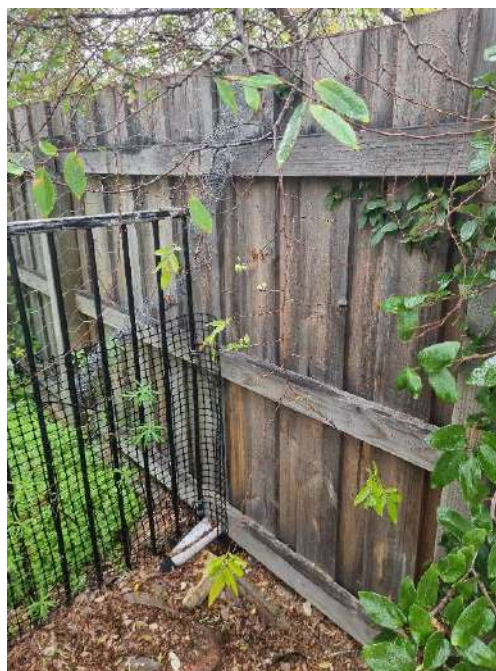
Timber in contact with ground. This provides conducive and concealed conditions and concealed entry for termite infestation.

There are timber sleepers in the garden. Termites love nesting below timber sleepers as it provides a good food source while also providing protection for the nest. It is recommended that all timber sleepers be removed or replaced with a non-susceptible product as they are conducive conditions for termites.

Tree/leafy environment: This property is located in a suburb which is high risk due to the environmental surrounds. It is close to large trees and parkland. A termite management plan/treatment is strongly advised.

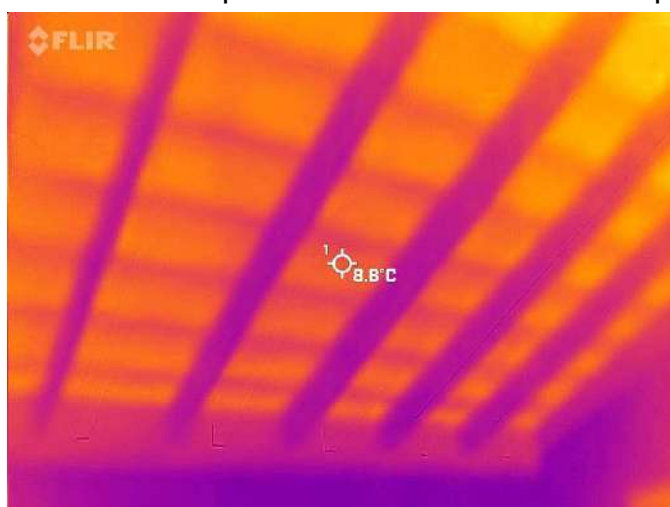
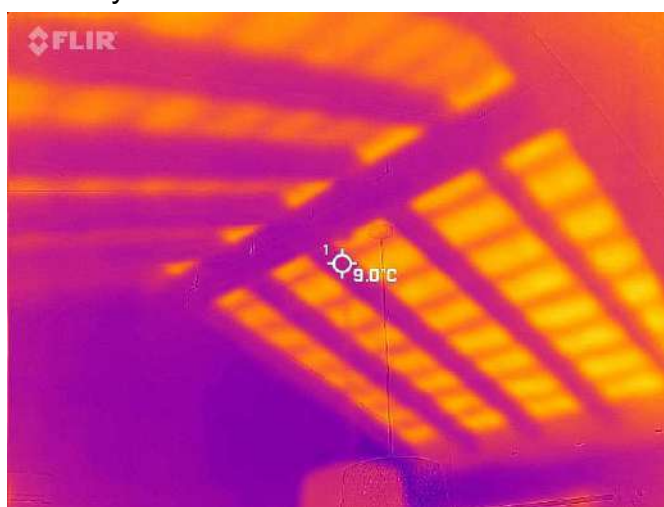
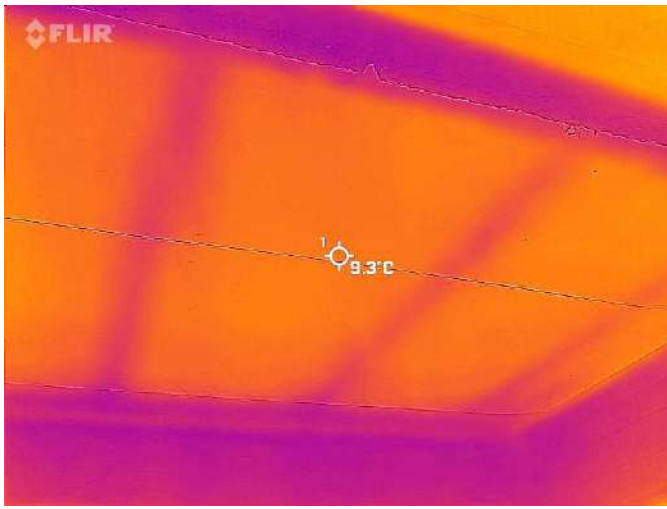
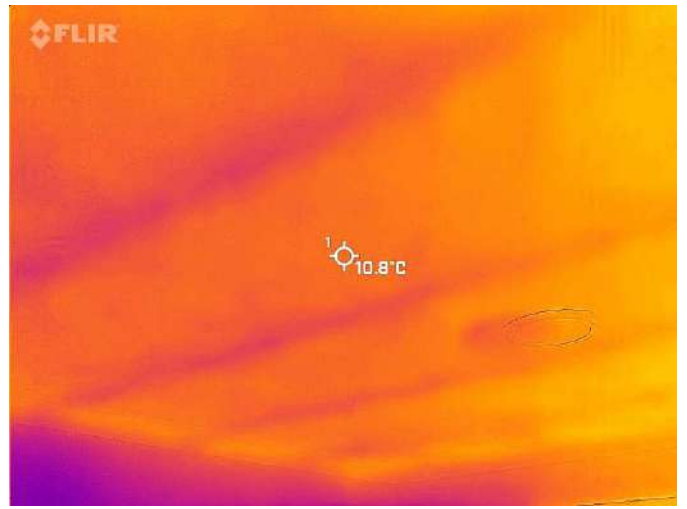
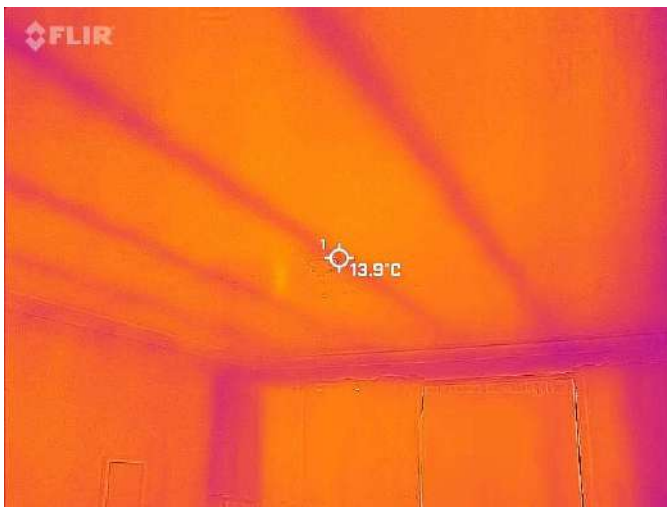
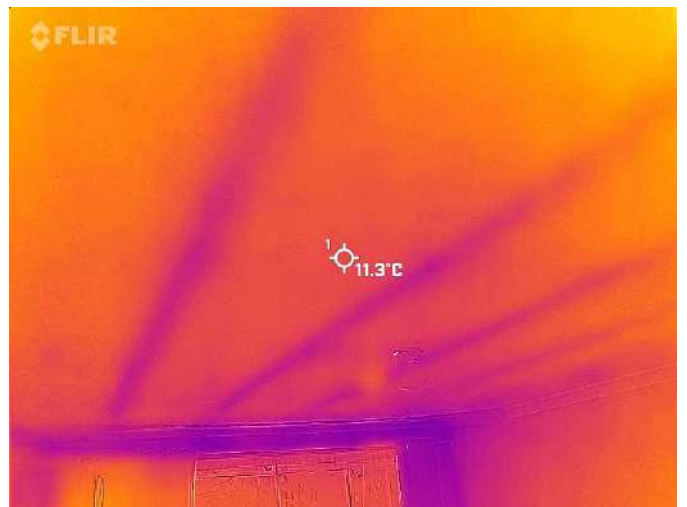
An infrared thermal imager was utilised during the inspection. No thermal anomalies were detected during this inspection, however various factors must be taken into effect which may hamper or impede the reading obtainable by the imager. These factors include obstructions, ambient temperature, wall material and thickness etc. If any surface is restricted visually or otherwise, a proper thermal reading is not possible and is not within the scope of this inspection. Any findings or otherwise is reported on at the time of the inspection only.
