Australian Standard<sup>®</sup>

**Inspection of buildings**

**Part 3: Timber pest inspections**

First published as AS 4349.3—1998.  
This edition 2010.

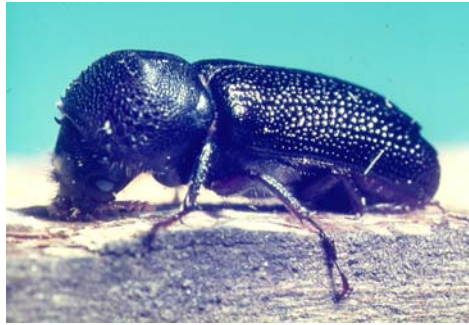
(c) Adult auger beetle (Bostrichid borer)

FIGURE B1 (in part) TYPES OF BORER THAT DAMAGE TIMBER

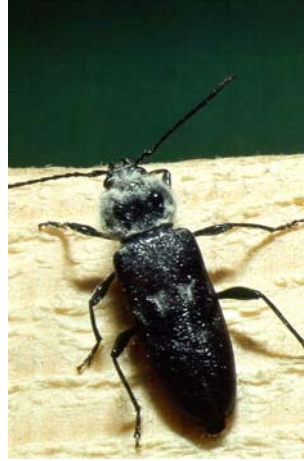
(e) Adult European house borer (*Hylotrupes bajulus*)

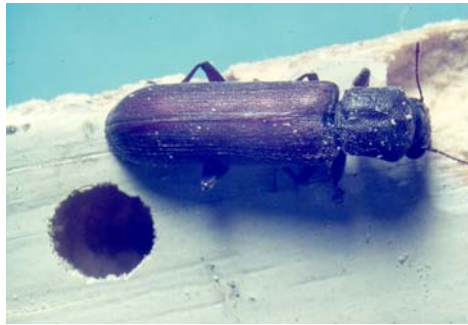
(f) Adult Lyctus (powder post) beetle

FIGURE B1 (in part) TYPES OF BORER THAT DAMAGE TIMBER

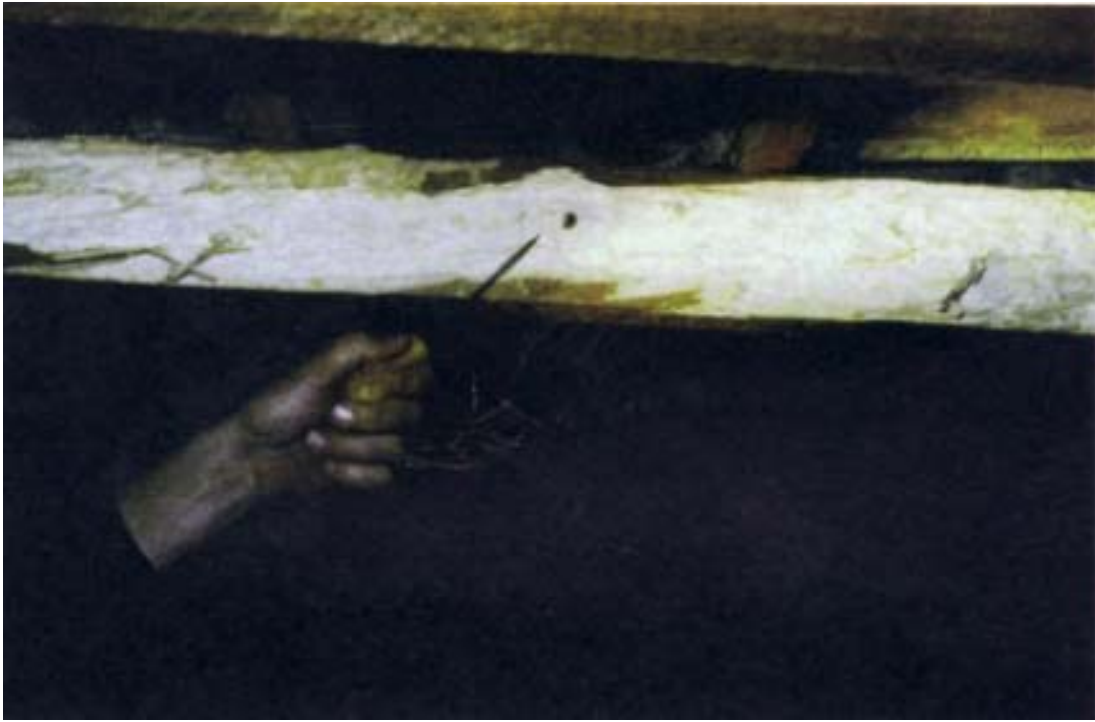
(c) Damage caused by *Hylotrupes bajulus*

FIGURE B2 (in part) DETECTION OF BORERS

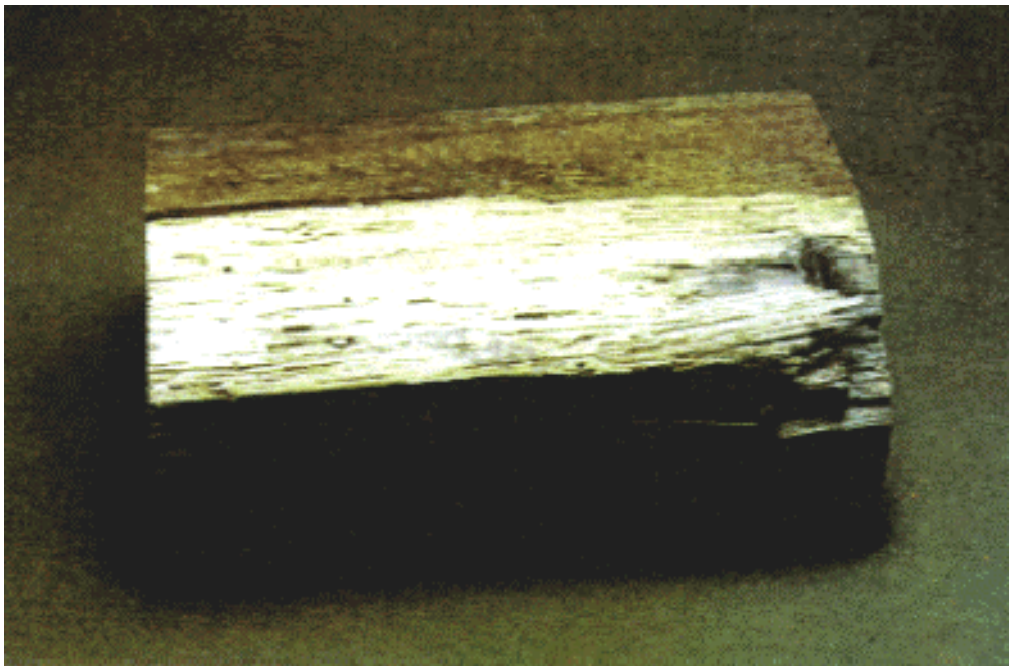
(d) Lyctid damage

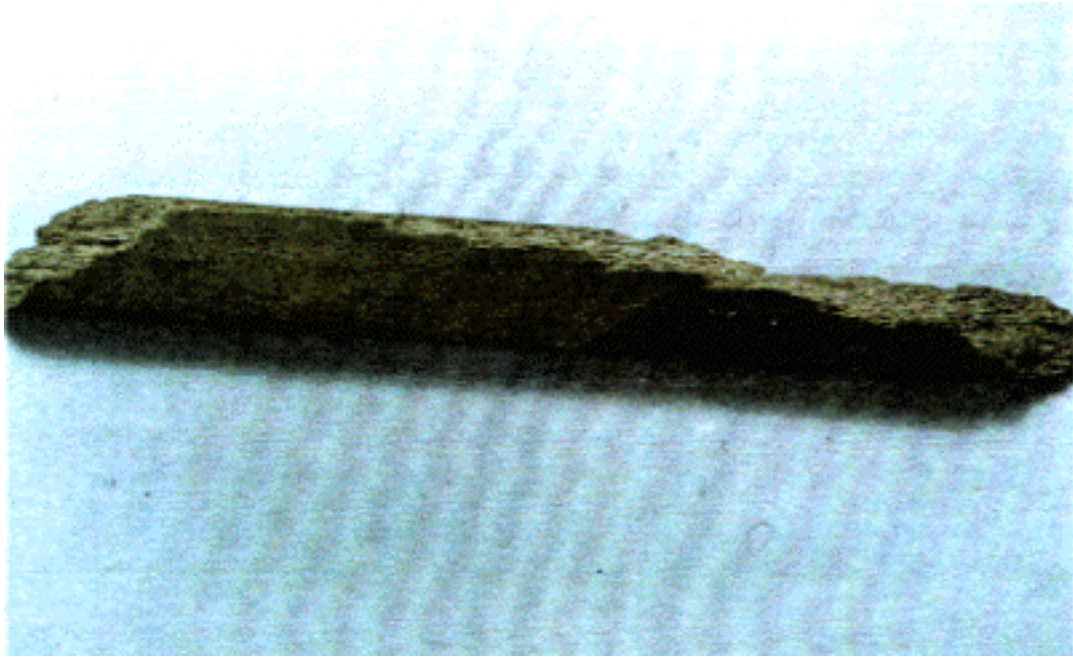
(e) *Anobium punctatum* damage

FIGURE B2 (in part) DETECTION OF BORERS

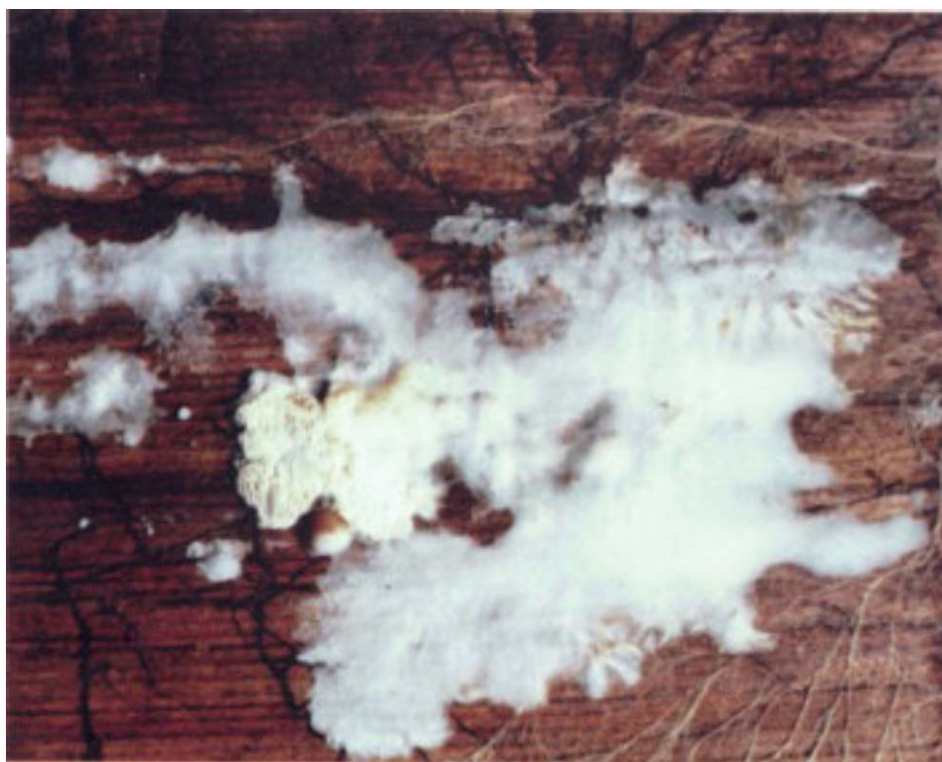
Early dense white vegetative growth of one fungus, late cream/fawn vegetative growth of a second fungus, dark brown/black water-conducting strands of a third fungus. Off centre can be seen the pored surface of a young reproductive fruit body.

FIGURE C1 VARIED FORMS OF GROWTH OF WOOD DECAY FUNGI ON THE SAME PIECE OF TIMBER

The reproductive spores of a mould fungus and the vegetative threads (mycelium) of a wood decay fungus, the latter usually white, if present in sufficient quantities, can be seen with the naked eye. However, vegetative growths of wood decay fungi may be cream, brown or black.

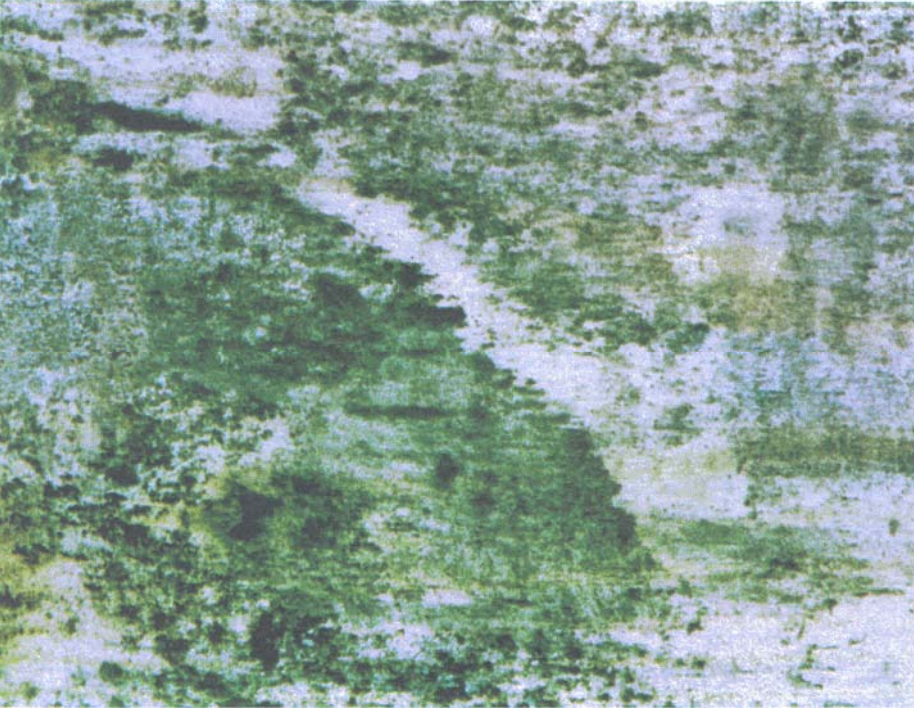
<p data-bbox="419 1921 1002 1955">(Reproductive growth of a mould fungus on timber)</p>	<p data-bbox="1193 1126 1422 1238">Cannot destroy wood (consumes cell contents, not cell walls).</p> <p data-bbox="1193 1261 1422 1294">Looks unsightly.</p> <p data-bbox="1193 1305 1422 1417">Produces mass of spores quickly. Potential respiratory problem to humans.</p>

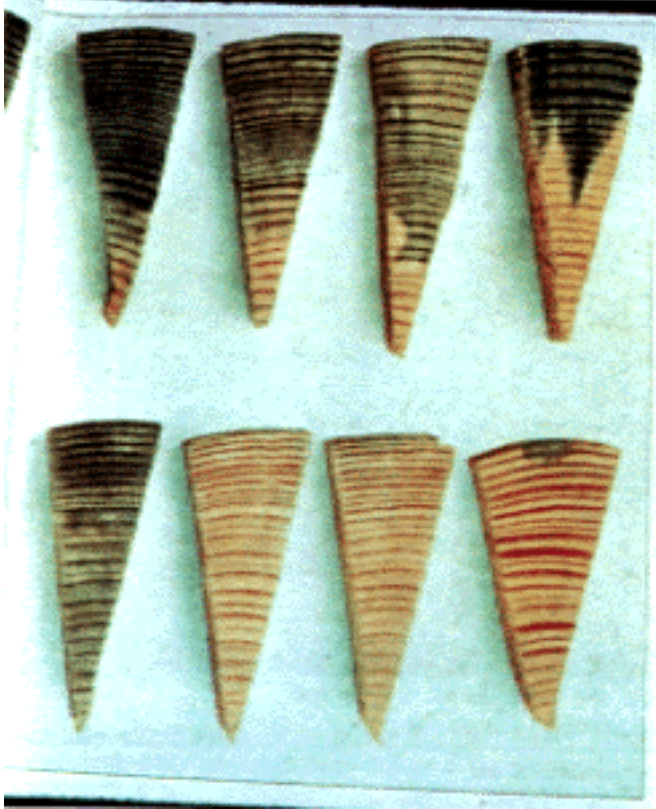
<p>(Varying amounts of bluestain in several sapwood sections)</p>	<p>Can only consume the free sugars that remain behind inside the cells of what was the sapwood of the living tree. Sapstain does not significantly affect the strength of timber.</p>

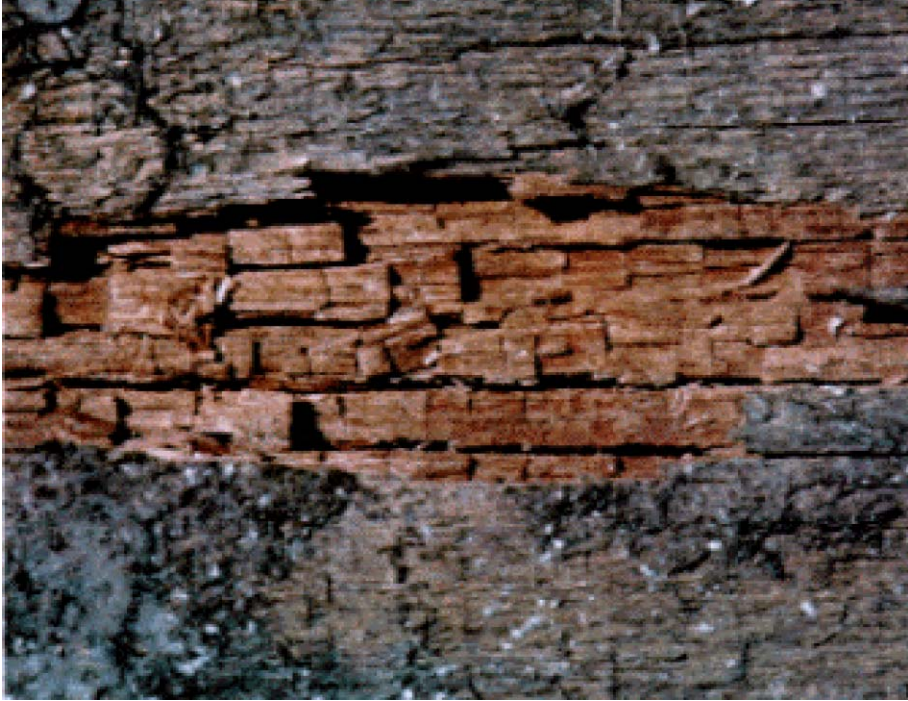
<p data-bbox="293 1106 1142 1167">(Above example shows brown rot fungus that has caused cracking across the grain)</p> <p data-bbox="248 1178 775 1211">*Brown rot is commonly called brown cubical rot</p>	<p data-bbox="1190 349 1406 618">Decomposes only the cellulose leaving exposed lignin, which oxidizes and turns brown. The decayed wood is darker than un-decayed wood.</p>
<p data-bbox="233 1256 464 1290">(ii) White rot fungus</p>

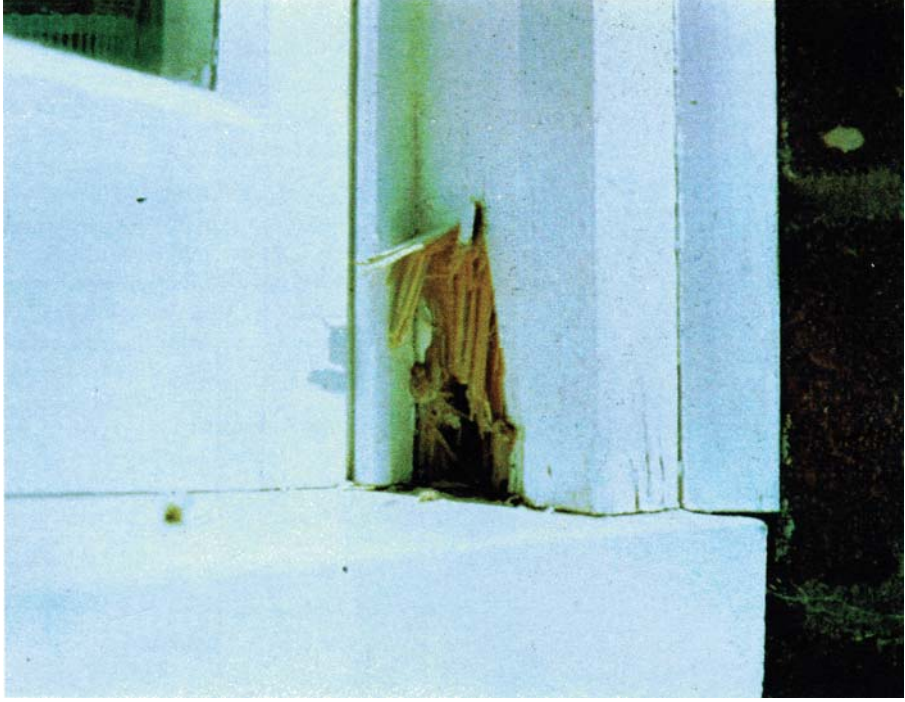
<p data-bbox="285 2011 1134 2072">(Above example shows brown rot fungus that has caused cracking across the grain)</p>	<p data-bbox="1190 1256 1414 1402">Decomposes both cellulose and lignin. Remaining exposed cellulose is white, fibrous, i.e., stringy.</p>

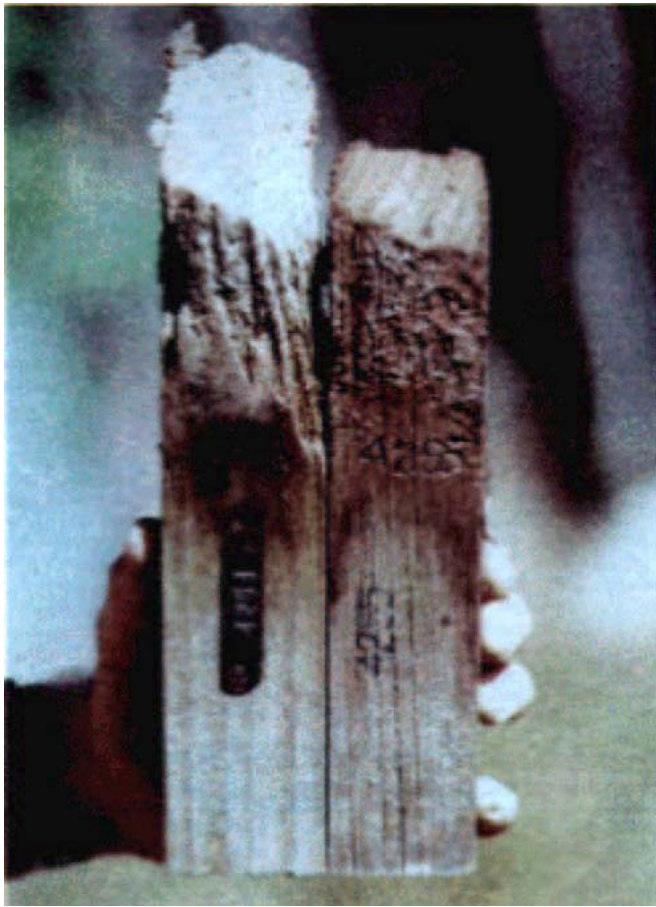
<p>(Above example shows soft rot fungus that has caused fracture in wooden state)</p>	<p>A mixed population of fungi and bacteria (normally soil-inhabiting) which decomposes the cell walls of the timber giving the appearance of small cubes of wood which tend to crack across the grain. The affected timber is always darker than undecayed wood. Also known as 'carrot rot.'</p>

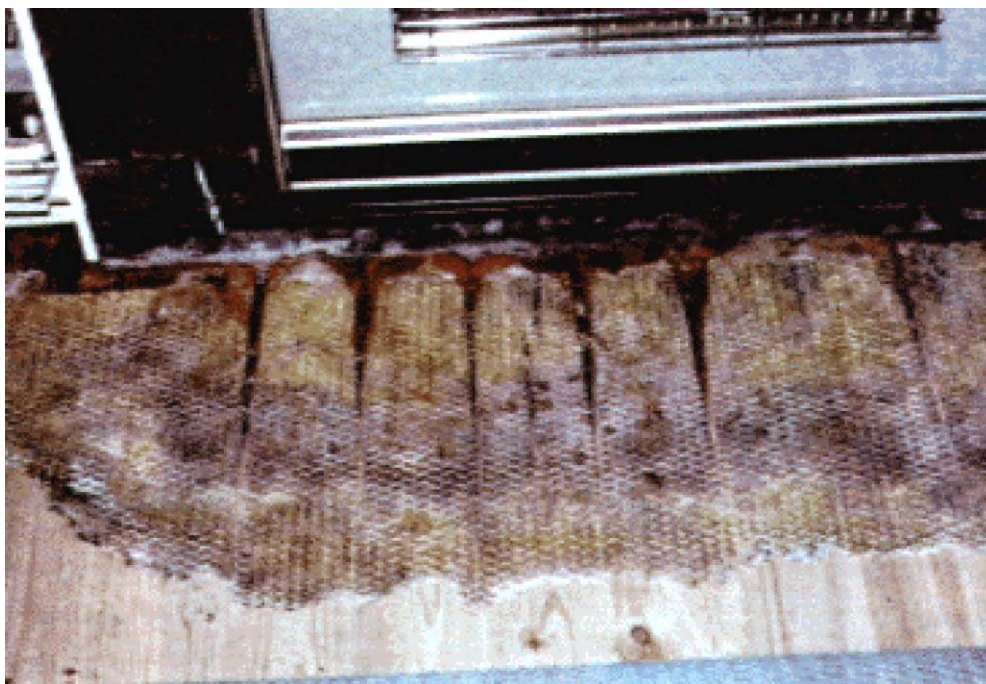
Imprint of underlay is seen on the white/grey/yellow vegetative fungal growth; additional early white vegetative growth is seen between brickwork; dark orange/brown deposits of reproductive spores of this decay fungus (*Serpula lacrymans*) are also evident.

FIGURE C2 ACTIVELY DECAYING FLOORING NOT YET FAILED UNDER HUMAN LOAD

In contrast decayed wood is reduced both in moisture content and size as indicated by cracking either along or across the grain or by fibres coming apart in a stringy manner. Decayed wood will have undergone considerable strength reduction and in the case of floorboards could eventually be expected to fail under the load of humans or furniture (see Figures C2 and C3).

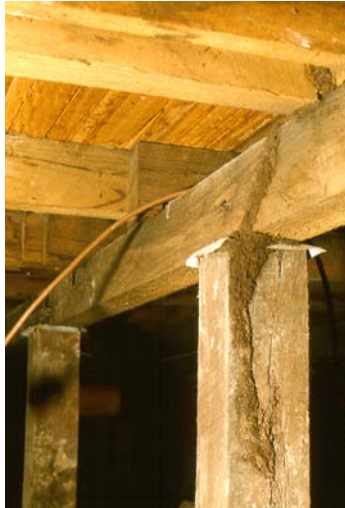
FIGURE D1 TERMITES BRIDGING TERMITE CAP BY MEANS OF A SHELTER TUBE

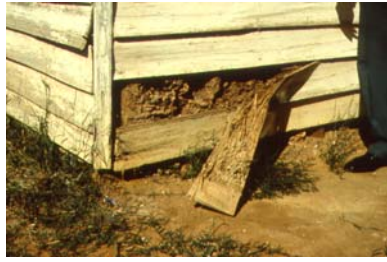
(a) Termite damage to external cladding

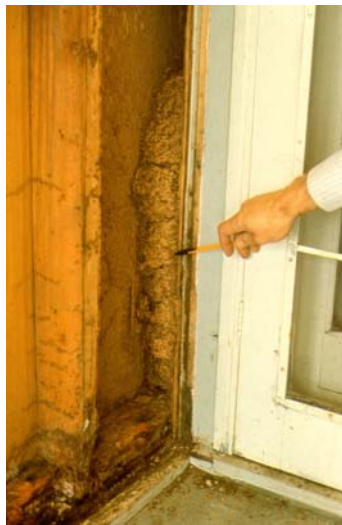
(b) Door jamb damaged by *Coptotermes frenchi*

FIGURE D2 (in part) TIMBERS DAMAGED BY TERMITES

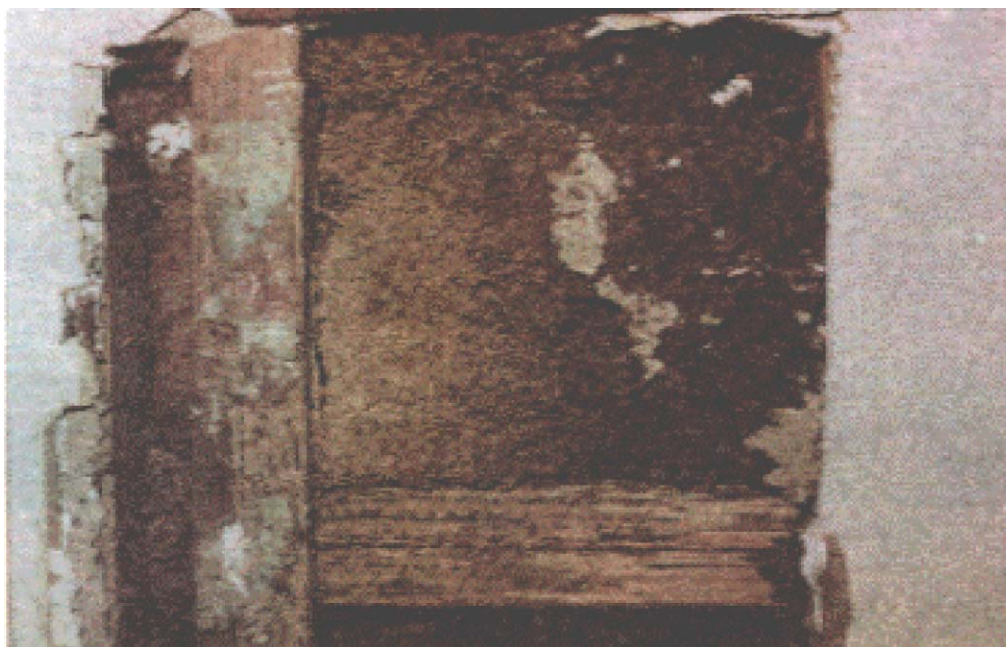
(d) Workings of *Coptotermes acinaciformis* in a stud wall

FIGURE D2 (in part) TIMBERS DAMAGED BY TERMITES

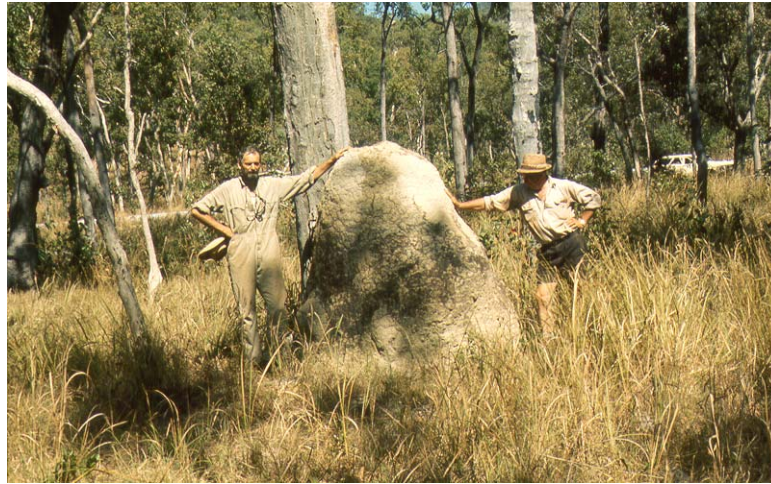
(a) *Coptotermes acinaciformis* mound in Northern Australia

A search should be made for nests for distances up to a distance of 30 m from the main building and within the boundary (see Figure D3). In most urban situations it is almost impossible to locate the nest during a visual inspection since it is usually located underground. Nests may be obvious mounds or may be concealed in the earth fill under a concrete slab floor or hearth. They may also be in the base of a stump, pole, fence post, railway sleeper or tree. All likely places should be examined carefully and should be probed to determine their soundness. No matter what the external shape, location or covering of a nest, the inner zones centred on the nursery always consist of concentric layers of cells with thin, fragile walls of organic matter and soil.

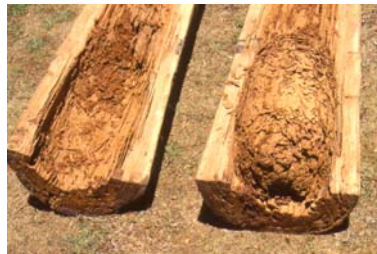
(b) Termite nest in a timber post

FIGURE D3 TERMITE NESTS

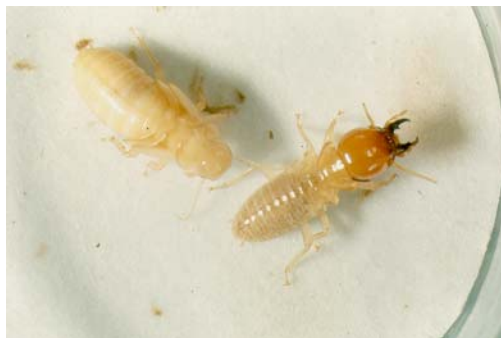
(c) Soldiers and workers of *Mastotermes darwiniensis*

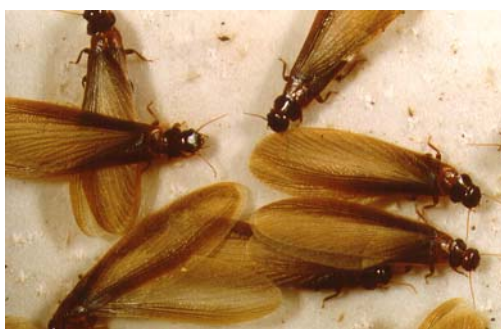
(d) Alates of *Mastotermes darwiniensis*

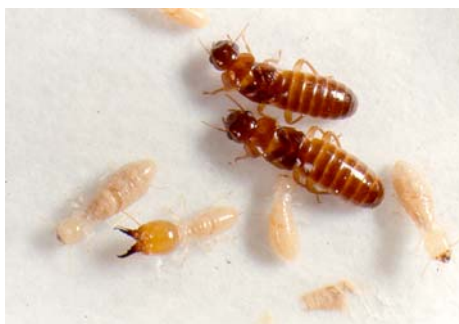
(e) King, queen, soldiers and workers of *Neotermes insularis*

FIGURE D4 (in part) SPECIES OF TERMITES
