# Inspection Report

SURE Pty Ltd

### Pest And Building Inspection

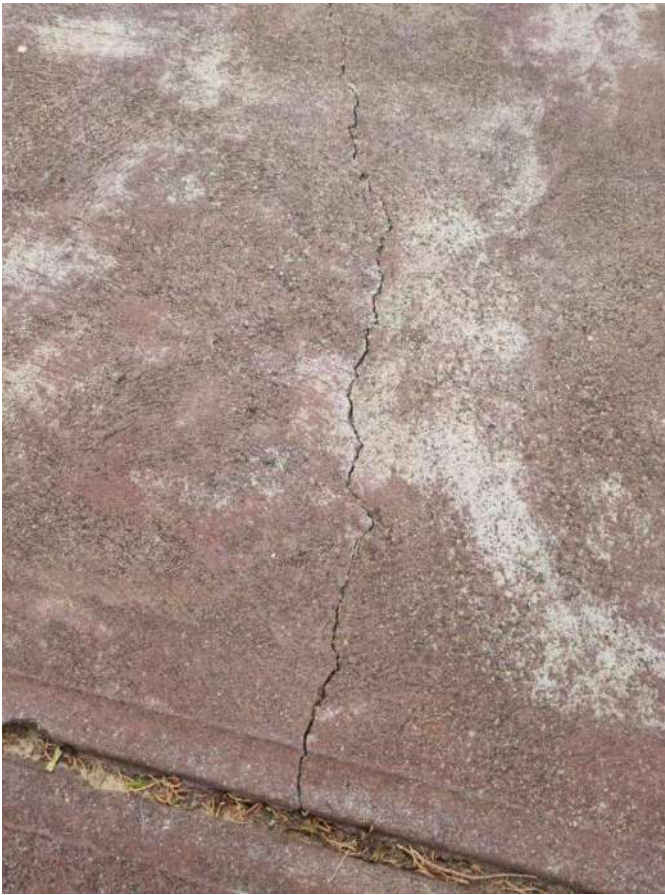
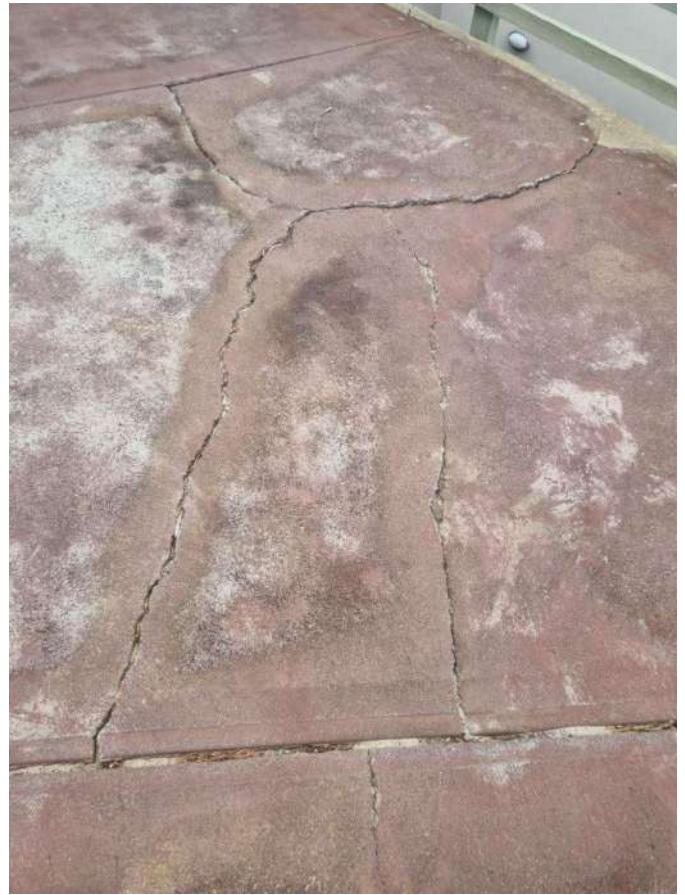
**Maintenance:** Common cracks and settlement was observed on the driveway. Recommendation: Whilst these cracks appeared to be typical at the time of inspection, we strongly recommend you monitor these cracks and if worsening occurs engage a concreter for further advice and repair.

**Maintenance:** Sections of the driveway are in poor condition and replacement is recommended. Recommendation: Engage a qualified concreter for a repair.

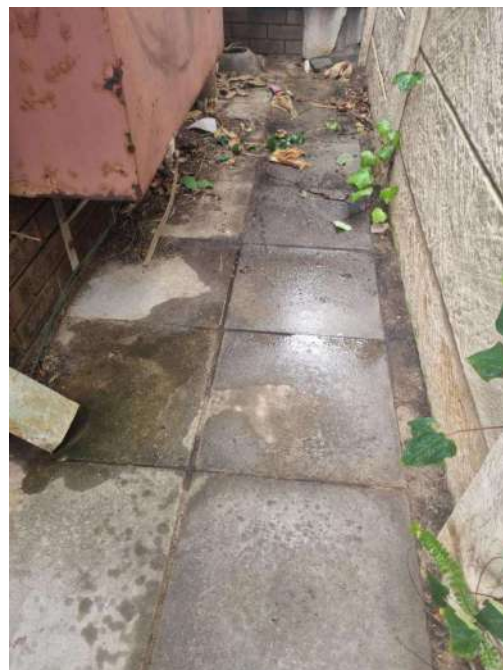
**Maintenance:** Common cracks and settlement was observed on the path area/s.

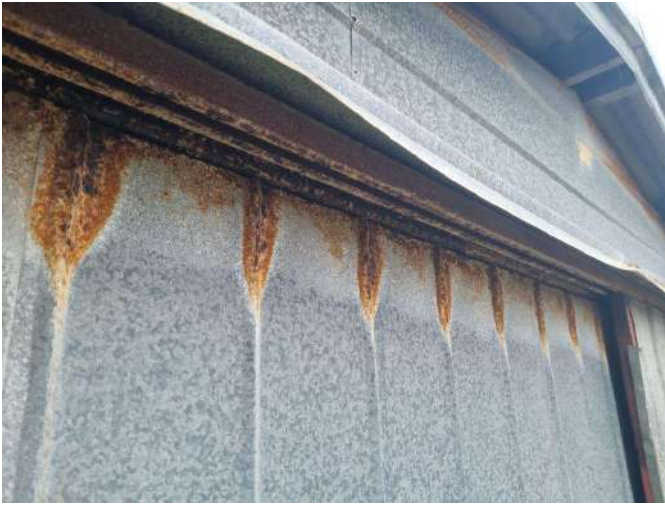
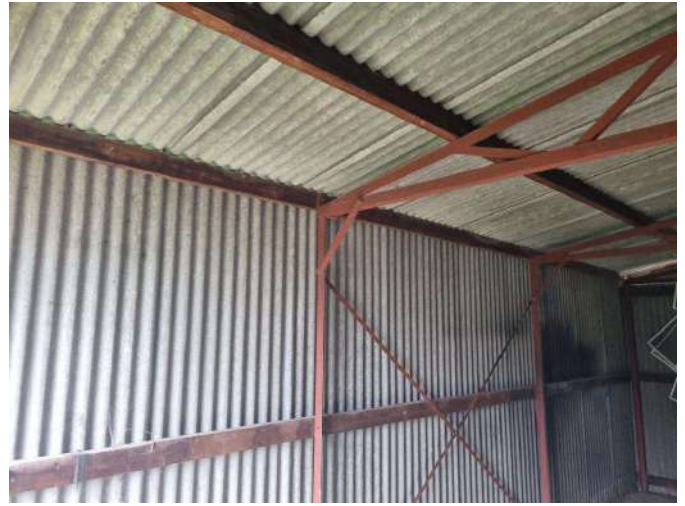
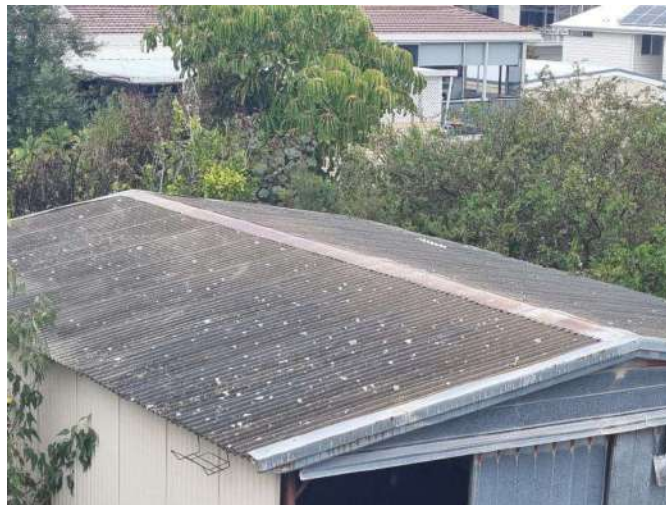
**Health and Safety:** Section of the shed are fibrous cement sheeting. Recommendation: Conduct an asbestos lab test to confirm material. Considered a potential health and safety defect.

**Maintenance:** Rust noted to be developing on cladding. Recommendation: Engage a handyman to complete repairs to restrict rust or replace affected sections if desired.

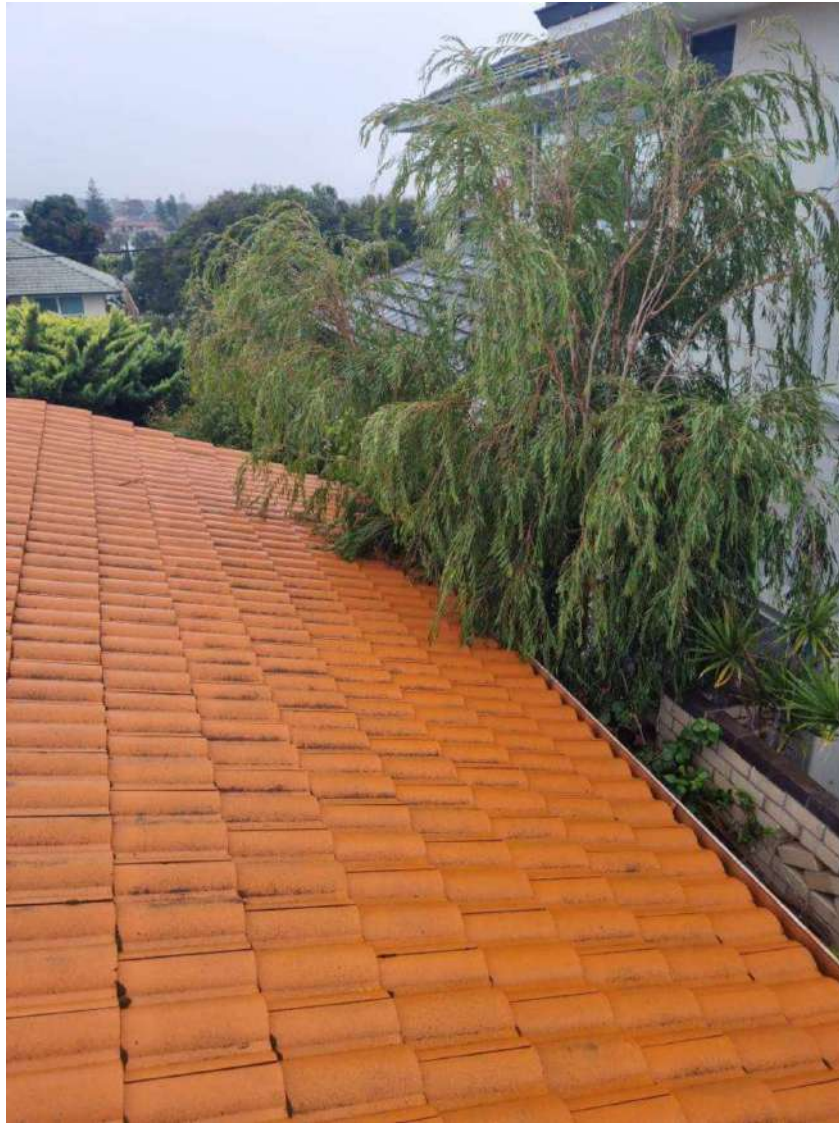
**Maintenance:** Trees are overhanging roof areas. Recommendation: Engage a tree lopper or arborist to cut back away from the roof line and gutters.

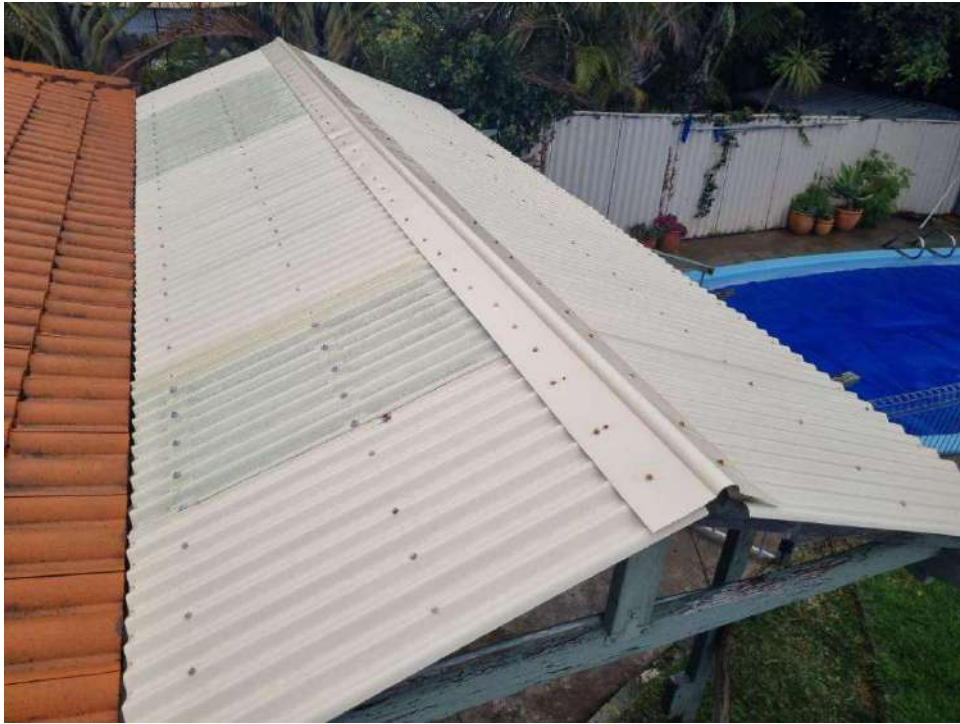
**Structural minor:** Rust observed to pergola post metal stirrups. If left unattended the pergola will become unstable/unsafe. Recommendation: Engage a carpenter to replace.

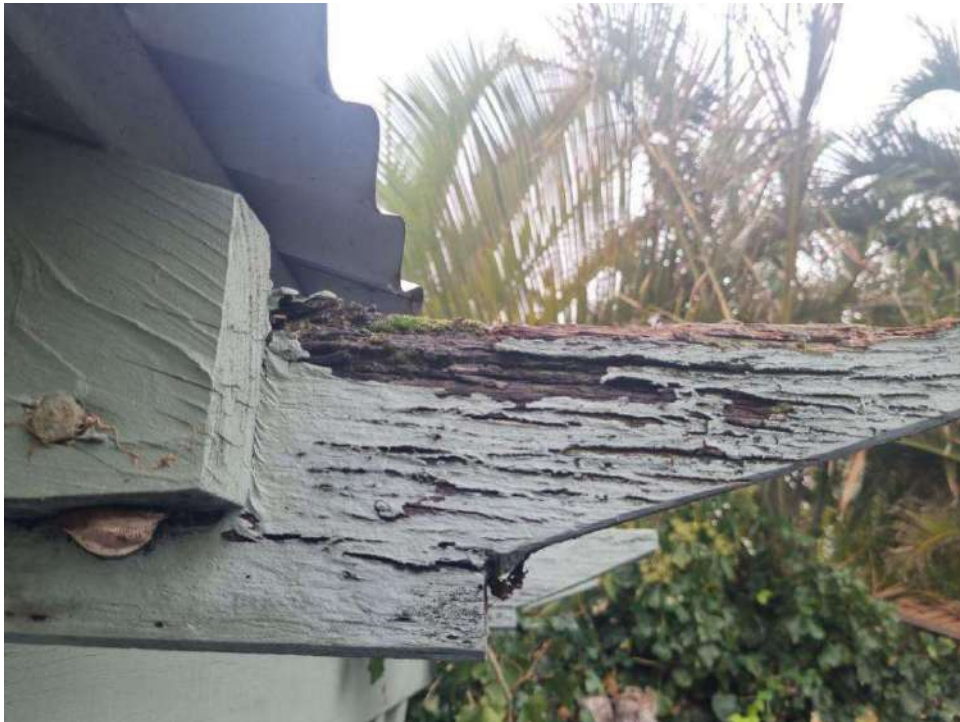
**Structural Minor:** Timber fungal decay observed in sections of bearers or joists. Recommendation: Engage a carpenter for repairs.

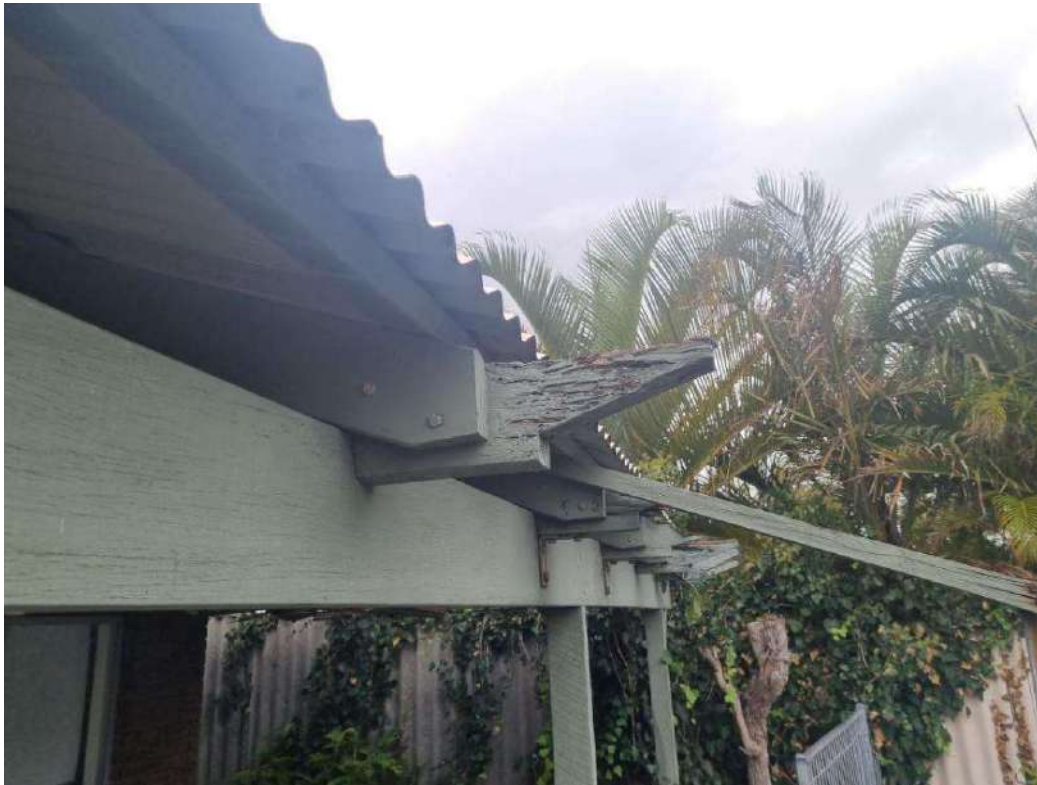
**Maintenance:** Gutters not fitted and not connected to storm water discharge. Water discharge not

connected to storm water has the potential to cause differential settlement to the footings, cause rising damp and is also conducive to termite infestation. Recommendation: Engage a roofing contractor for repairs.

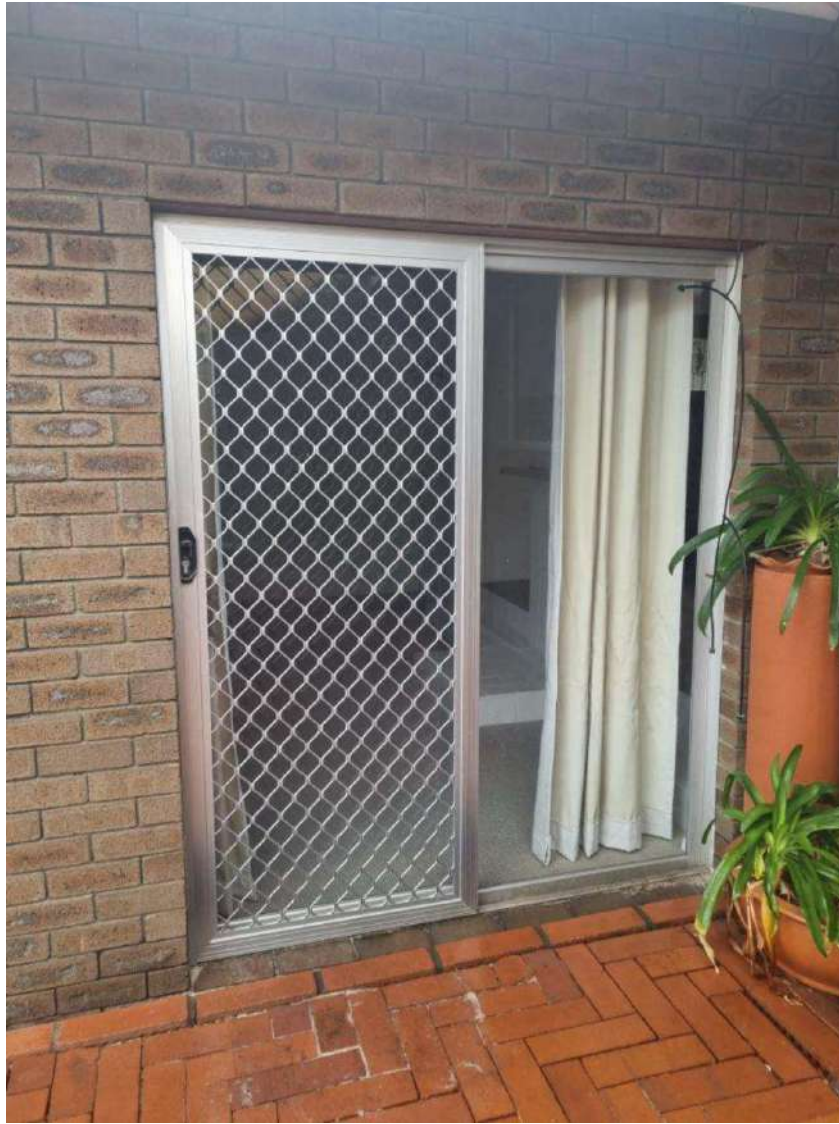
**Maintenance:** Some weep holes are partially blocked by soil. Recommendation: Engage a landscaper to lower finished ground levels to fully expose all weep holes on the lower brick courses around the dwelling.

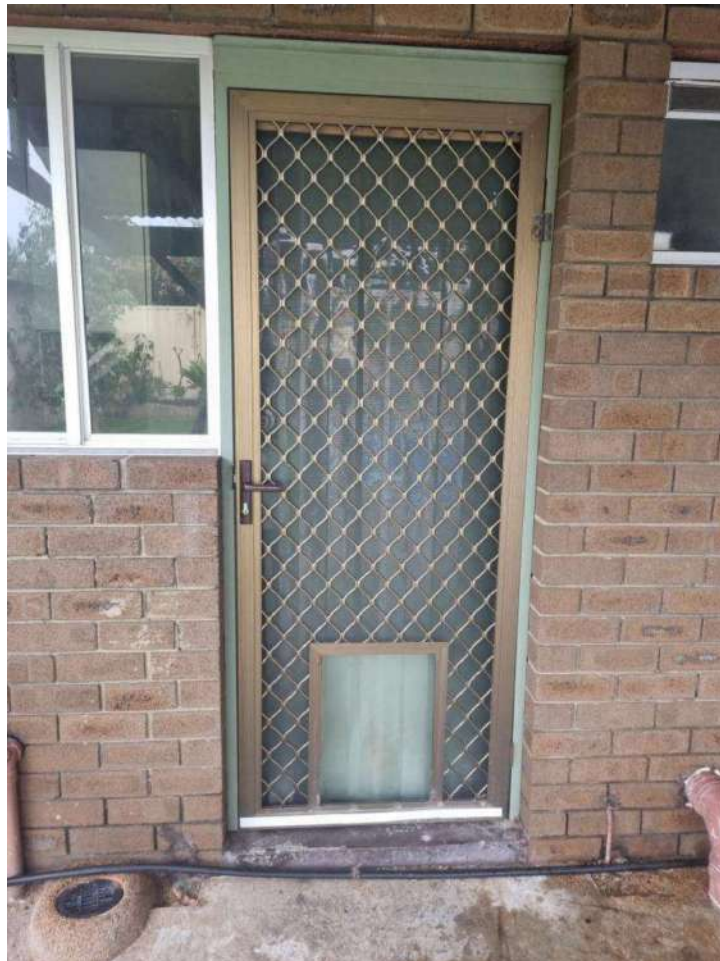
**Maintenance:** Lintel rust observed above front entry door. Rust in lintels can cause cracking in the above brickwork. Recommendation: Engage a painter to polish out the rust and re-coat.

**Maintenance:** General age/damage has occurred to door frame, face or components. Recommendation: Engage a carpenter and/or painter for repairs.

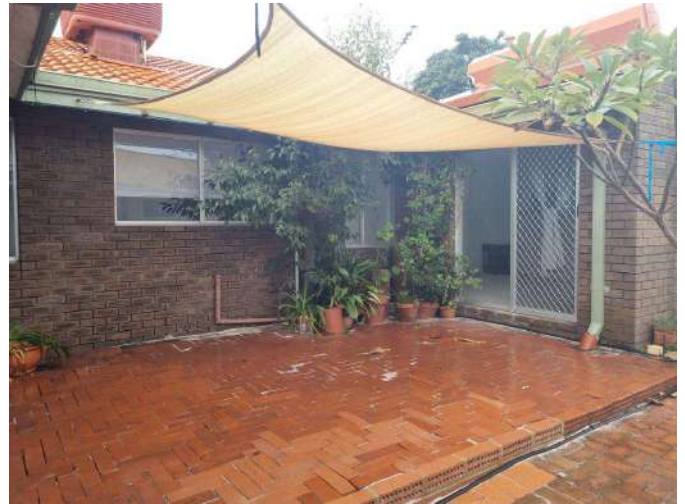
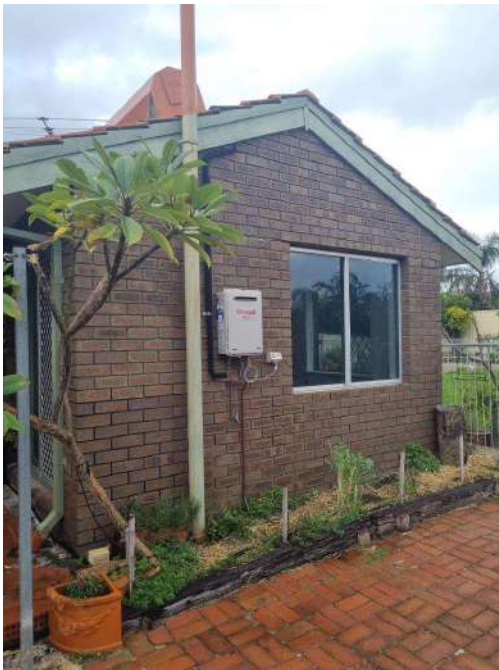
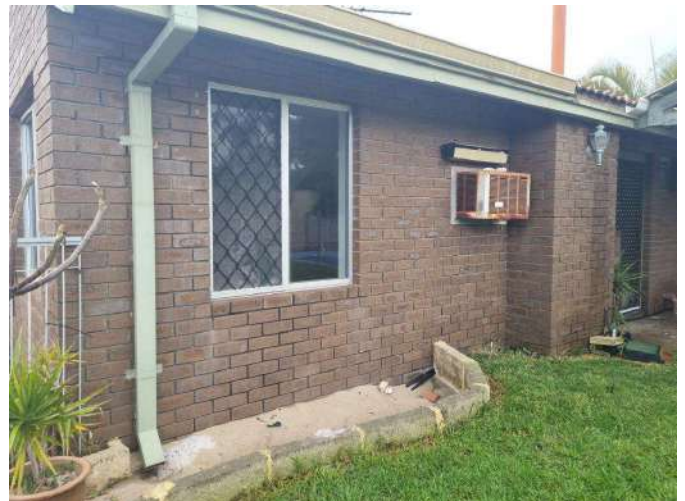
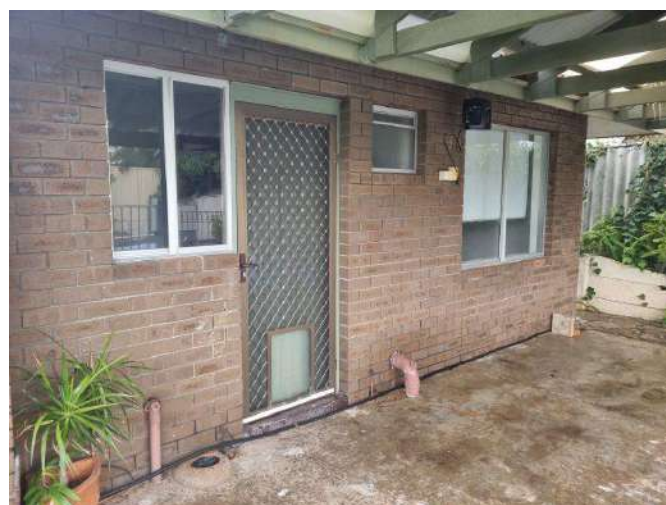
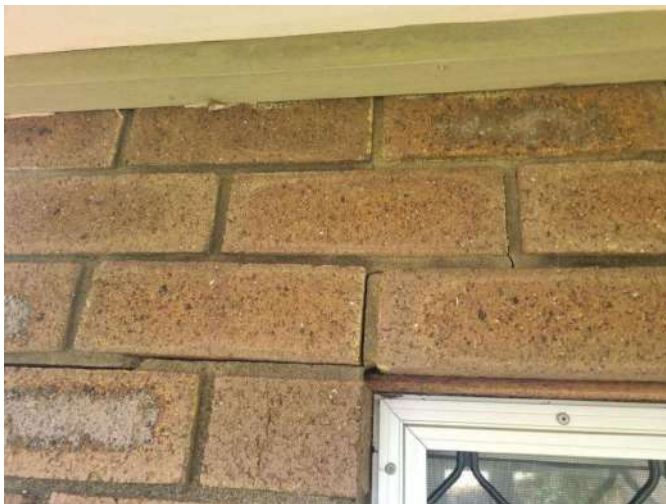
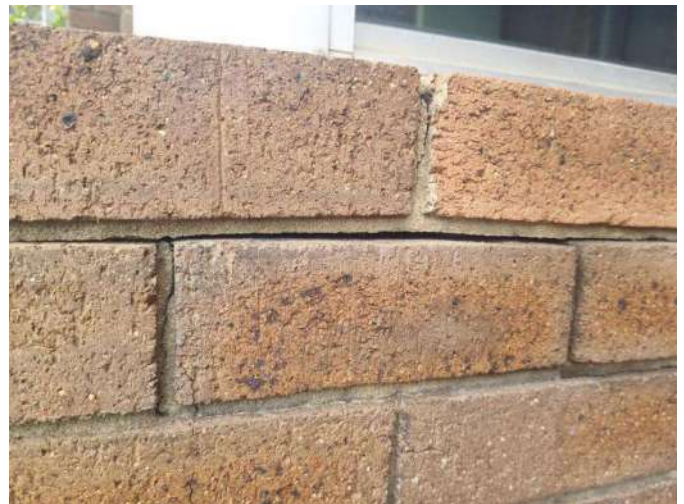
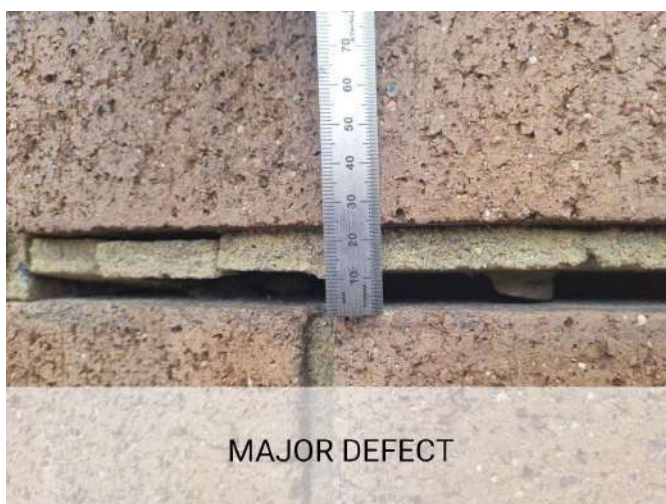
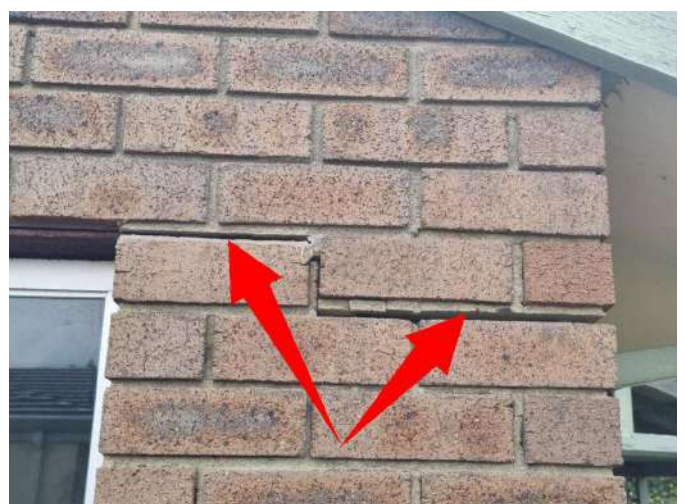
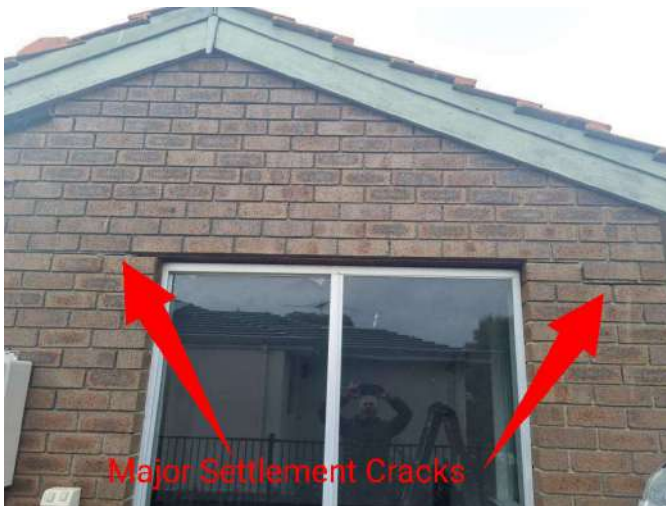
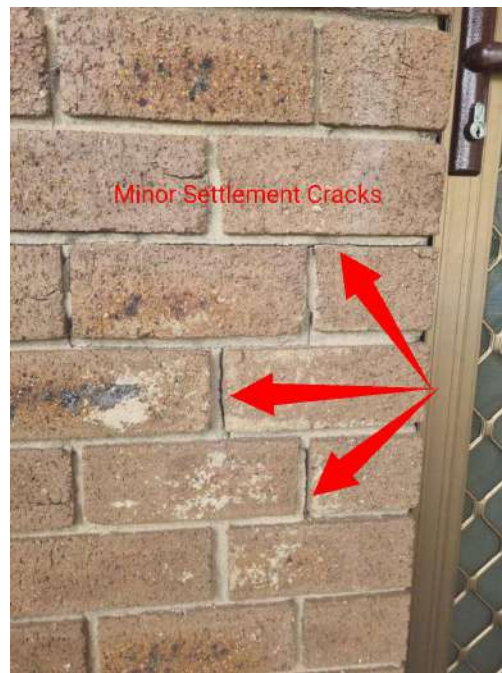
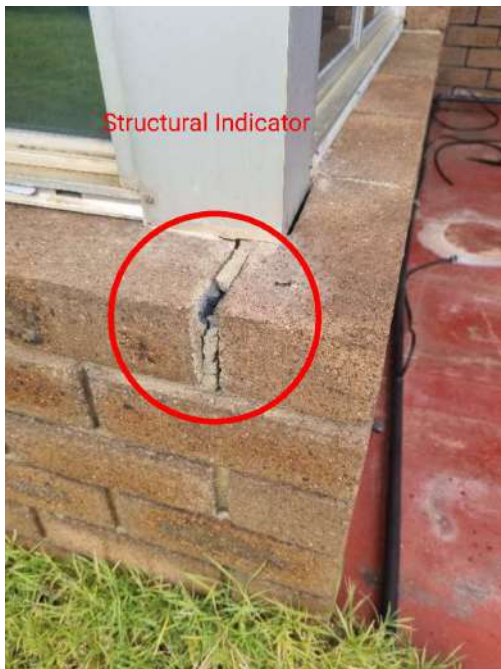
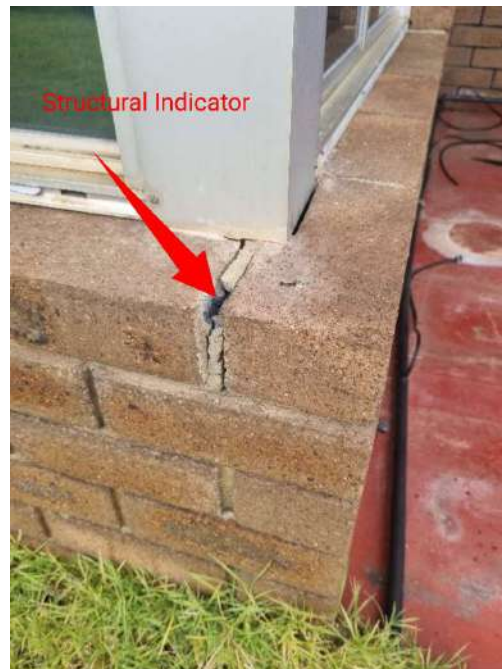
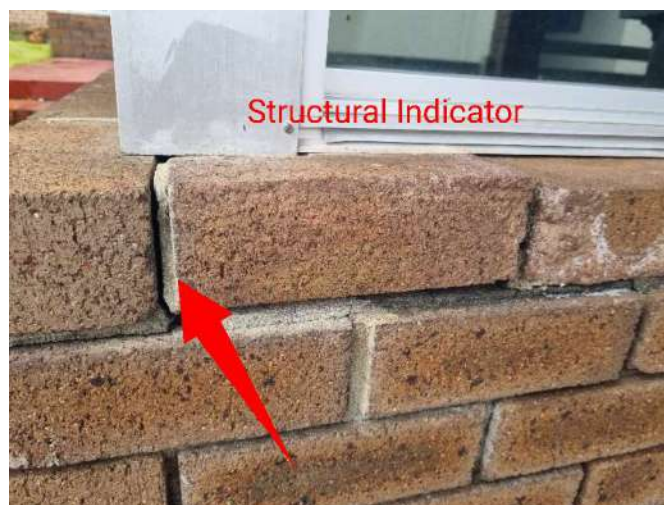
## External Wall Observations

**Structural Major:** Cracks observed in damage Category 3 to 4. Possible causes may be

foundation movement, support structure deflection, thermal movement, moisture uptake or loss or failure under external loads. Recommendation: Engage a registered builder to complete repair works. A structural engineer should be consulted for further evaluation to determine scope of repair.

**Structural Minor:** There appears to have been some settlement in the building which has caused some cracking to the walls. These cracks are categorized as 0 to 2. This can also cause some doors to bind or be out of square. In the inspectors opinion these cracks are due to settlement, usually due to ground movement and subsequent movement to building materials can be expected. All cracks should be monitored and if cracks increase in size, further investigation should be carried out by a structural engineer. Engage a bricklayer to repair.

**Structural Indication:** Sections of the top course masonry brick wall/s have become loose around areas of the window frames with mortar cracking observed. Cracks and lifting of bricks have developed. This is an indication that frame movement may have occurred but is visually inaccessible due to the window frame components being situated in the cavity wall. Recommendation: Monitoring advised and if further opening occurs reassessment should be completed.

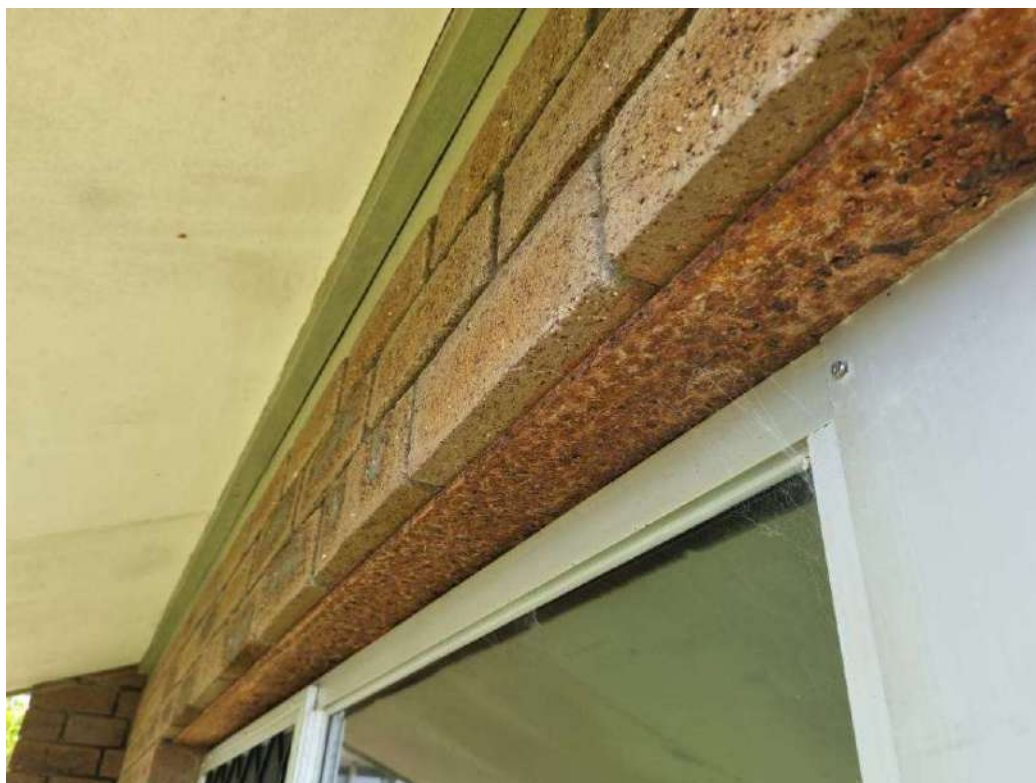
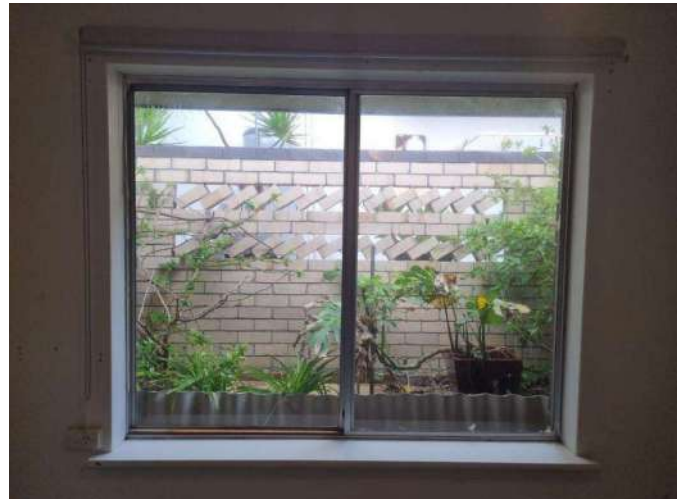
## External Window Observations

**Maintenance:** Lintel rust observed above door/s. Rust in lintels can cause cracking in the above brickwork. Recommendation: Engage a painter to polish out the rust and re-coat.

**Maintenance:** General age/damage has occurred to window components. Recommendation: Monitor condition and engage a glazer for restoration work and repairs as required.

**Maintenance:** Damaged fly screen/s observed. Recommendation: Engage a handyman to repair.

**Maintenance:** Missing fly screen/s observed. Recommendation. Engage a handyman to repair.

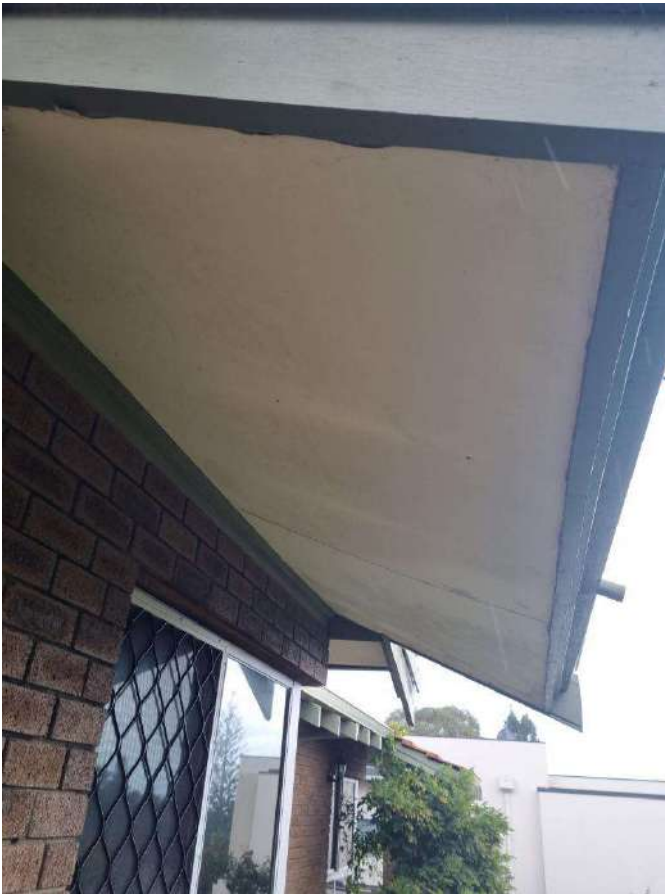
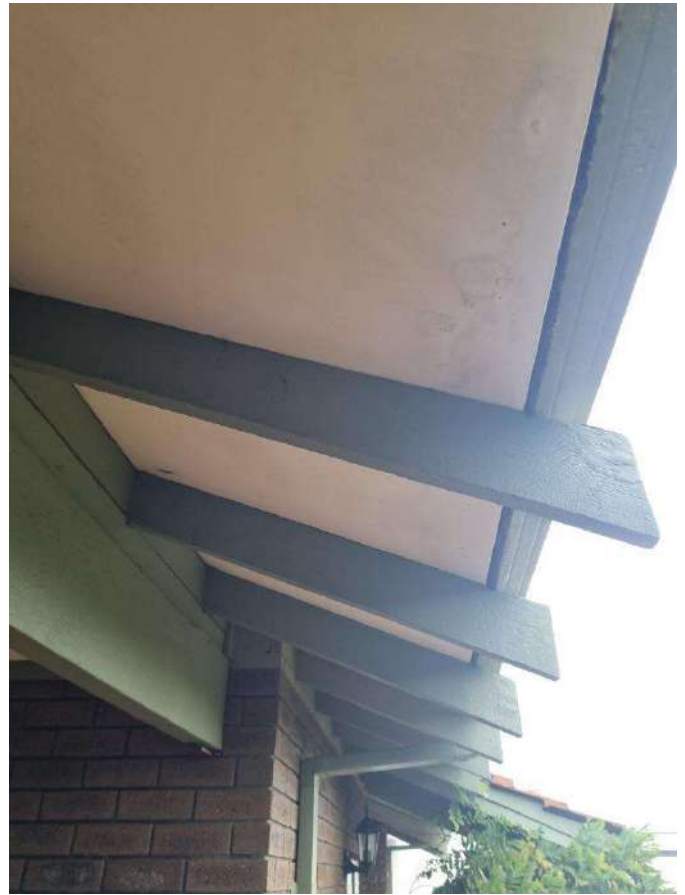
## Eave Observations

**Maintenance:** Eave lining stains observed. Normally this occurs due to overflow in blocked gutters. Recommendation: Ensure gutters are clear of debris, engage a painter to re-paint eave sections.

**Maintenance:** Paint flake/deterioration is evident. Normally due to overflowing/blocked or leakage guttering. Recommendation: Engage a painter for repairs.

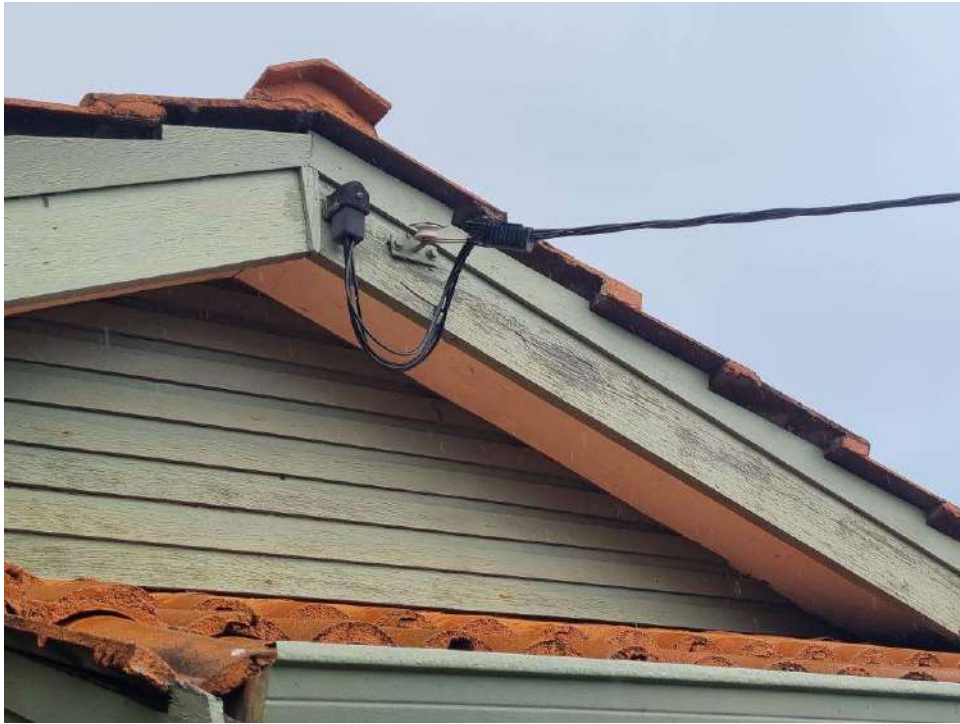
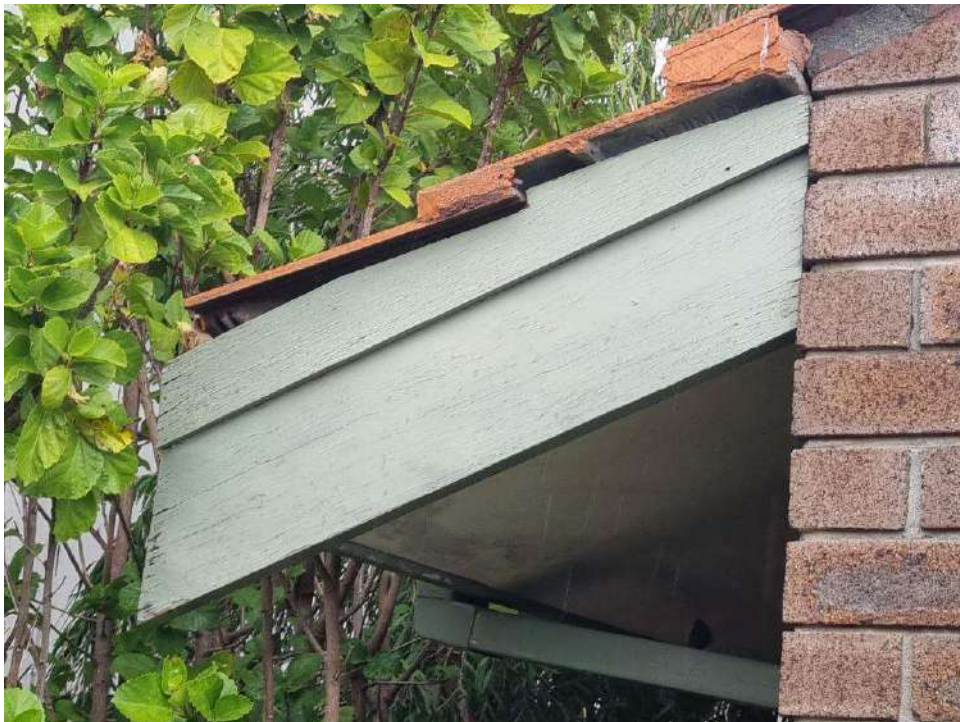
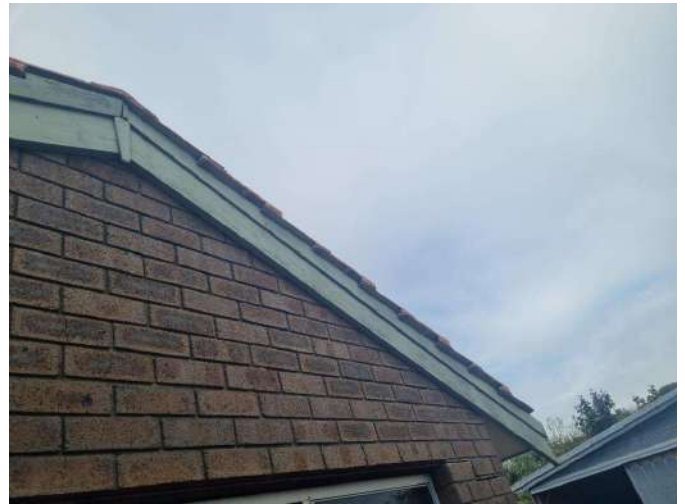
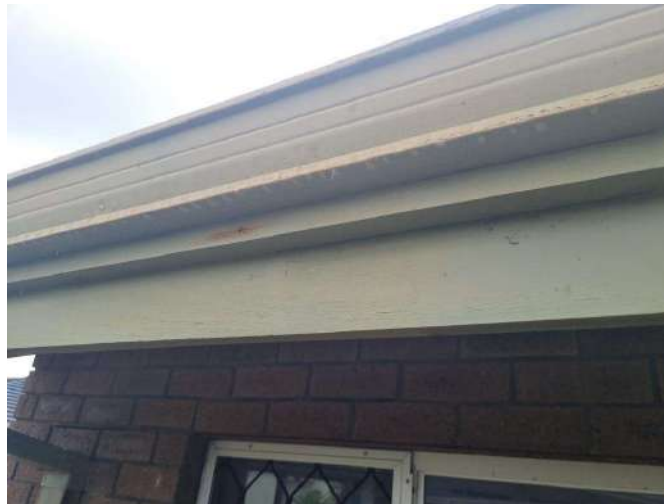
### **Facia and Barge Boards Observations**

**Maintenance:** Paint deterioration observed in areas. Recommendation: Engage a painter for repairs.

**Maintenance:** Timber fungal decay (rot) observed. Recommendation: Engage a carpenter for repairs.

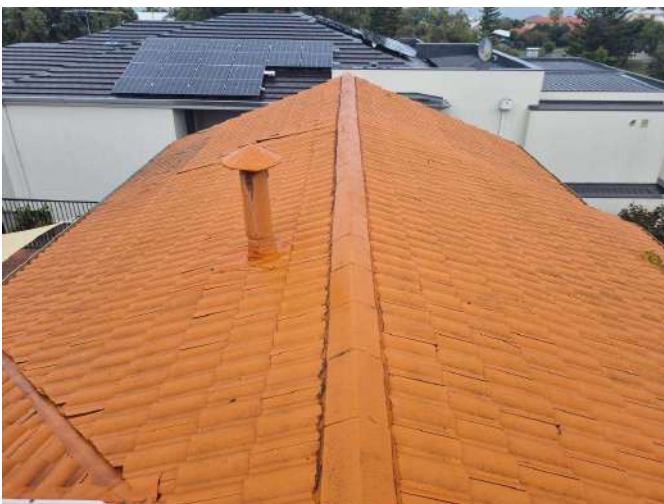
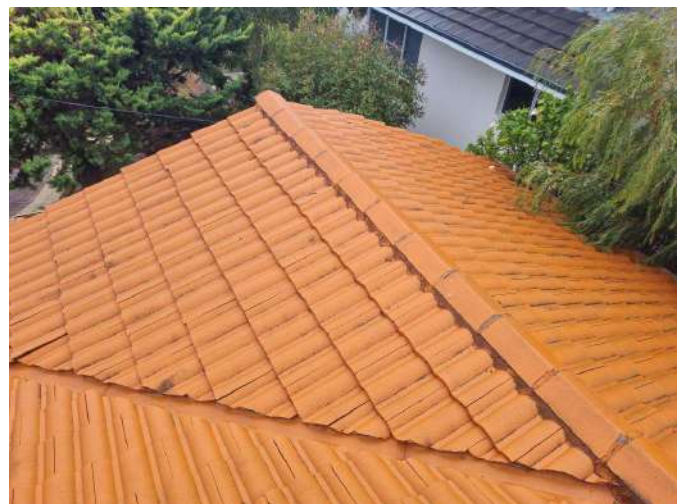
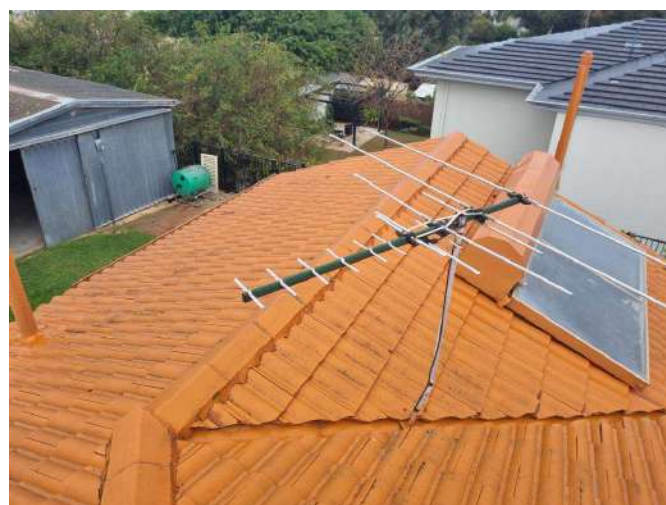
## Roof Clad Observations

**Structural Indication:** Roof line unevenness observed. Refer to Roof Void section for frame

**Maintenance:** Cracked tile ends observed. Recommendation: Engage a qualified roofing contractor to repair.

**Maintenance:** Mortar cracks observed. Recommendation: Engage a roofing contractor to repoint affected sections as they may contribute to water ingress.

**Maintenance:** Moss has built up on the tiles over time. Recommendation: It is preferable to have removed / cleaned to prevent deterioration. Engage a roofing contractor for removal.

**Maintenance:** Tile lift/unevenness observed. Recommendation: Engage a roofing contractor to re-lay affected sections.

**Maintenance:** The roof mounted solar hot water system appears to be decommissioned. Recommendation: Confirm with seller. If decommissioned engage a plumber to remove the unit.

**Maintenance:** The antenna has been mounted in the valley. This creates disruption to water flow and could result in a leak. Recommendation: Engage an electrician to move.

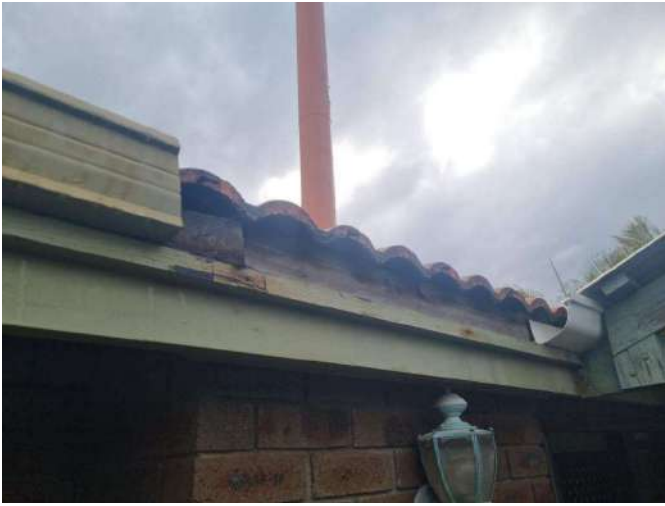
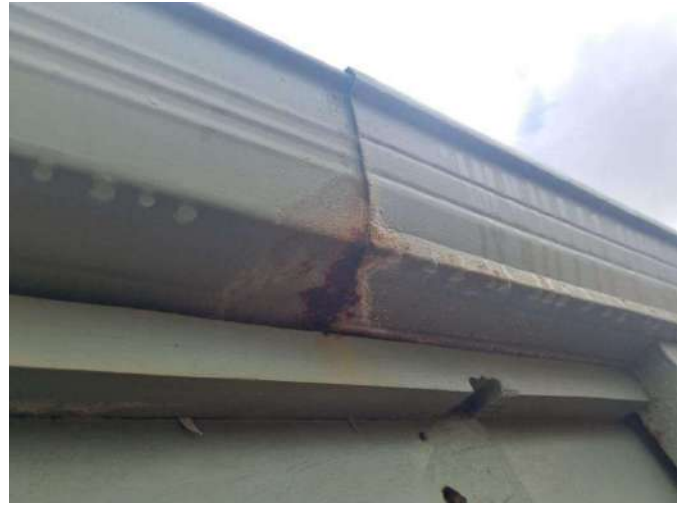
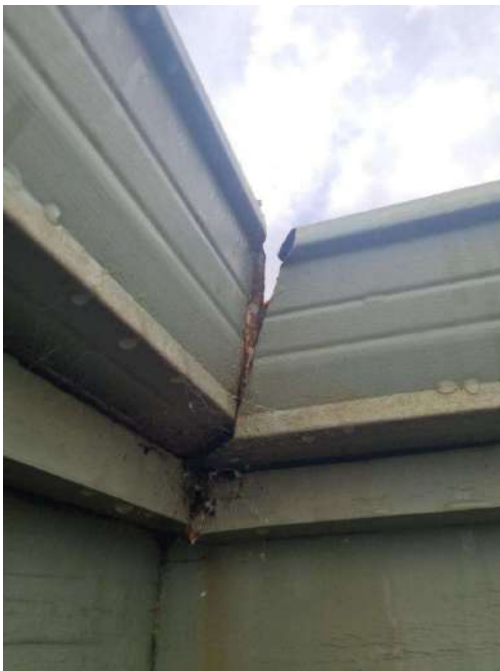
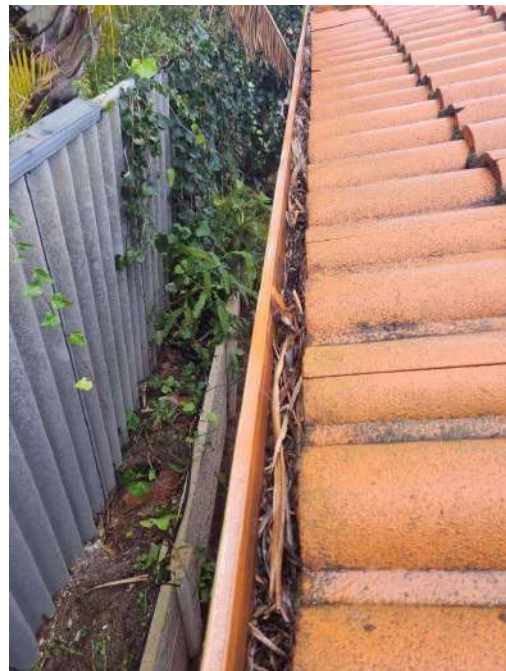
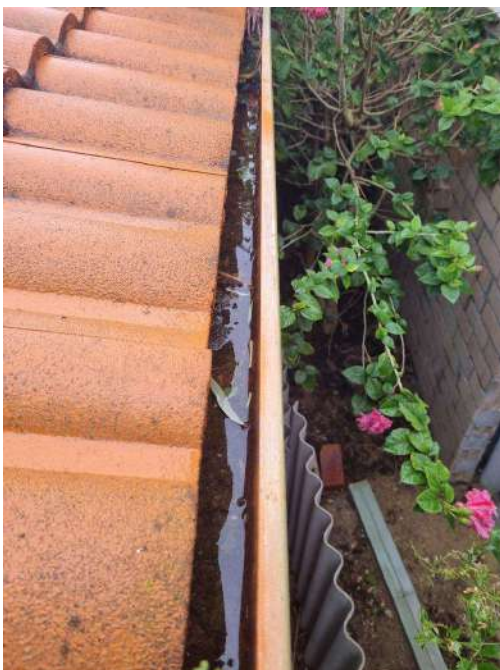
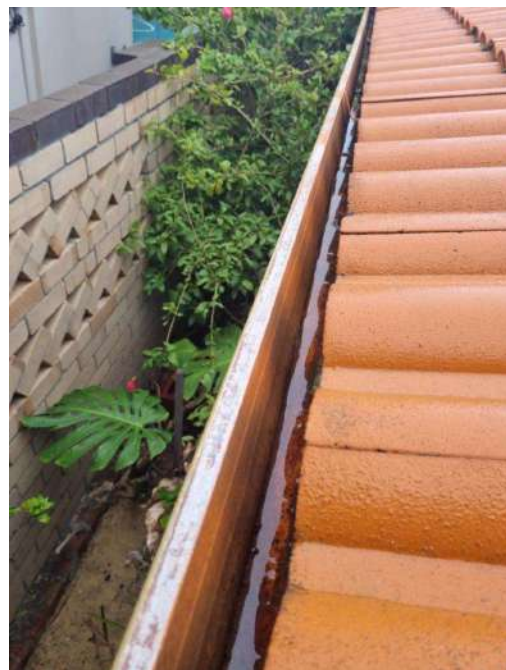
**Maintenance:** Debris observed in guttering area - this requires cleaning out to prevent blocking of downpipes and leaking into eaves and fascia. Recommendation: Engage a handyman to clean out. Regularly debris removal should be completed to prevent ponding. Ponding water will contribute to rust.

**Maintenance:** Standing water in gutter observed. This is likely due to debris build up in the affected areas, however it can also relate to poor fall, inadequate down pipes or a blocked down pipe. Recommendation: Engage a handyman to clean out debris and re-assess for any standing water. If condition continues to exist, engage a roofing contractor for repairs.

**Maintenance:** Surface rust observed to sections of the gutter. Recommendation: Engage a painter to clean and re-seal the guttering.

**Maintenance:** There is evidence of leaking gutters. Recommendation: Engage a roofing contractor for repair.

**Maintenance:** The gutter join/s have separated and will leak during rainfall. Recommendation: Engage a roofing contractor for repair.

**Maintenance:** Section/s of guttering missing.  
Recommendations - Engage a licensed roof plumber for advice and repair.

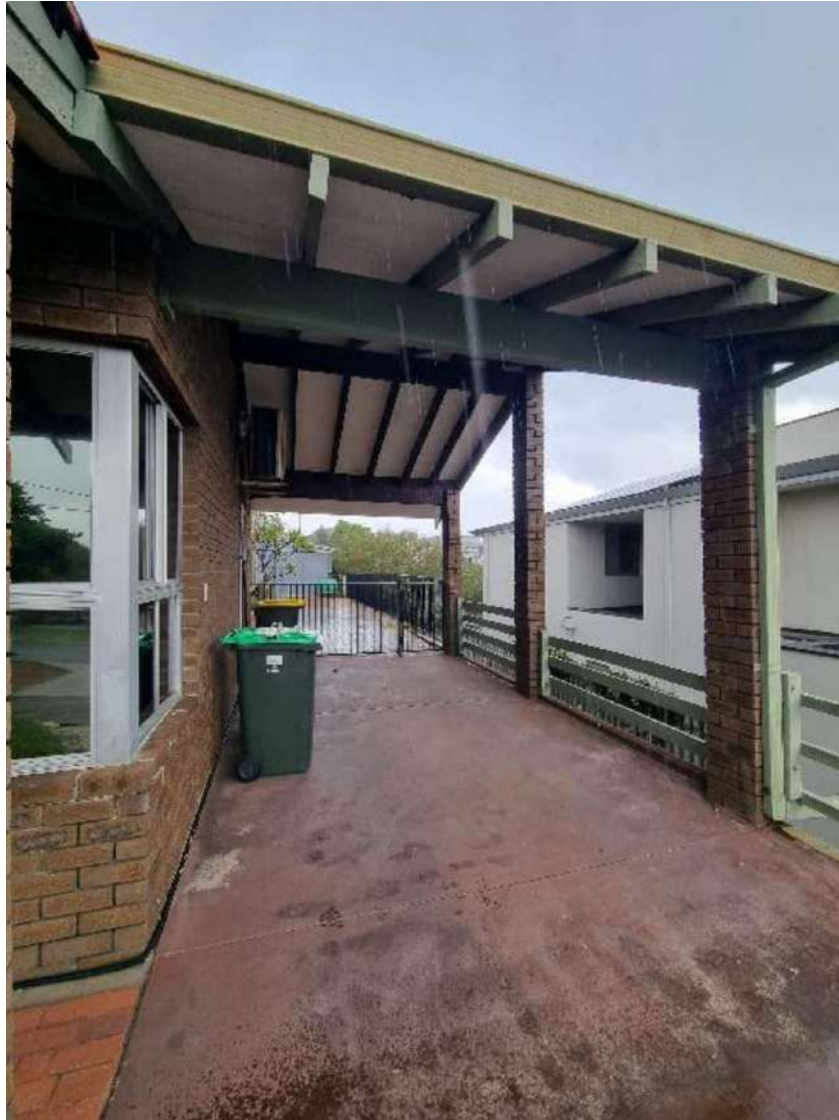
**Structural Major:** The footings of the brick post have settled with significant ground movement observed. The structural integrity of this supporting post/column has been compromised. In the inspectors opinion the stability of the load bearing post is of concern.

Recommendation: Engage a structural engineer for further assessment and advice regarding repairs.

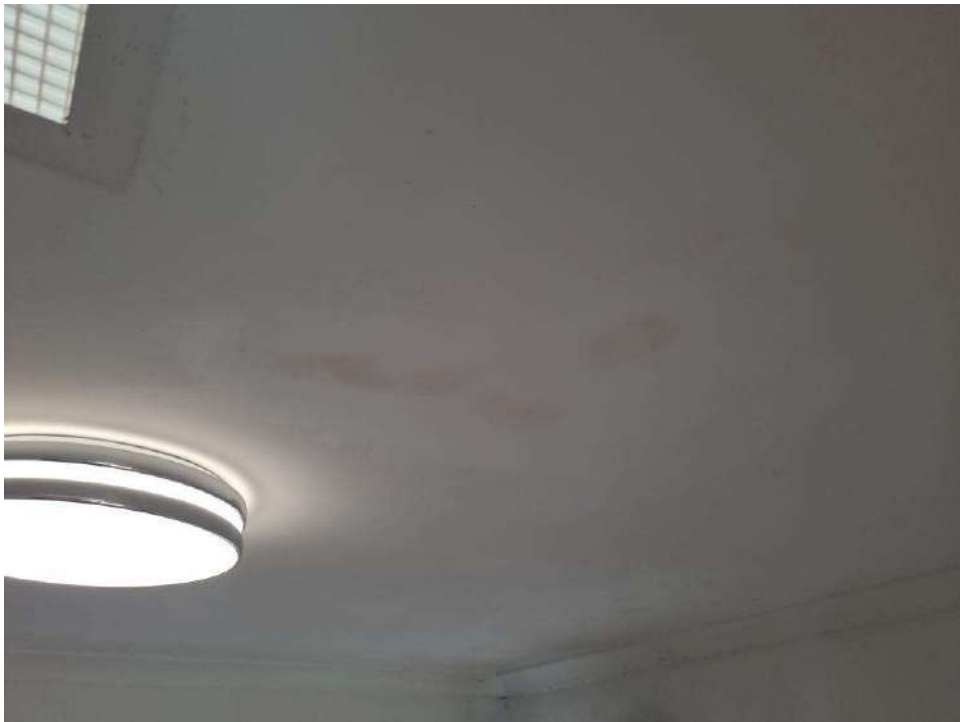
**Maintenance:** General ageing and/or denting and the like is evident on wall linings.  
Recommendation: Engage a painter for repairs.
