# Inspection Report

SURE Pty Ltd

### Pest And Building Inspection

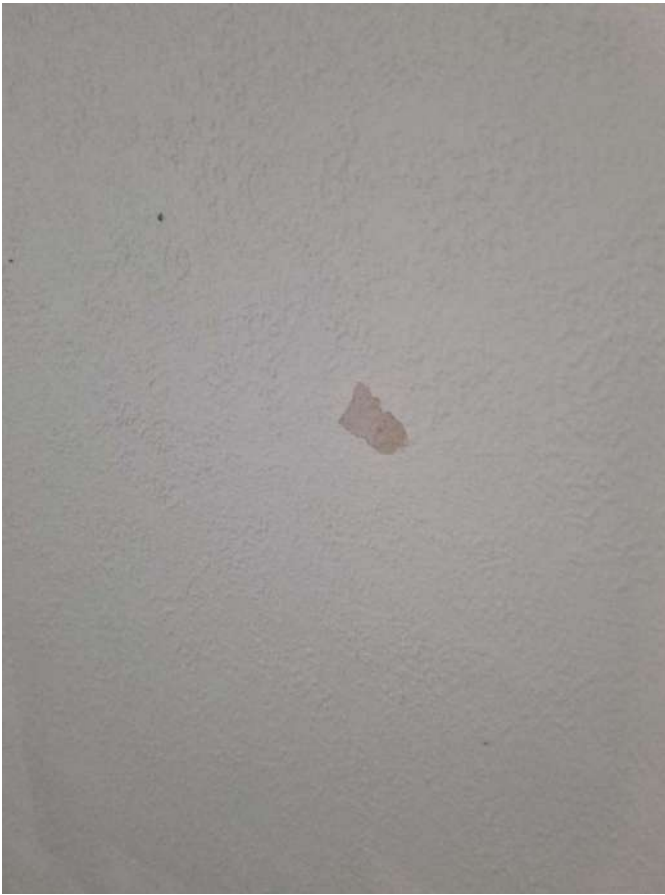
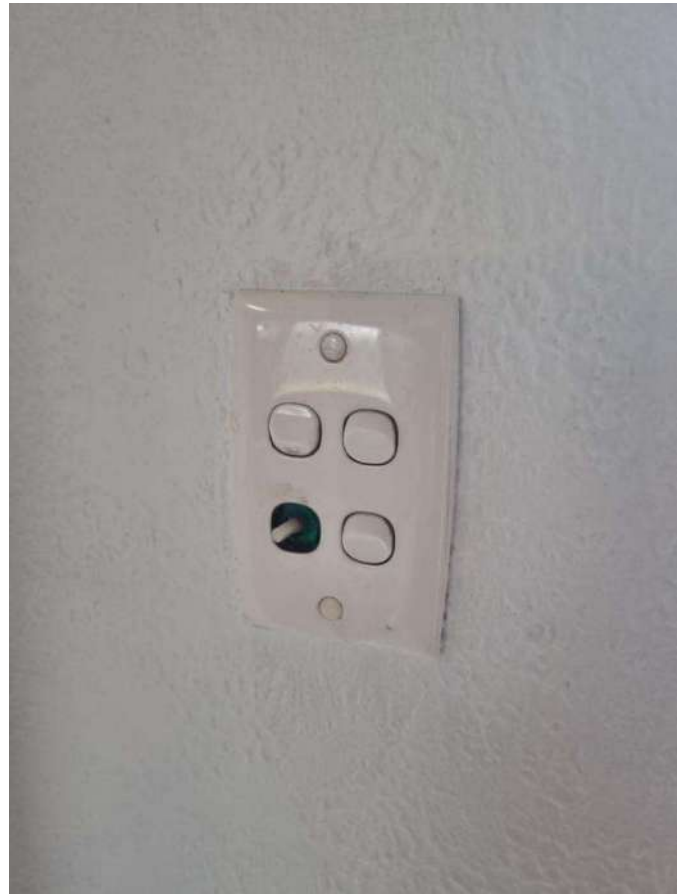
**Maintenance:** General scuffs and marks to walls. Recommendation: Engage a painter for repairs.

**Maintenance:** The light switch appears to be faulty (e.g. internally loose switch mechanism).  
Recommendation: Engage an electrician to repair.

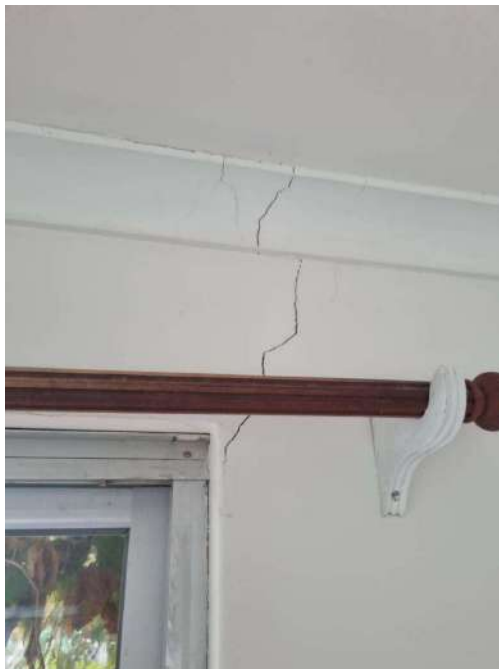
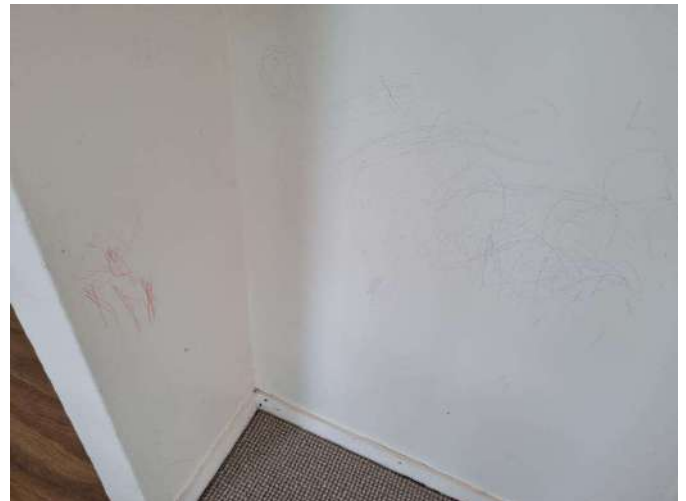
**Structural Minor:** There appears to have been some settlement in the building which has caused some cracking to the walls. These cracks are categorized as 0 to 2. This can also cause some doors to bind or be out of square. In the inspector's opinion, these cracks are due to settlement, usually due to ground movement and subsequent movement to building materials can be expected. All cracks should be monitored and if cracks increase in size, further investigation should be carried out by a structural engineer. Engage a painter to patch and paint.

**Maintenance:** General scuffs and marks to walls. Recommendation: Engage a painter for repairs.

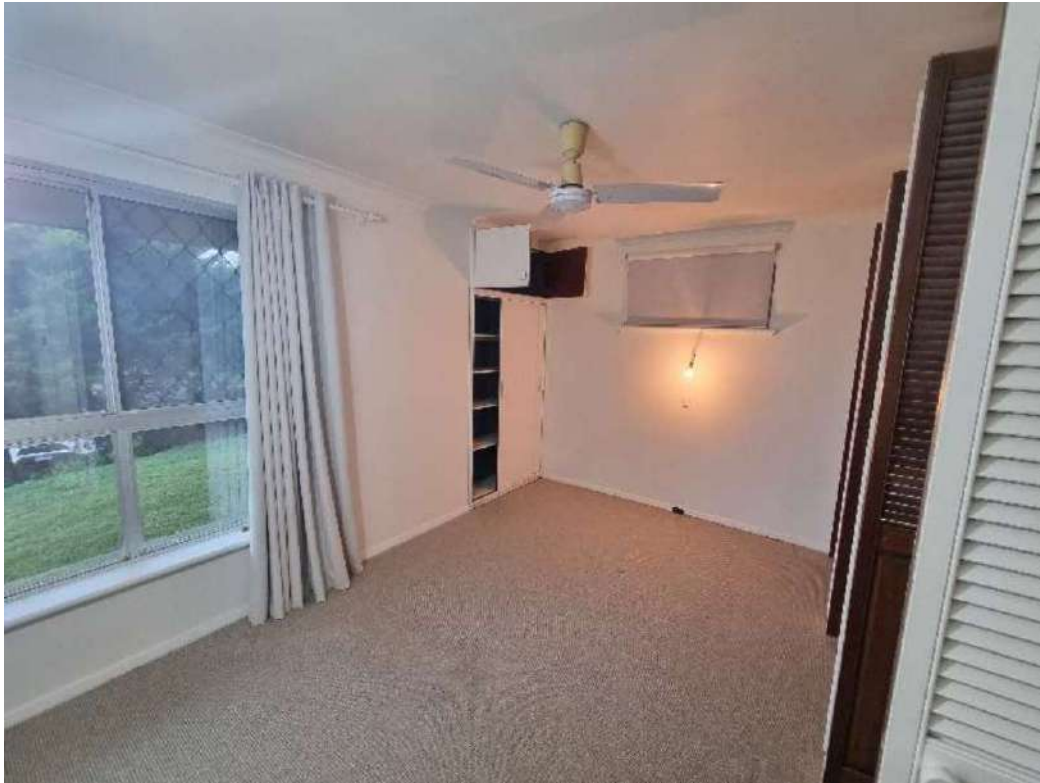
**Maintenance:** Wall damage from door handle impacting wall lining observed. Recommendation: Engage a handyman to install new door stop and touch up paint.

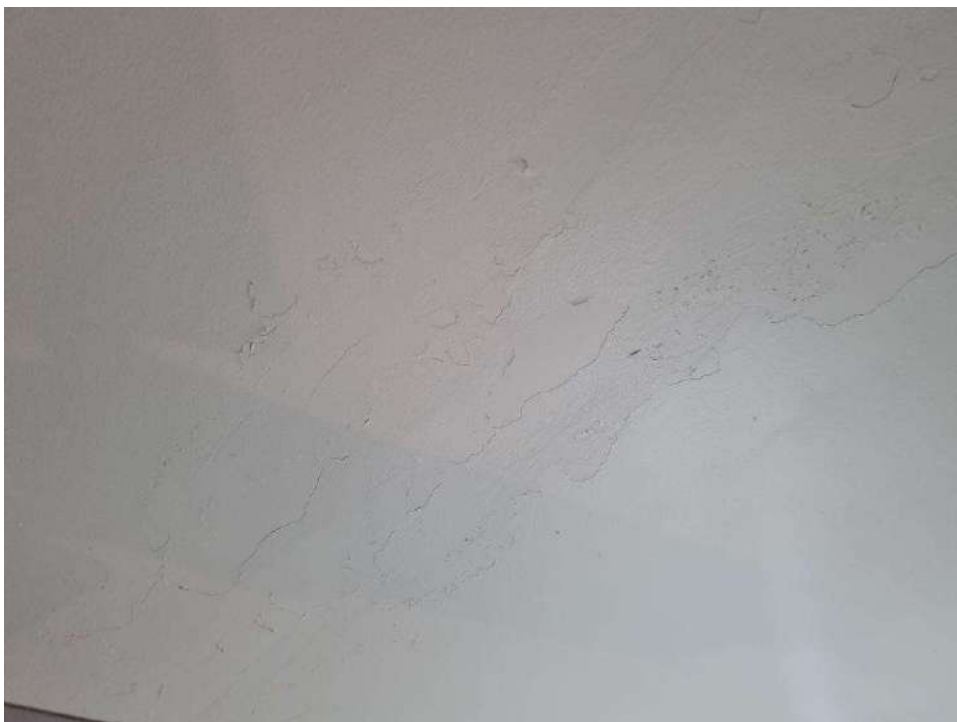
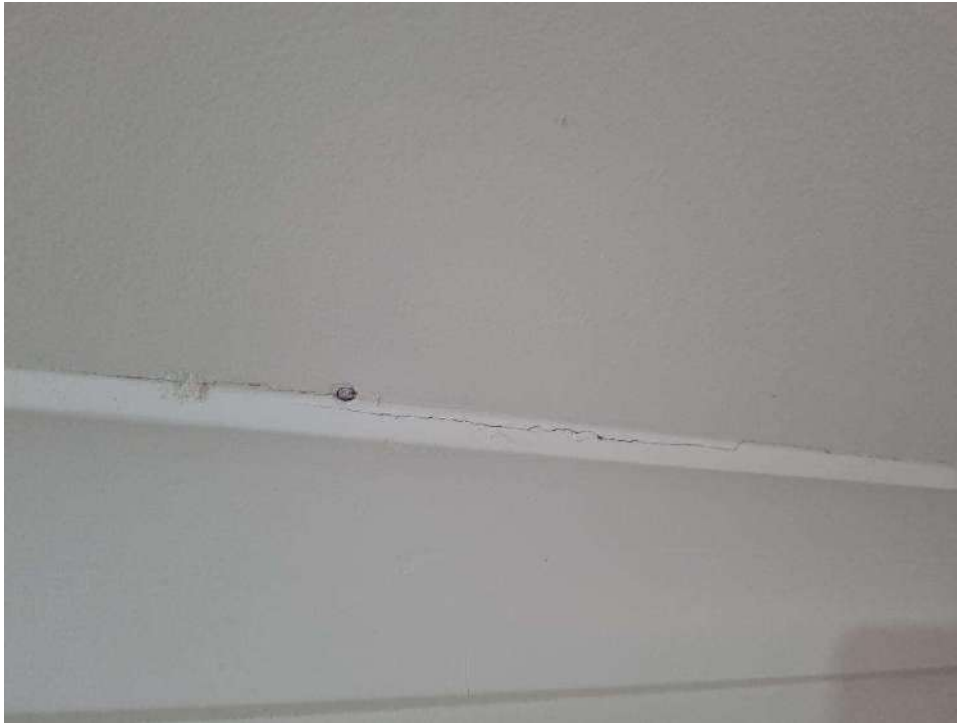
**Maintenance:** Paint deterioration observed. Recommendation: Engage a painter to repair.

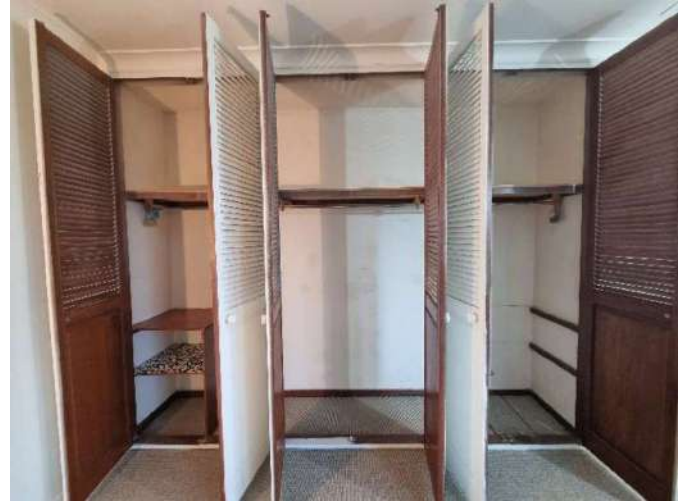
**Structural Minor:** There appears to have been some settlement in the building which has caused some cracking to the walls. These cracks are categorized as 0 to 2. This can also cause some doors to bind or be out of square. In the inspector's opinion, these cracks are due to settlement, usually due to ground movement and subsequent movement of building materials can be expected. All cracks should be monitored and if cracks increase in size, further investigation should be carried out by a structural engineer. Engage a painter to patch and paint.

**Maintenance:** The walls in the robe are aged and marked. Recommendation: Engage a painter to repair.

**Maintenance:** General scuffs and marks to walls. Recommendation: Engage a painter for repairs.

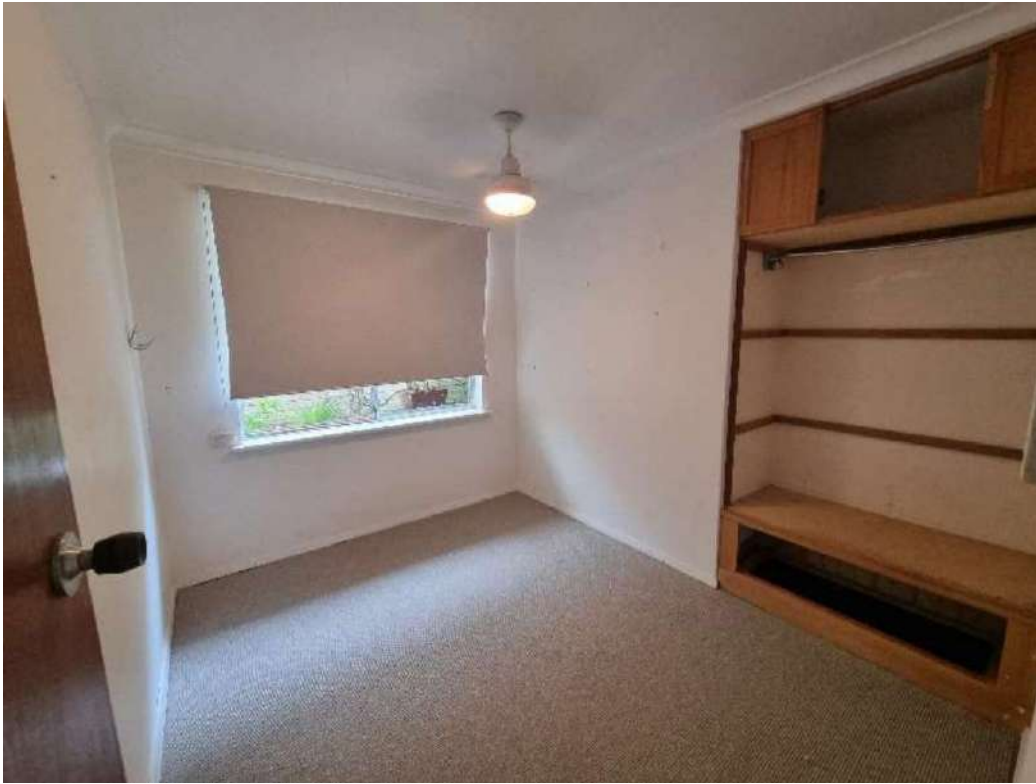
**Maintenance:** Ceiling/cornice join crack/s observed. Recommendation: Engage a painter for repairs.

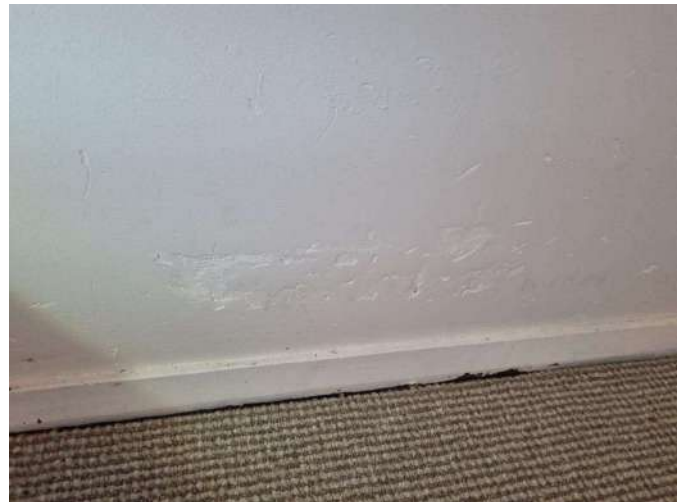
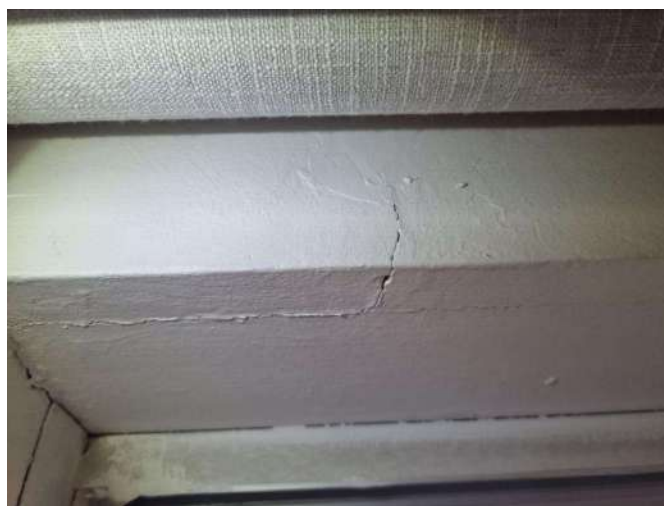
**Structural Minor:** There appears to have been some settlement in the building which has caused some cracking to the walls. These crack are catergorized as 0 to 2. This can also cause some doors to bind or be out of square. In the inspectors opinion these cracks are due to settlement, usually due to ground movement and subsequent movement to building materials can be expected. All cracks should be monitored and if cracks increase in size, further investigation

**Maintenance:** The walls in the robe are aged and marked. Recommendation: Engage a painter to repair.

**Maintenance:** General scuffs and marks to walls. Recommendation: Engage a painter for repairs.

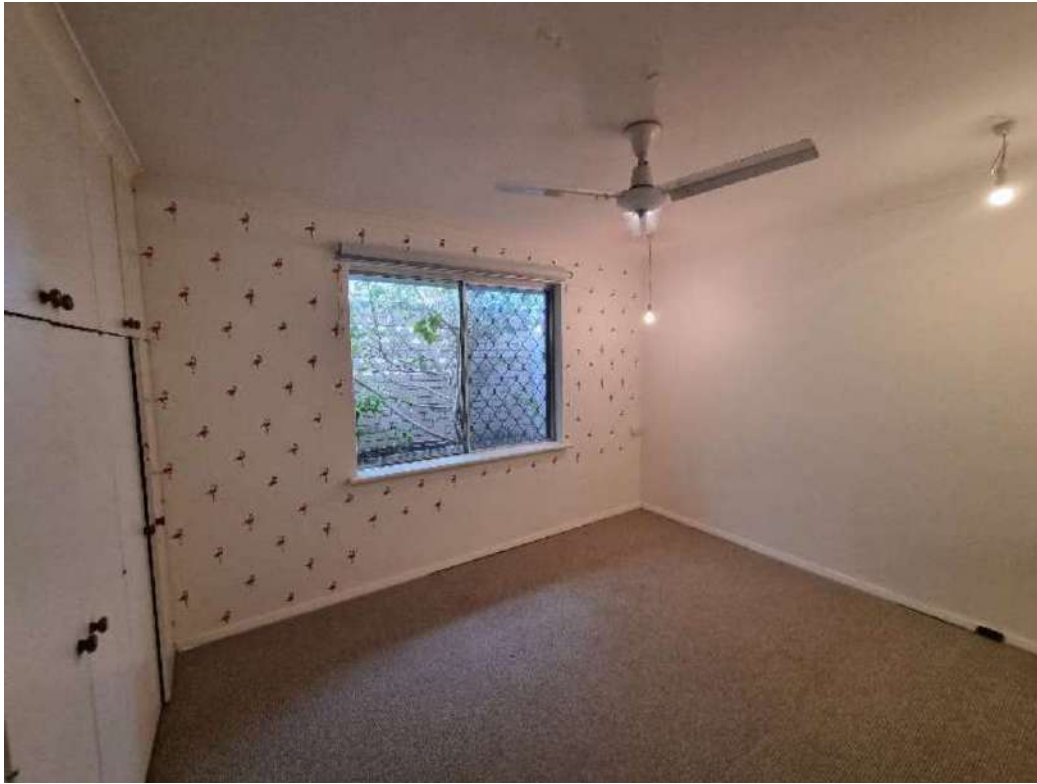
**Maintenance:** Paint deterioration observed. Recommendation: Engage a painter to repair.

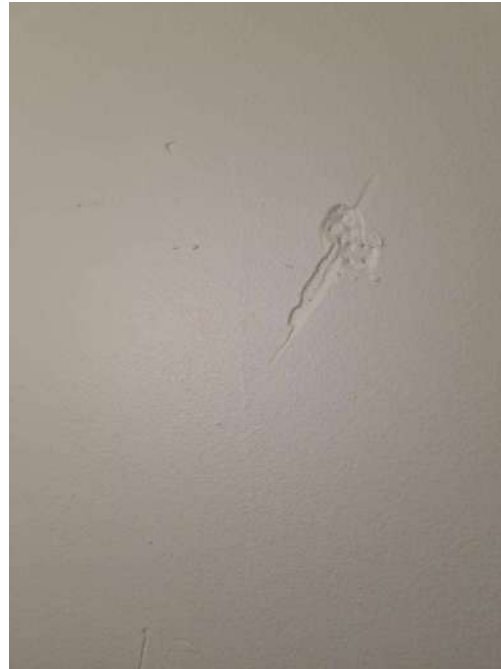
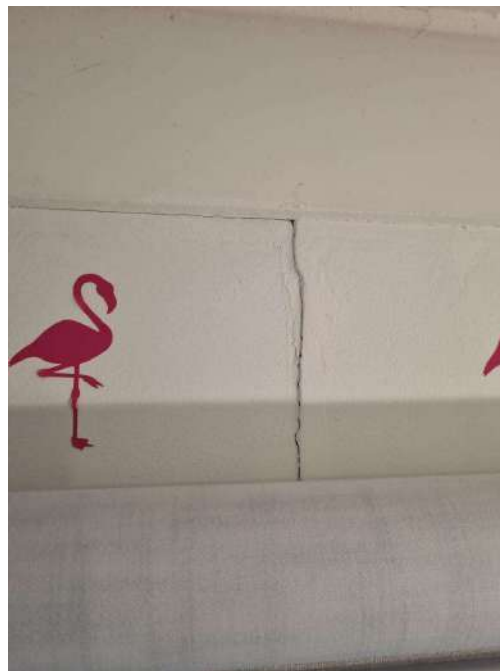
**Structural Minor:** There appears to have been some settlement in the building which has caused some cracking to the walls. These cracks are categorized as 0 to 2. This can also cause some doors to bind or be out of square. In the inspectors opinion these cracks are due to settlement, usually due to ground movement and subsequent movement to building materials can be expected. All cracks should be monitored and if cracks increase in size, further investigation should be carried out by a structural engineer. Engage a painter to patch and paint.

**Maintenance:** General ageing and/or denting and the like is evident on wall linings.  
Recommendation: Engage a painter for repairs.

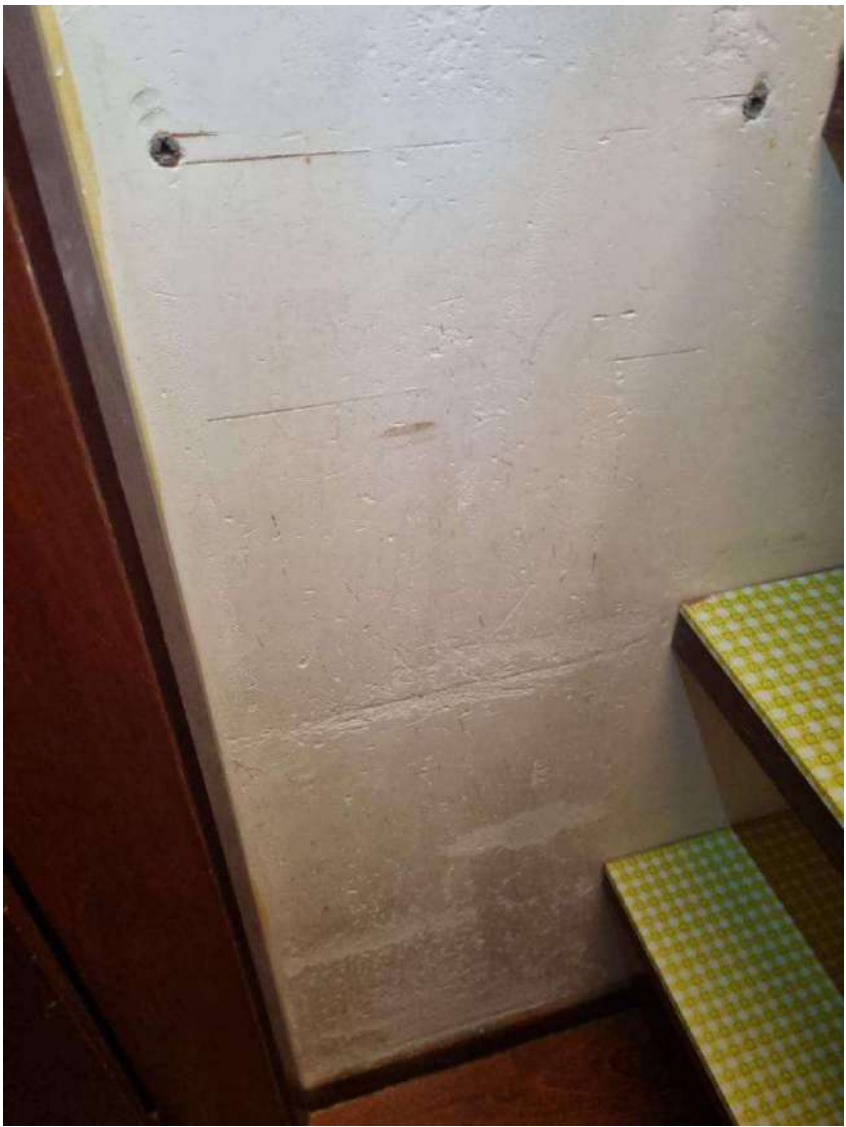
**Maintenance:** General ageing and/or denting and the like is evident on wall linings.

Recommendation: Engage a painter for repairs.

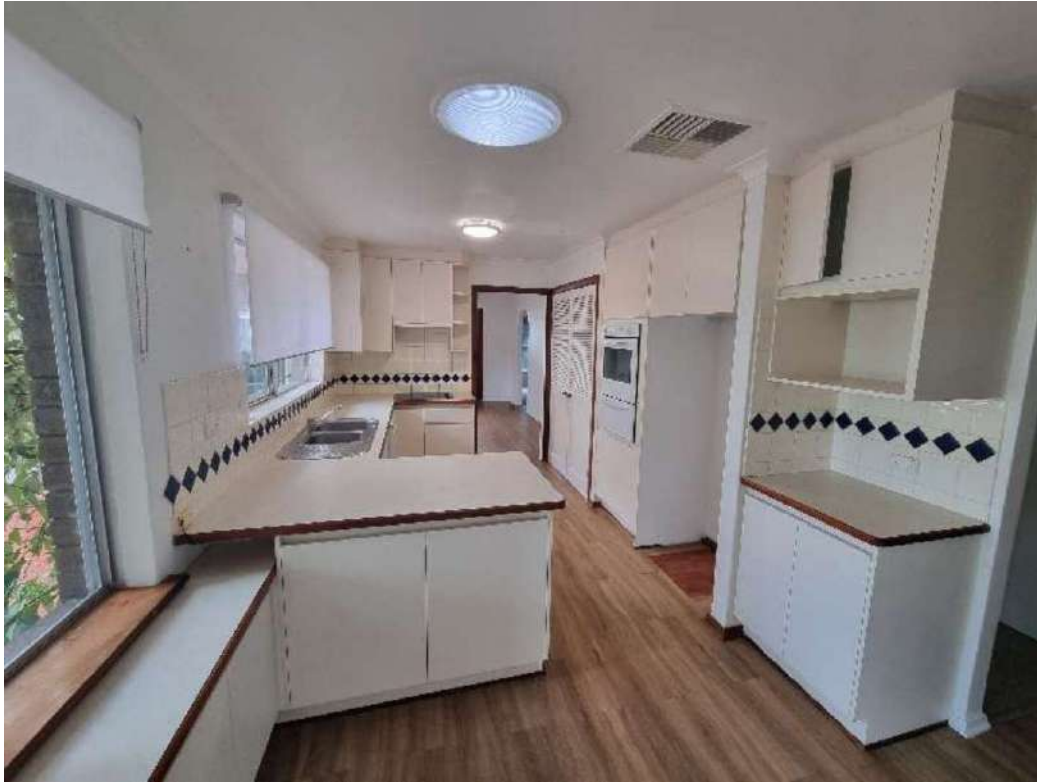
**Maintenance:** Paint deterioration observed. Recommendation: Engage a painter to repair.

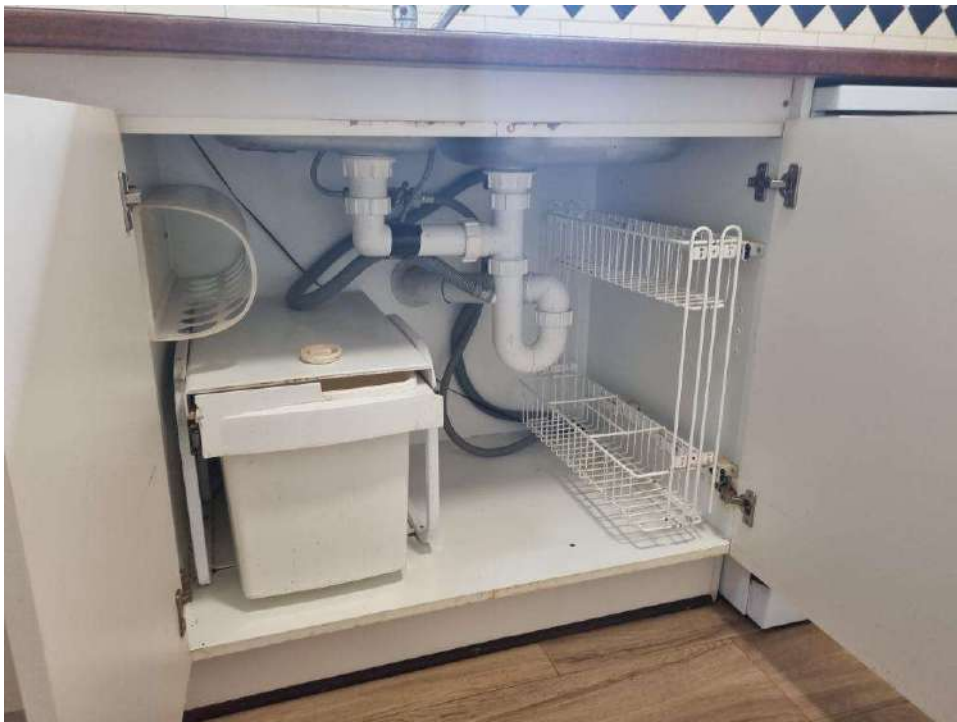
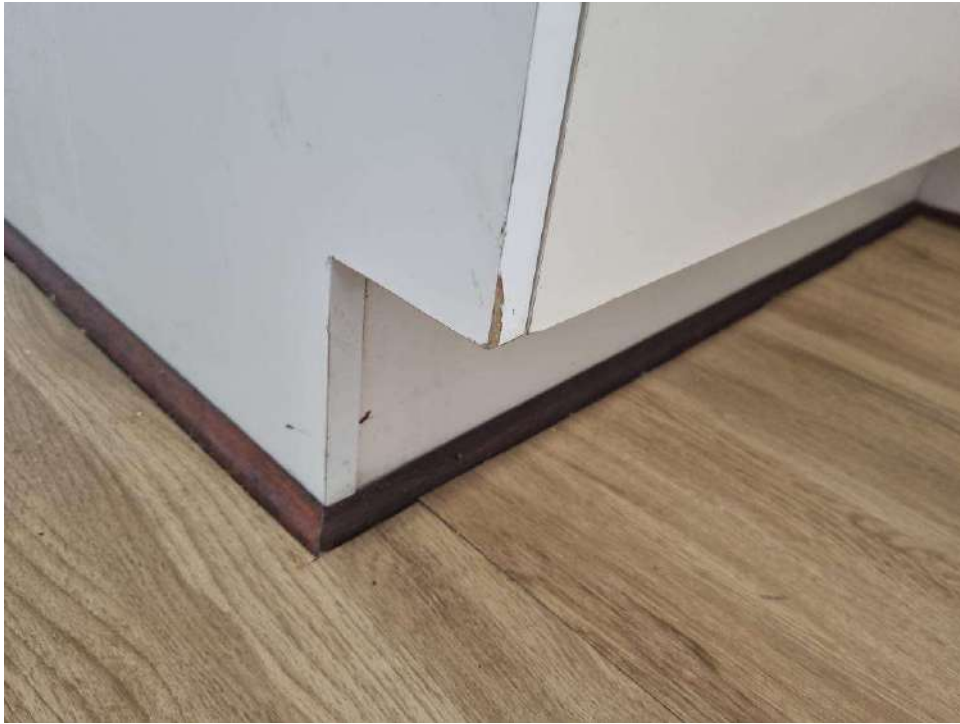
**Maintenance:** General wear and tear to cupboards and benches. Recommendation: Engage a cabinet maker for refurbishment if desired.

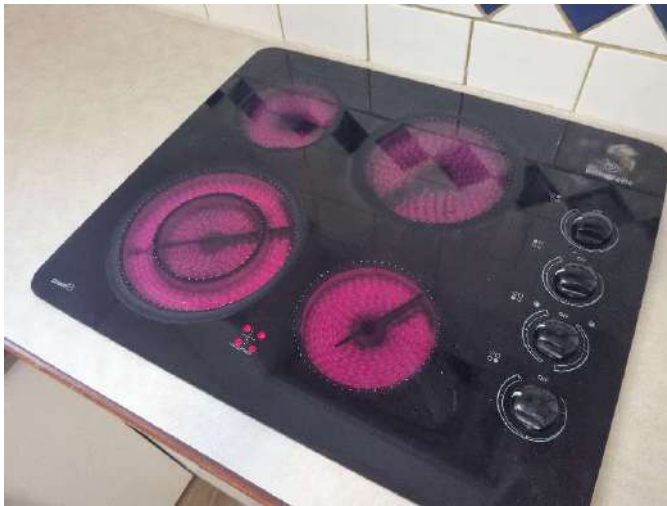
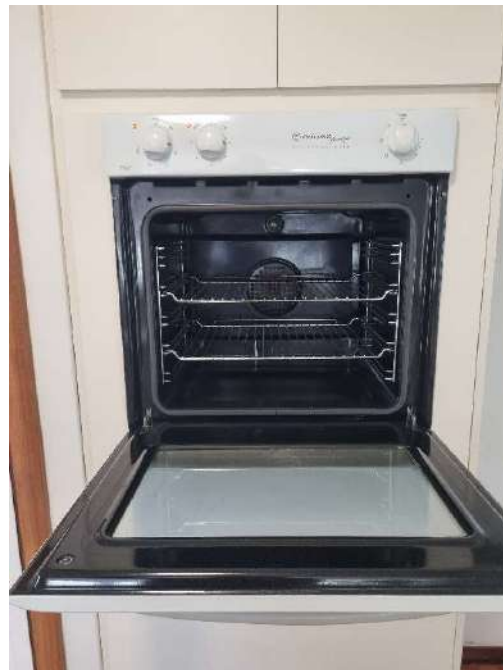
**Maintenance:** The oven light did not operate as expected. Recommendation: Replacement bulb required.

**Maintenance:** The exhaust fan light is not operating. Recommendation: Engage an appliance technician to replace bulb/s.

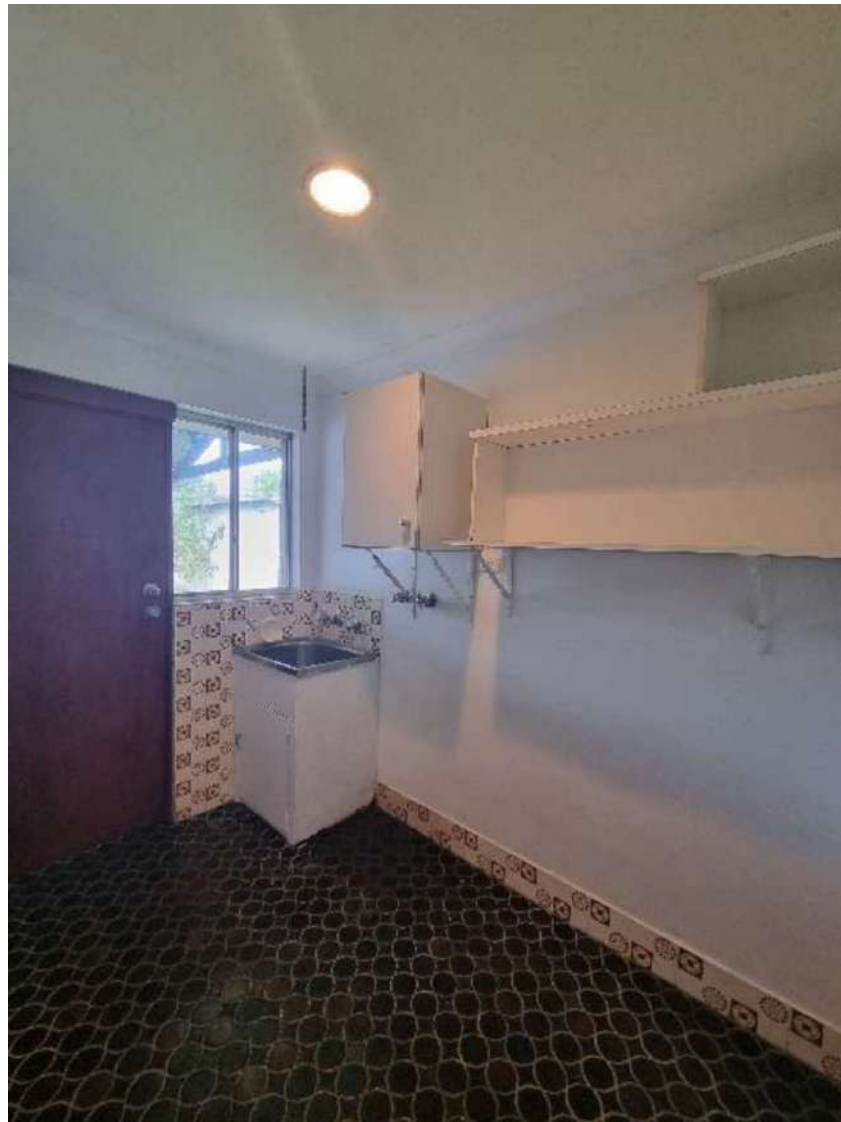
**Maintenance:** Paint deterioration observed. Recommendation: Engage a painter to repair.

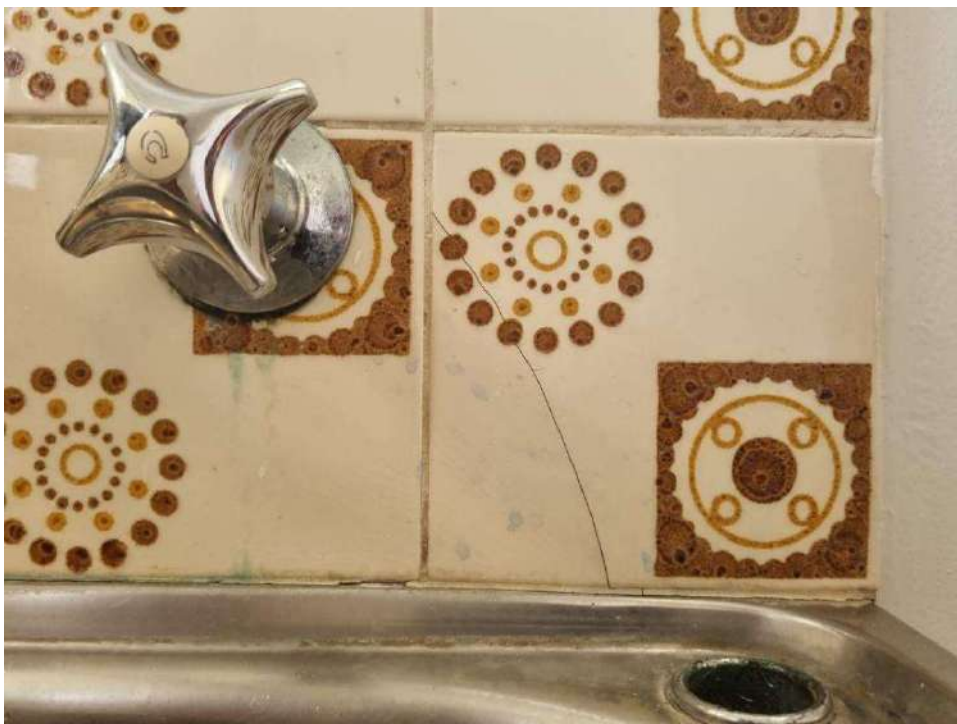
**Maintenance:** Cracked wall tiles noted. Recommendation: Engage a tiler for repairs.

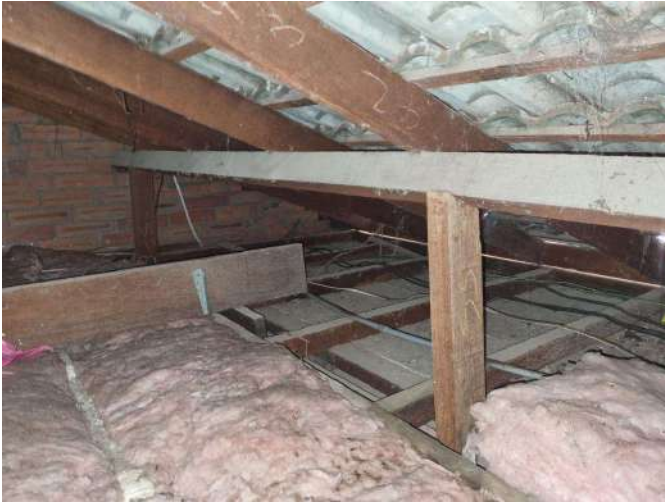
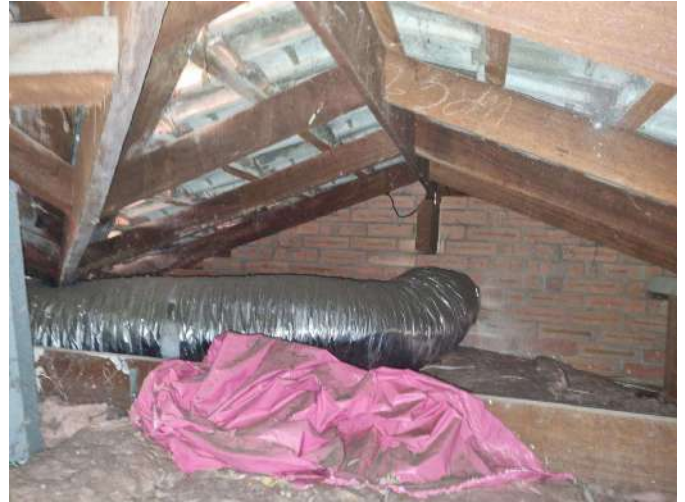
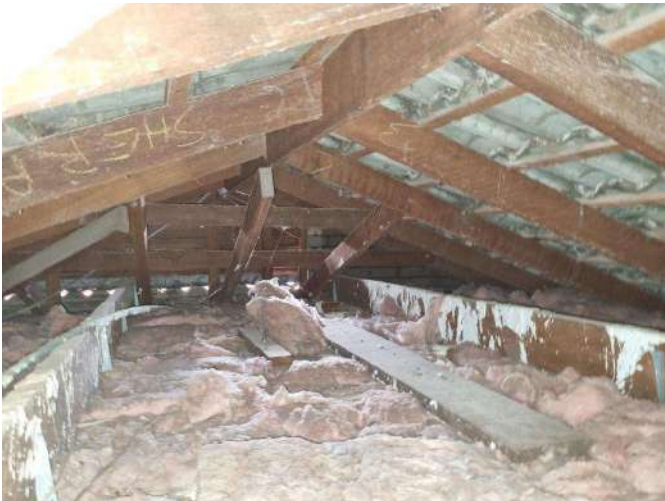
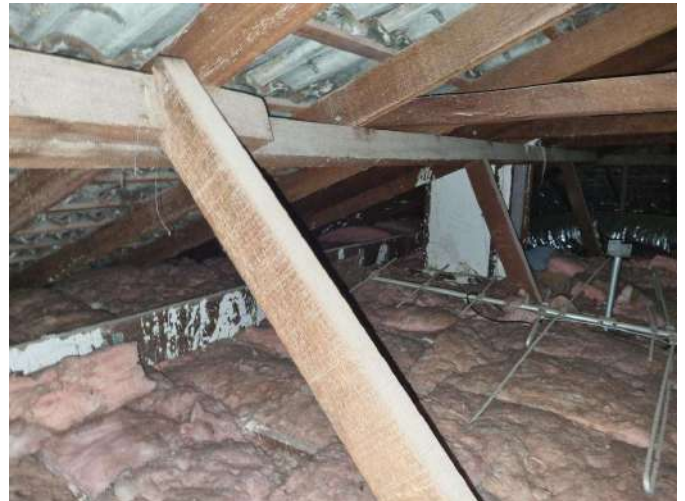
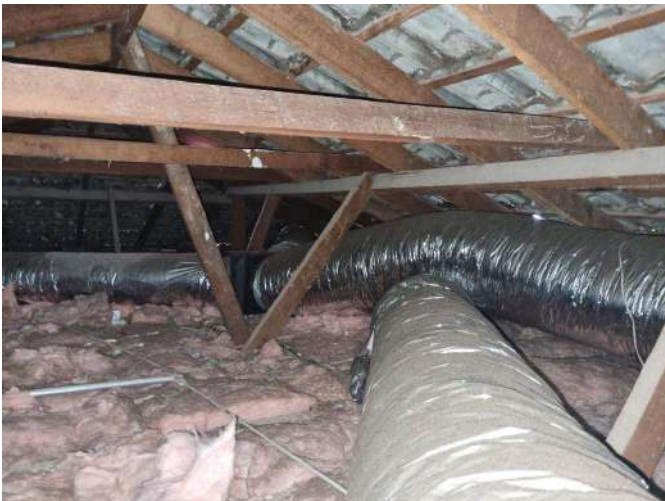
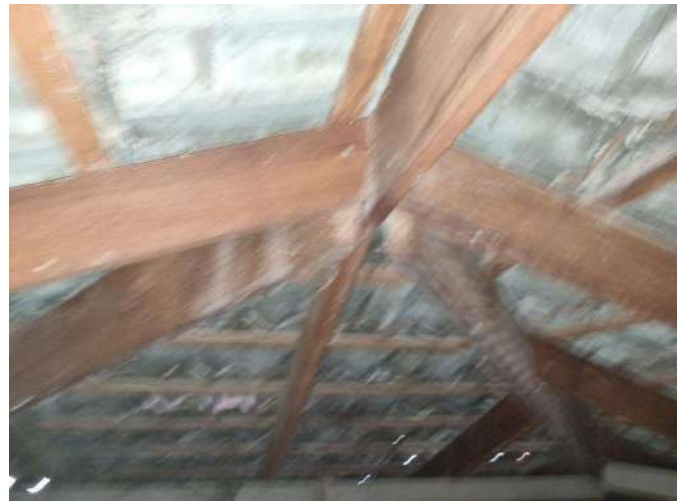
**Structural Major:** Unevenness in underpurlin - insufficient load support contributing to sagging / unevenness in roof line. Recommendation: Engage a carpenter for installation of additional strut components to adequately support the load of the roof frame/covering.

**Maintenance:** Framing timbers are aged. Recommendation: Maintain a regular inspection routine and engage a carpenter to complete maintenance as required.

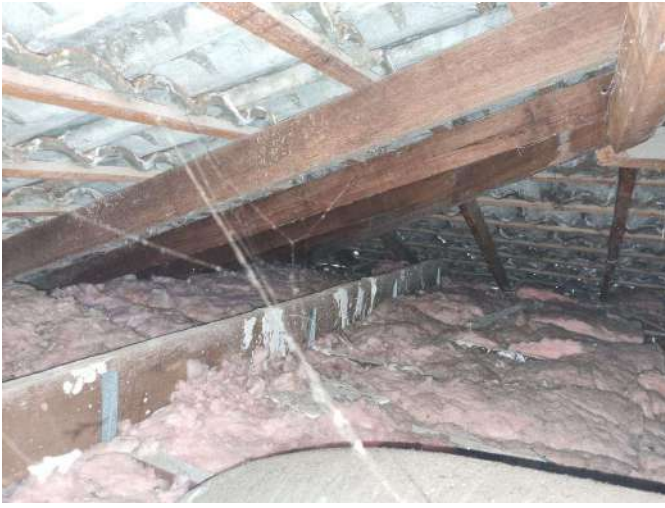
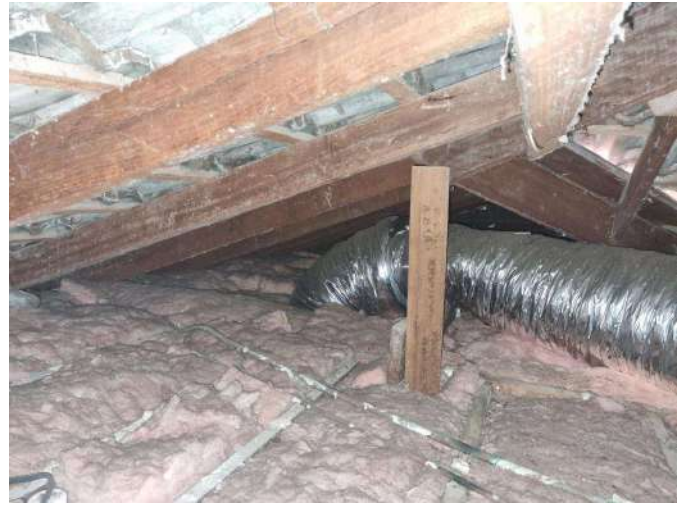
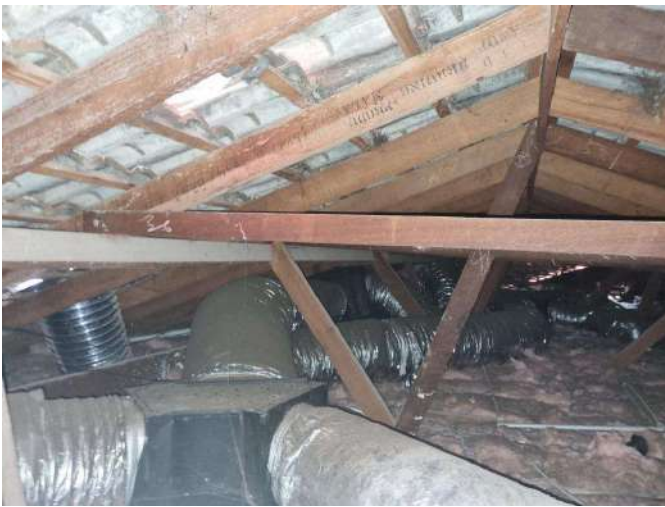
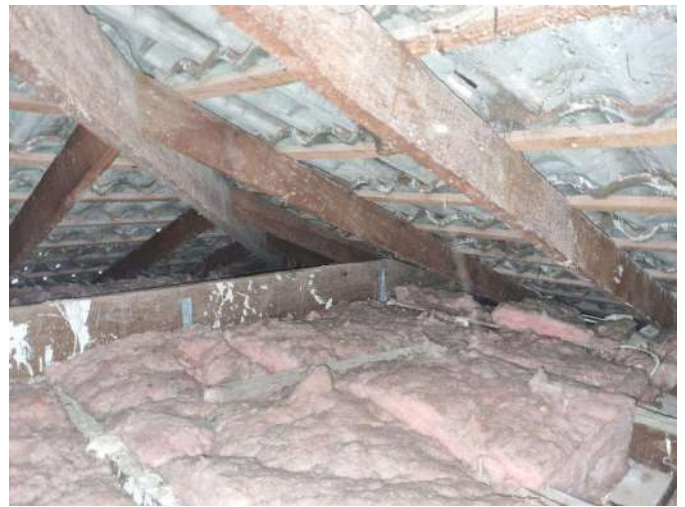
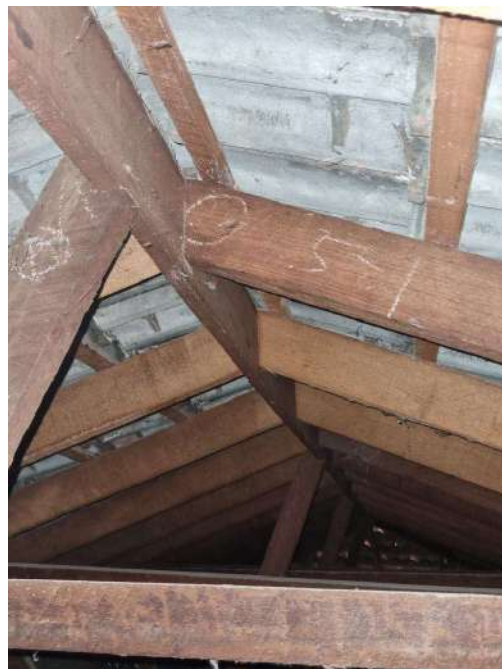
On inspection, defects were present that will require further assessing and recommendations by a qualified trades persons, please read below for details.

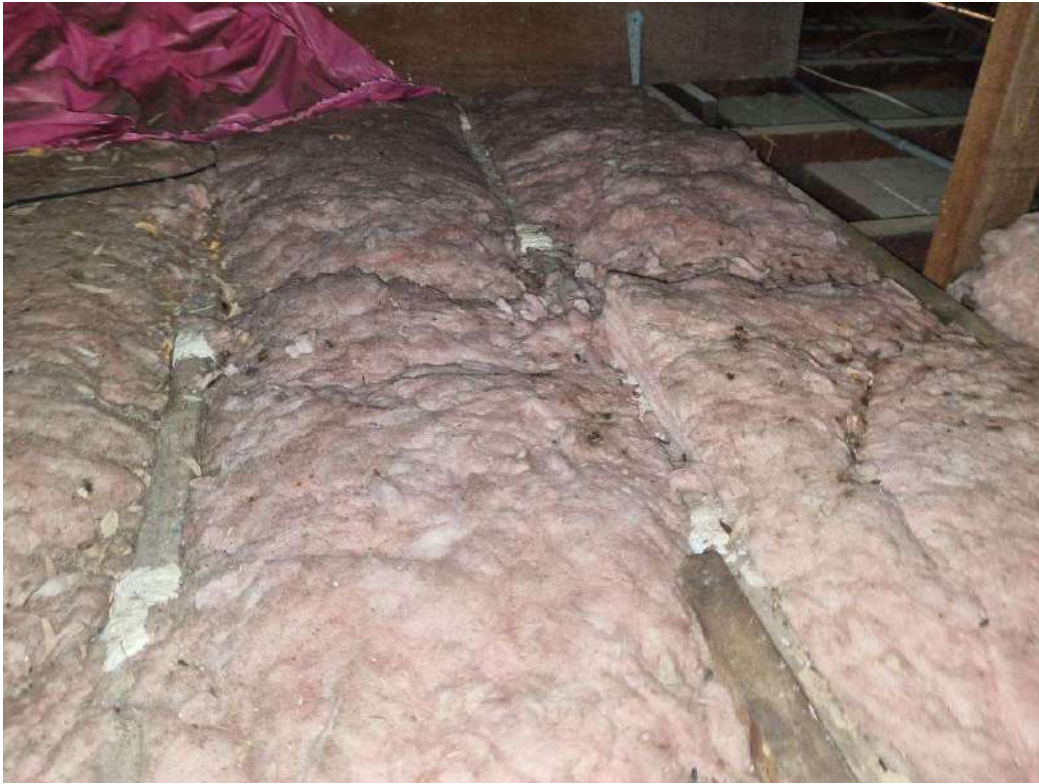
From the visible and accessible areas, the general condition of the roof void insulation is serviceable for the age of the building.

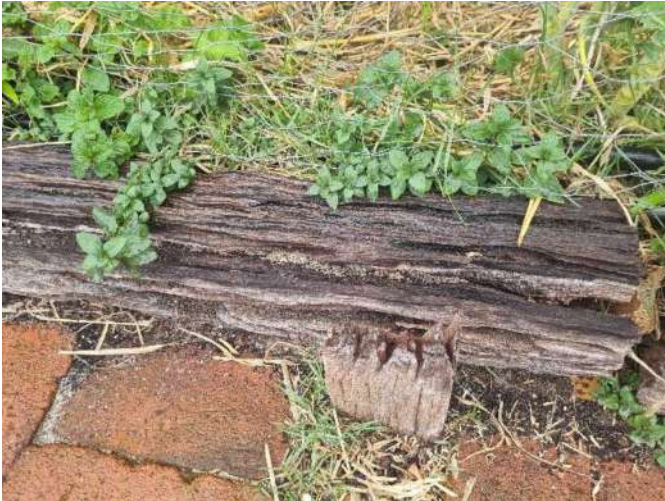
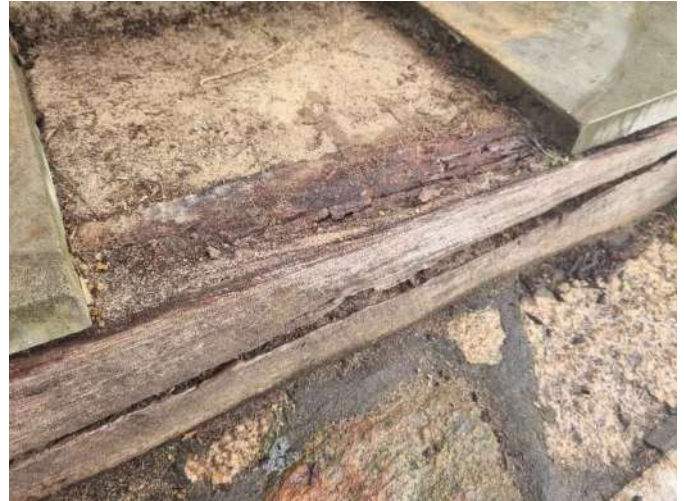
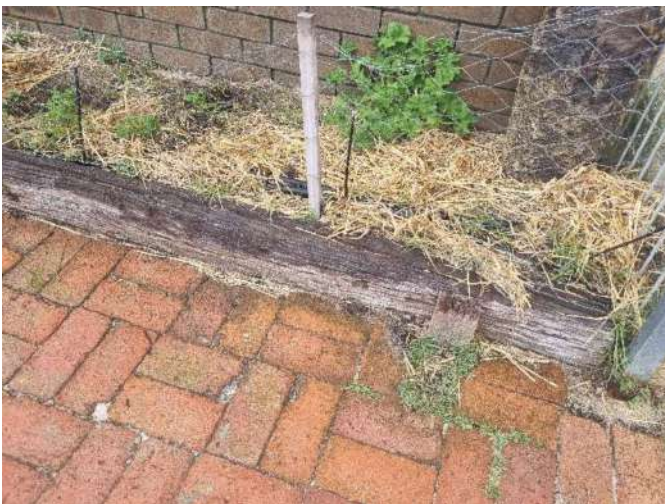
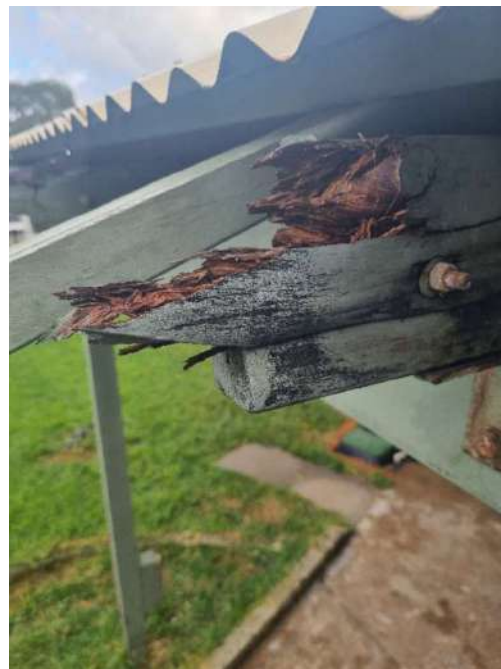
Yes, in the following areas ,  
Garden landscaping sleepers/timbers.  
Pergola framing timbers.

The extent of rot damage is considered to be high.

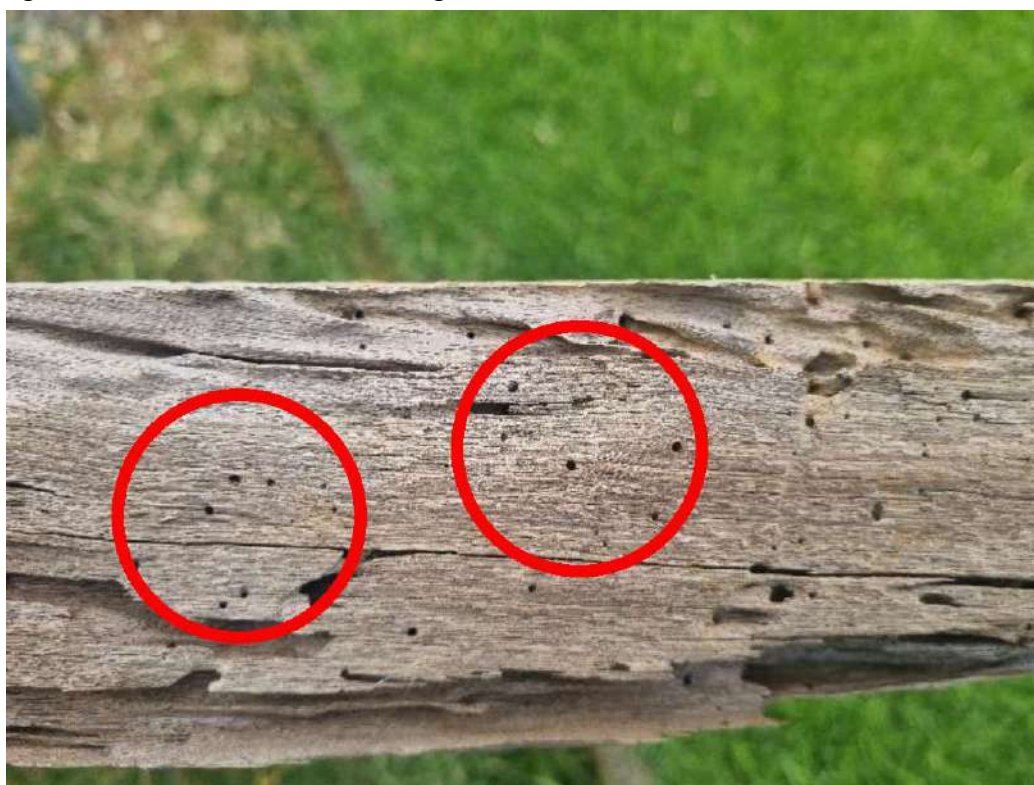
Borer damage was observed to areas of garden timbers.

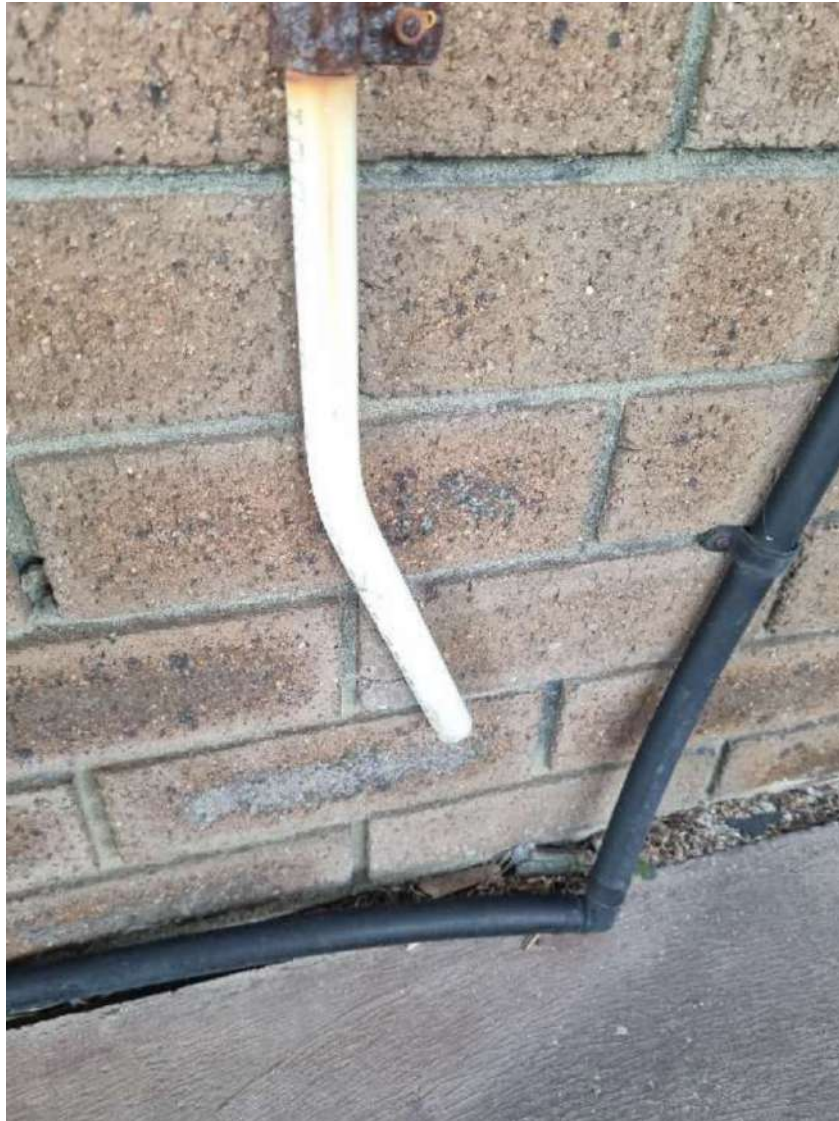
No. Divert hot water overflow away from the building perimeter.

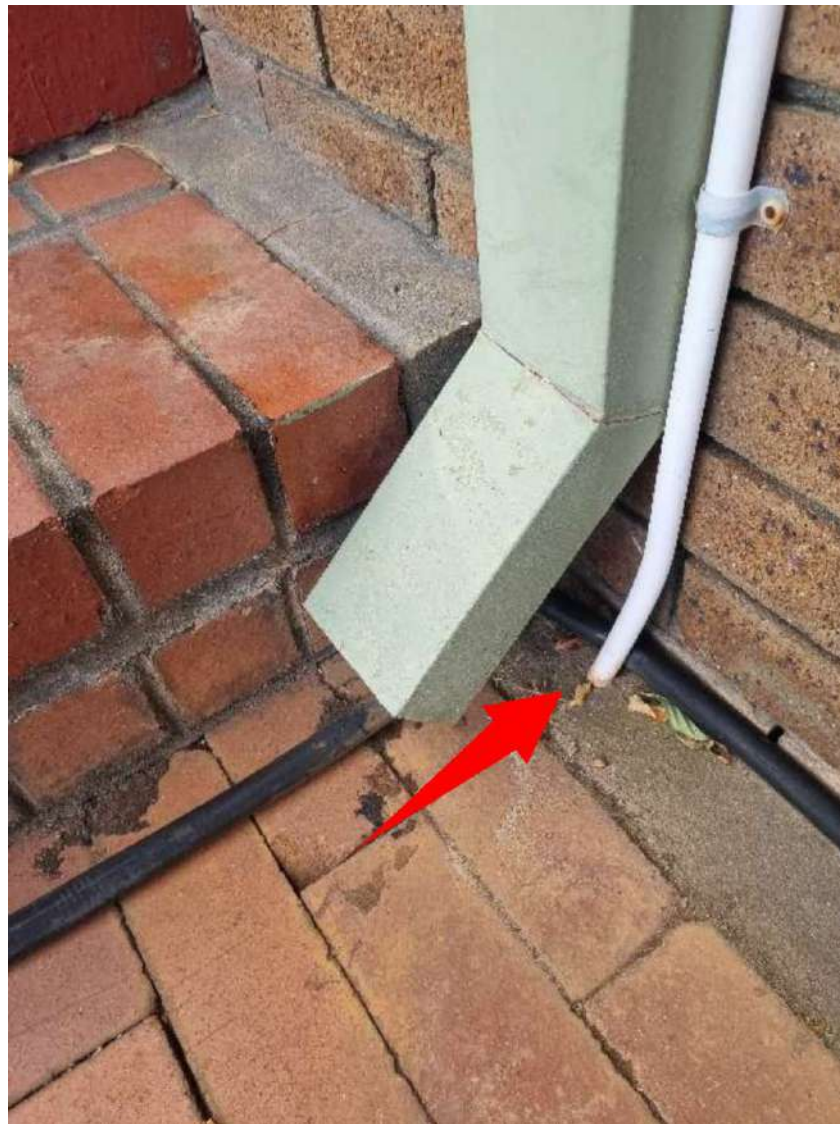
No - Divert A/C overflow away from the building perimeter.
