# Inspection Report

SURE Pty Ltd

### Pest And Building Inspection

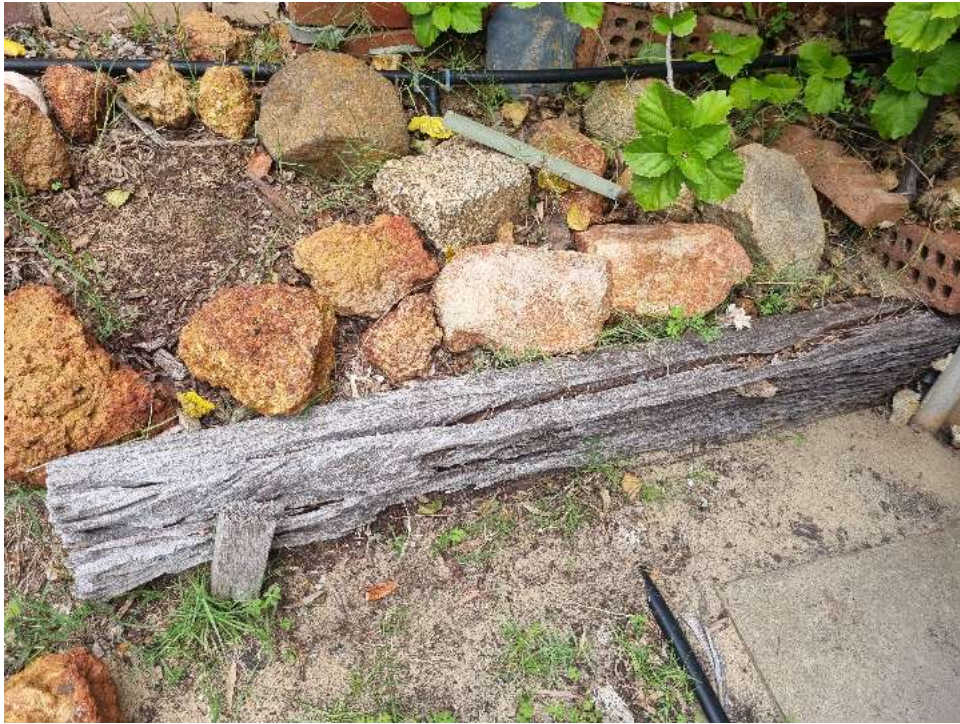
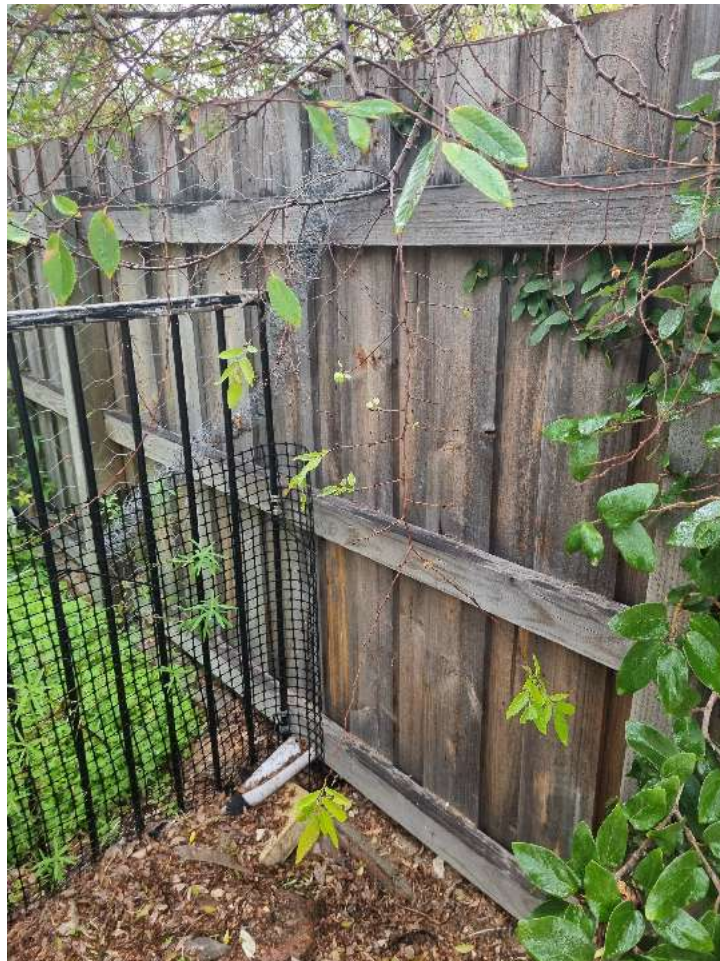
Tree stump/s are located at the site. These need to be removed by a suitably qualified tradesperson as they are conducive conditions for a termite nest.

Tree/leafy environment: This property is located in a suburb which is high risk due to the environmental surrounds. It is close to large trees and parkland. A termite management plan/treatment is strongly advised.
