Inspection Report

SURE Pty Ltd

Pest And Building Inspection

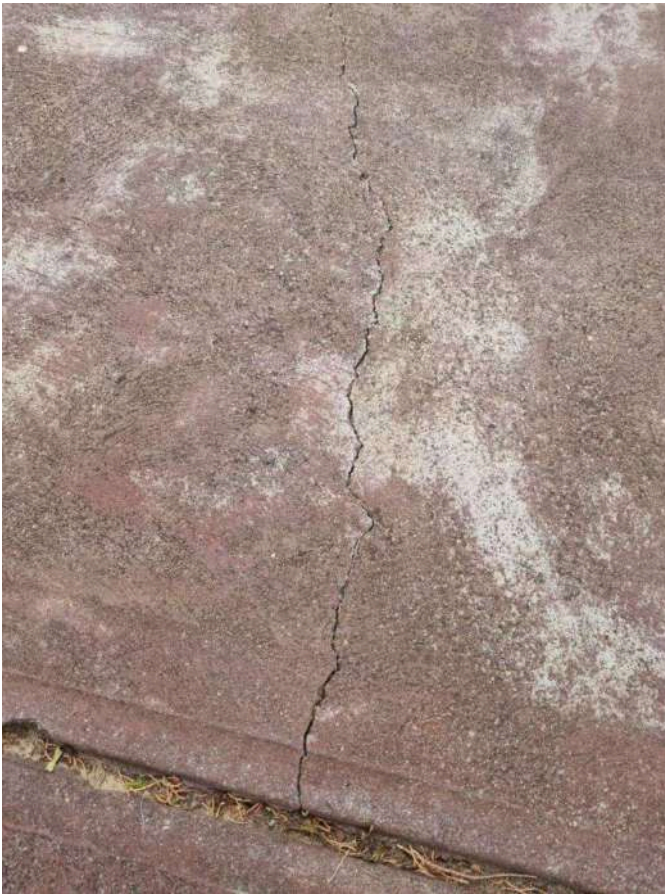
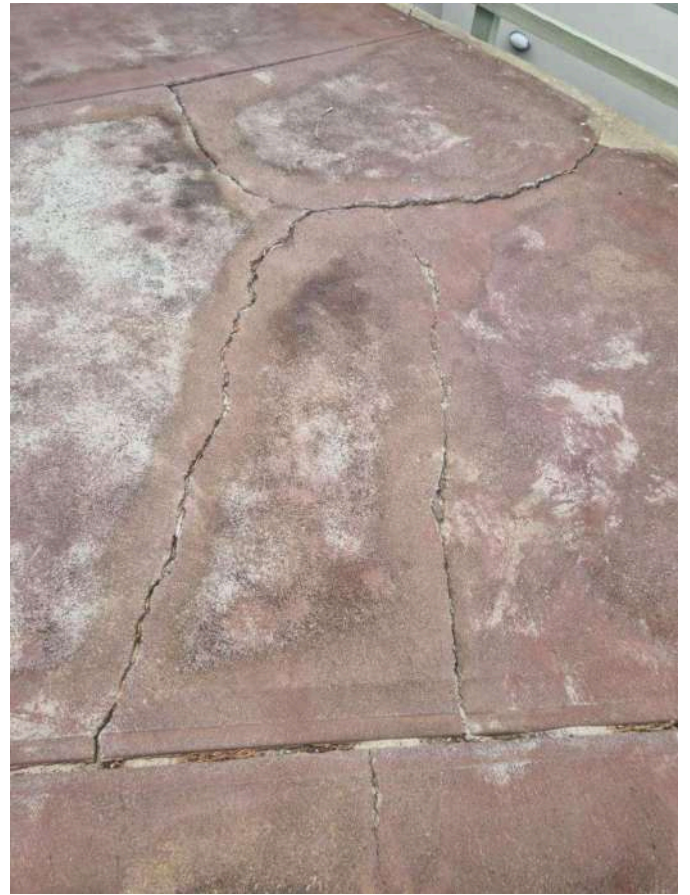
Maintenance: Common cracks and settlement was observed on the driveway. Recommendation: Whilst these cracks appeared to be typical at the time of inspection, we strongly recommend you monitor these cracks and if worsening occurs engage a concreter for further advice and repair.

Maintenance: Sections of the driveway are in poor condition and replacement is recommended. Recommendation: Engage a qualified concreter for a repair.

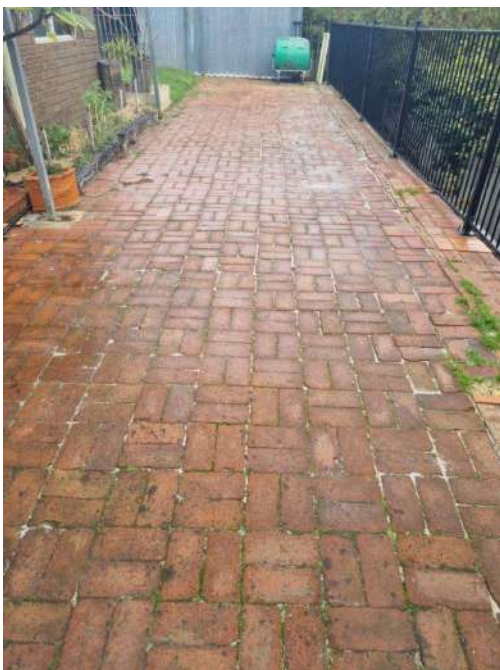
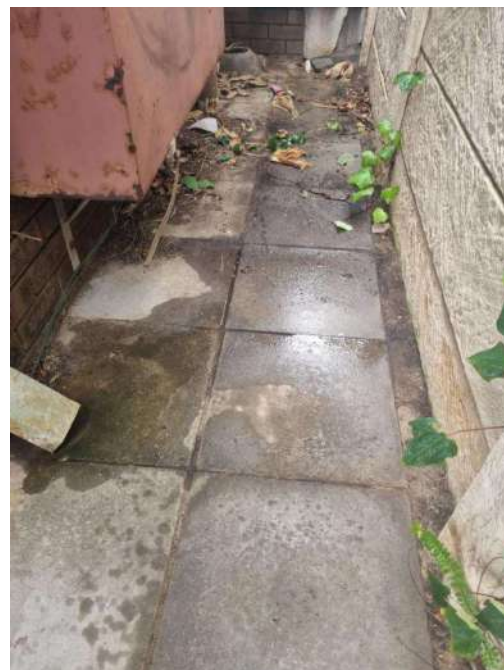
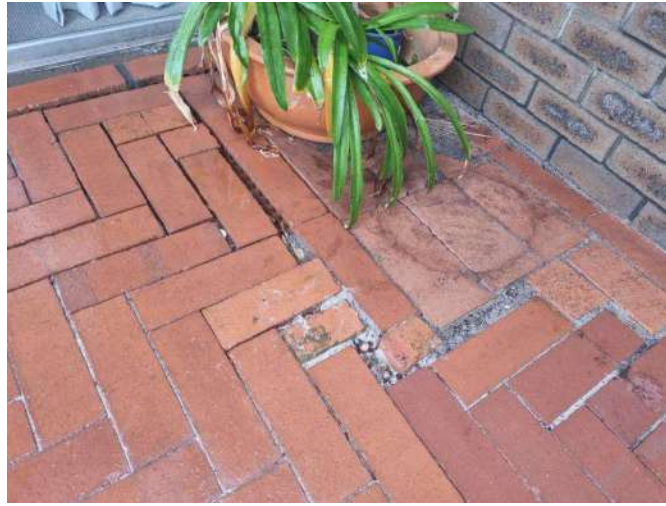
Paths

Maintenance: Common cracks and settlement was observed on the path area/s.

Maintenance: The surface has raised and settled in some areas. This can cause water ponding.

Recommendation: Whilst these cracks appeared to be typical at the time of inspection, we strongly recommend you monitor these cracks and if worsening occurs engage a concreter for further advice and repair.

Recommendation: Engage a landscaper for relay affected sections.

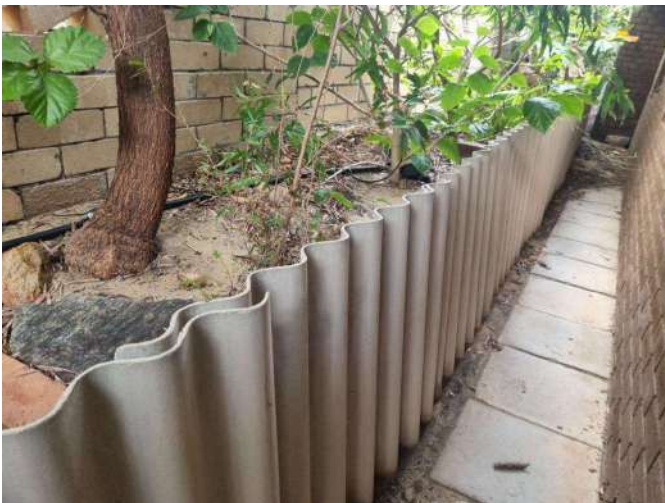
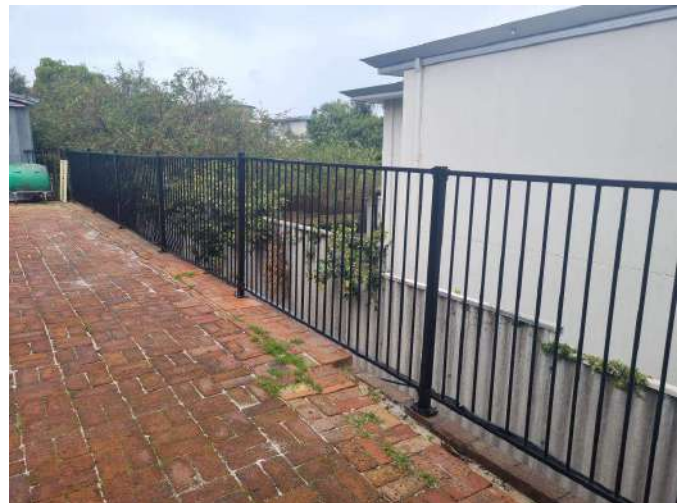
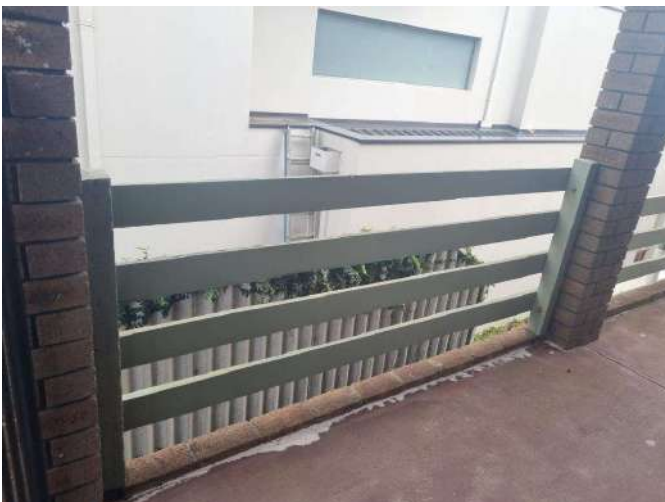
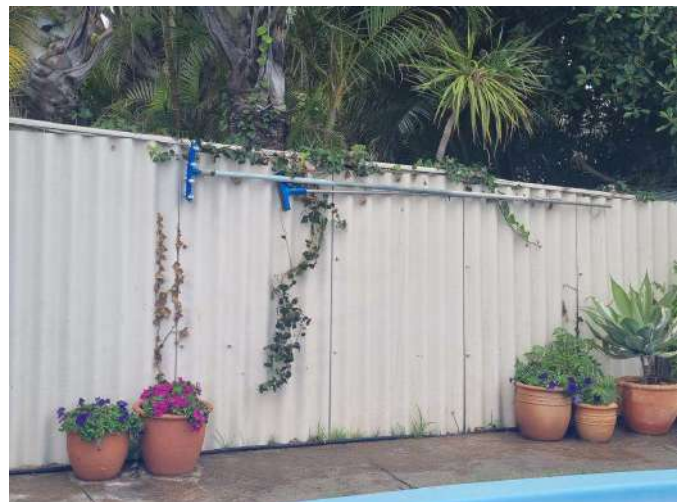
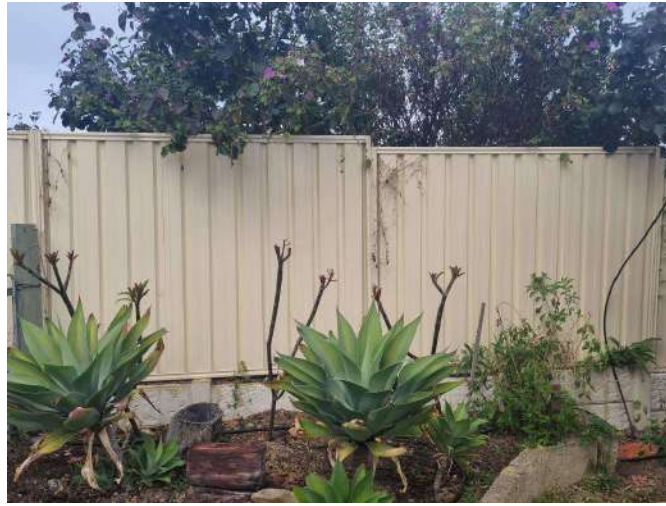
Fence Observations

Health and Safety: The brick fence can be rocked by hand and is unstable. This is a safety hazard. Recommendation: Engage a qualified bricklayer for advice and repair.

Health and Safety: Section of the fence are fibrous cement sheeting. Recommendation: Conduct an asbestos lab test to confirm material. Considered a potential health and safety defect.

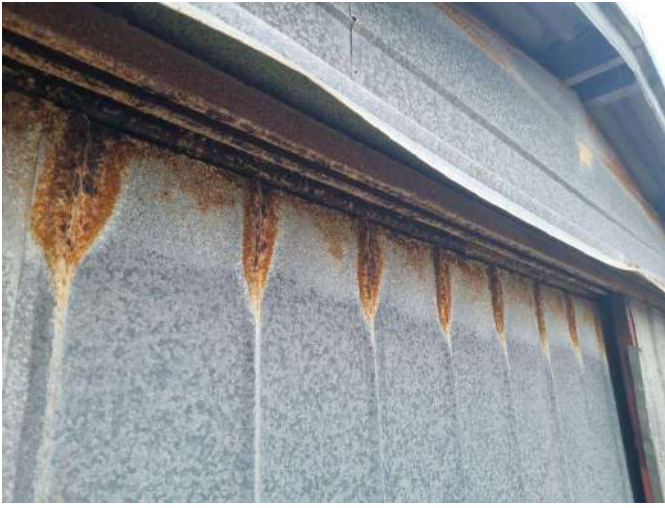
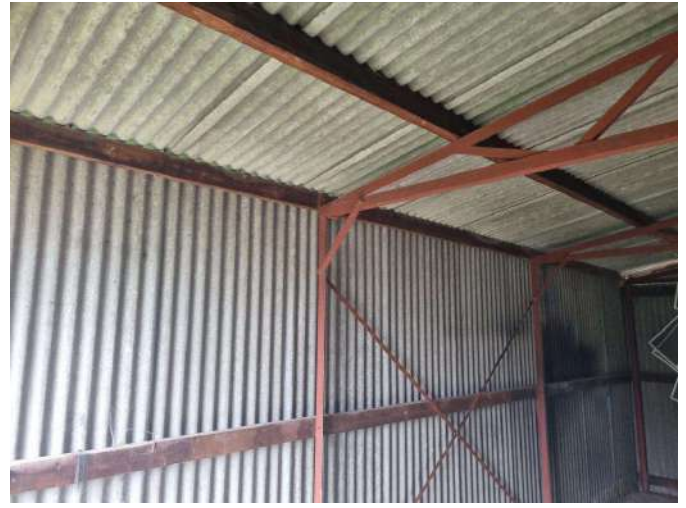
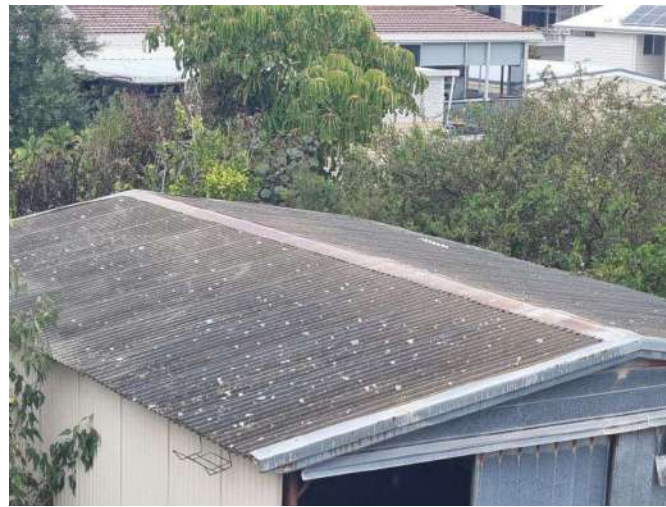
Health and Safety: Section of the shed are fibrous cement sheeting. Recommendation: Conduct an asbestos lab test to confirm material. Considered a potential health and safety defect.

Maintenance: Rust noted to be developing on cladding. Recommendation: Engage a handyman to complete repairs to restrict rust or replace affected sections if desired.

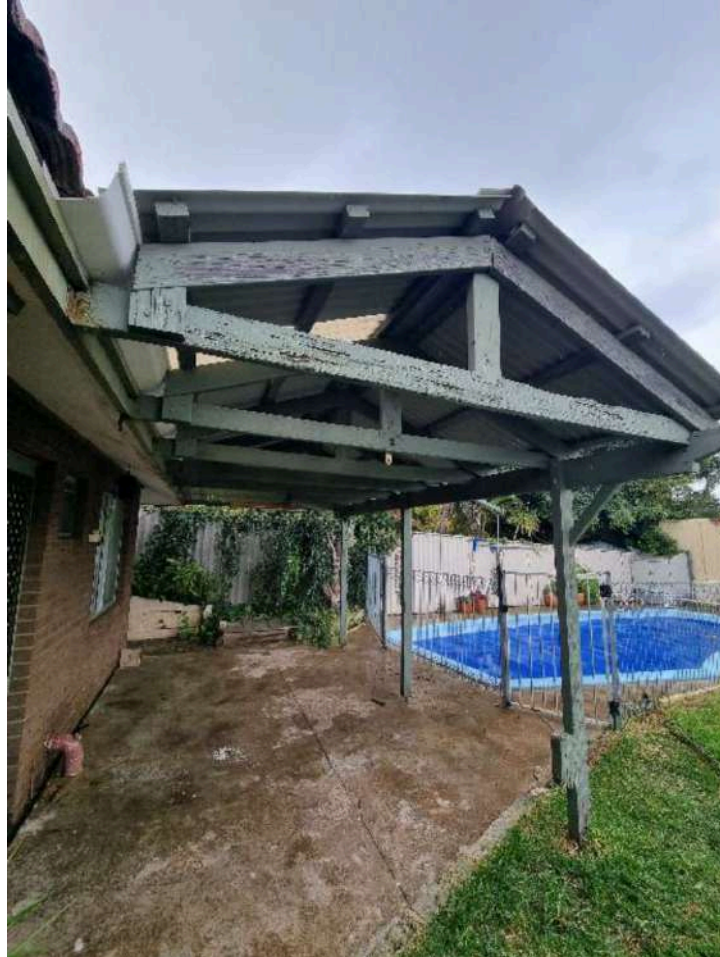
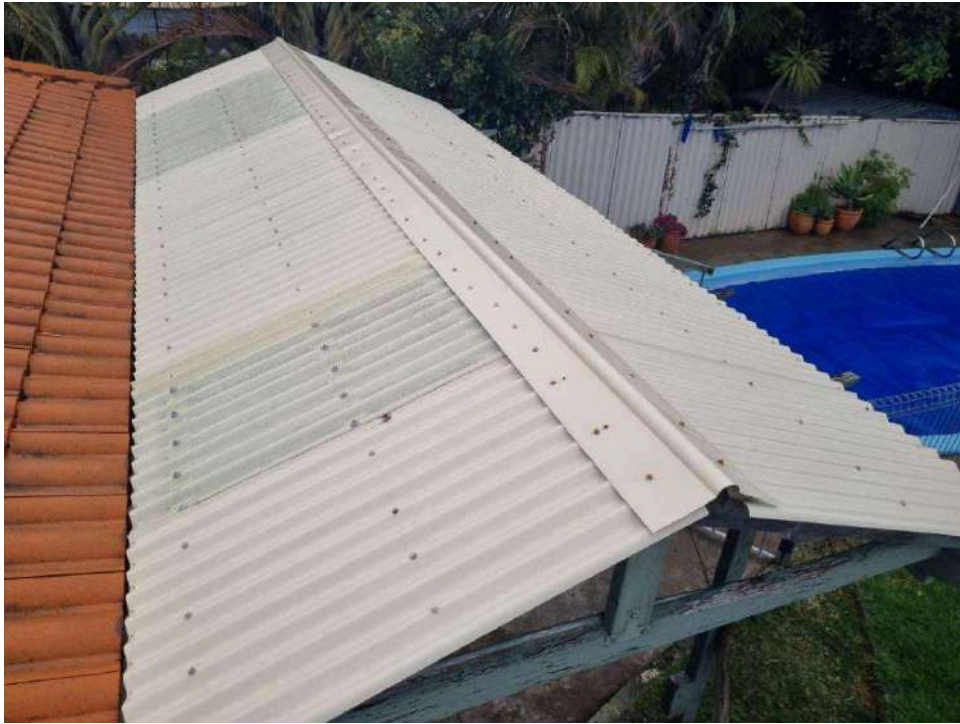
Post Observations

Structural minor: Rust observed to pergola post metal stirrups. If left unattended the pergola will become unstable/unsafe. Recommendation: Engage a carpenter to replace.

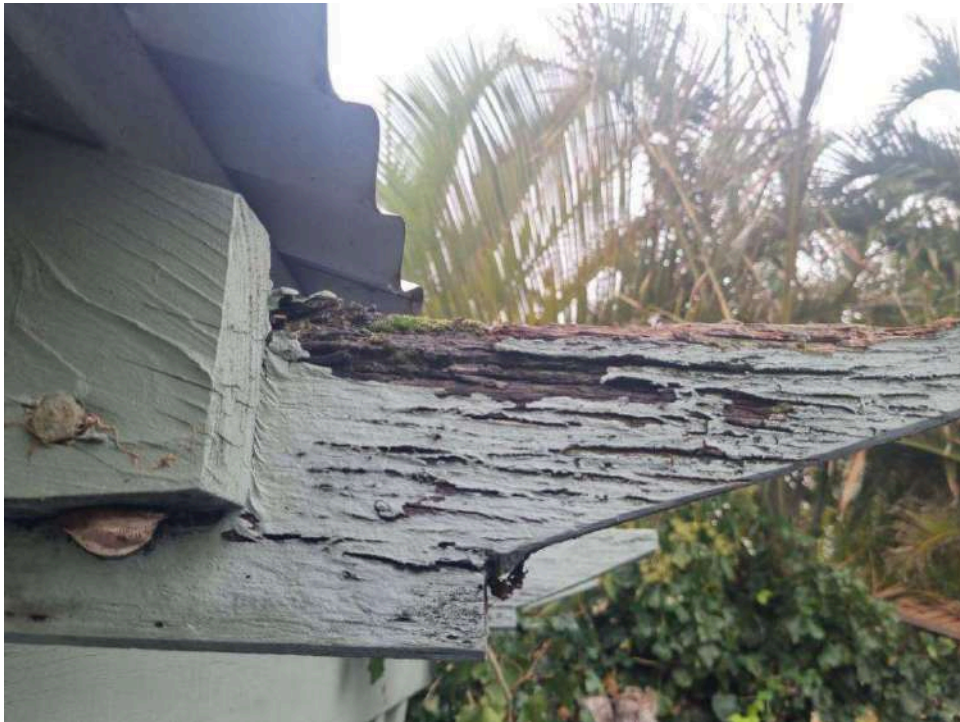
Frame Observations

Structural Minor: Timber fungal decay observed in sections of bearers or joists. Recommendation: Engage a carpenter for repairs.

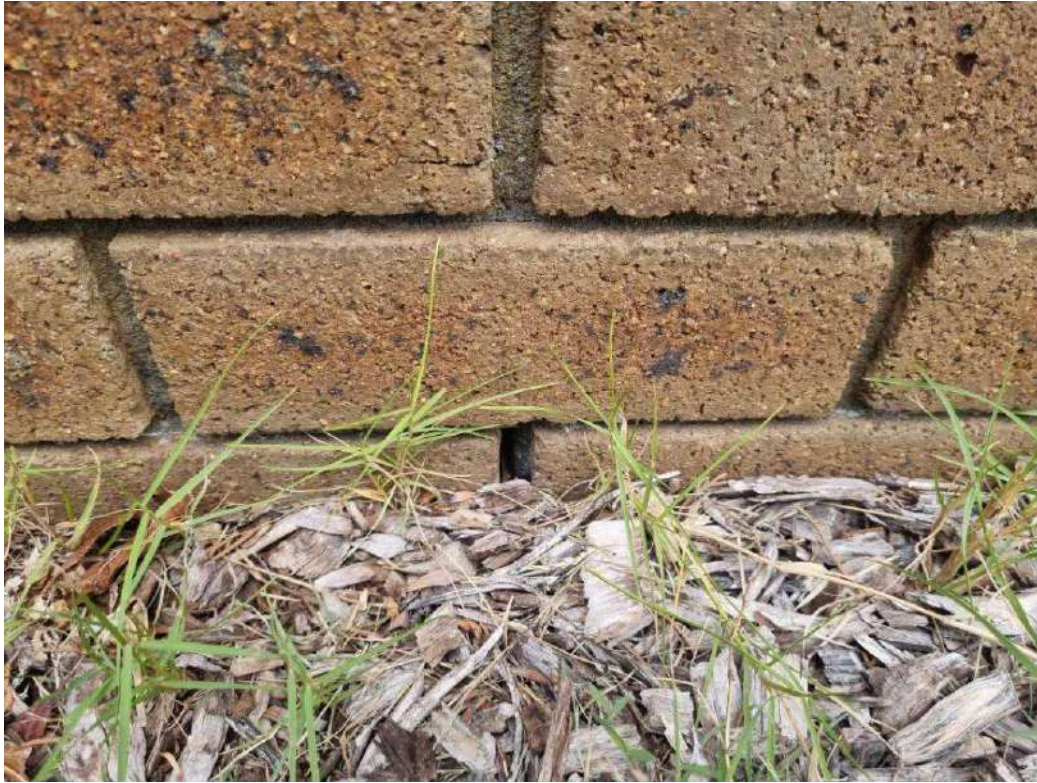
Weep Holes and Ventilation Observations

Maintenance: Some weep holes are partially blocked by soil. Recommendation: Engage a landscaper to lower finished ground levels to fully expose all weep holes on the lower brick courses around the dwelling.

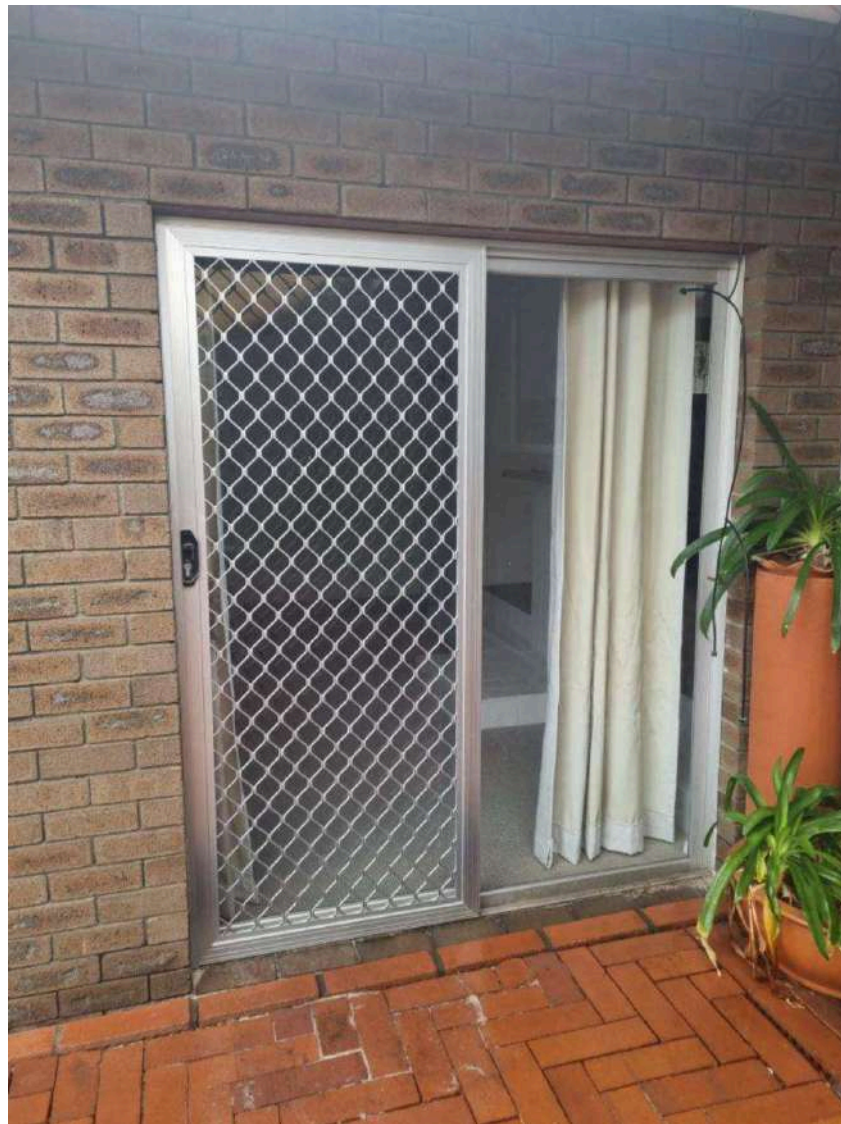
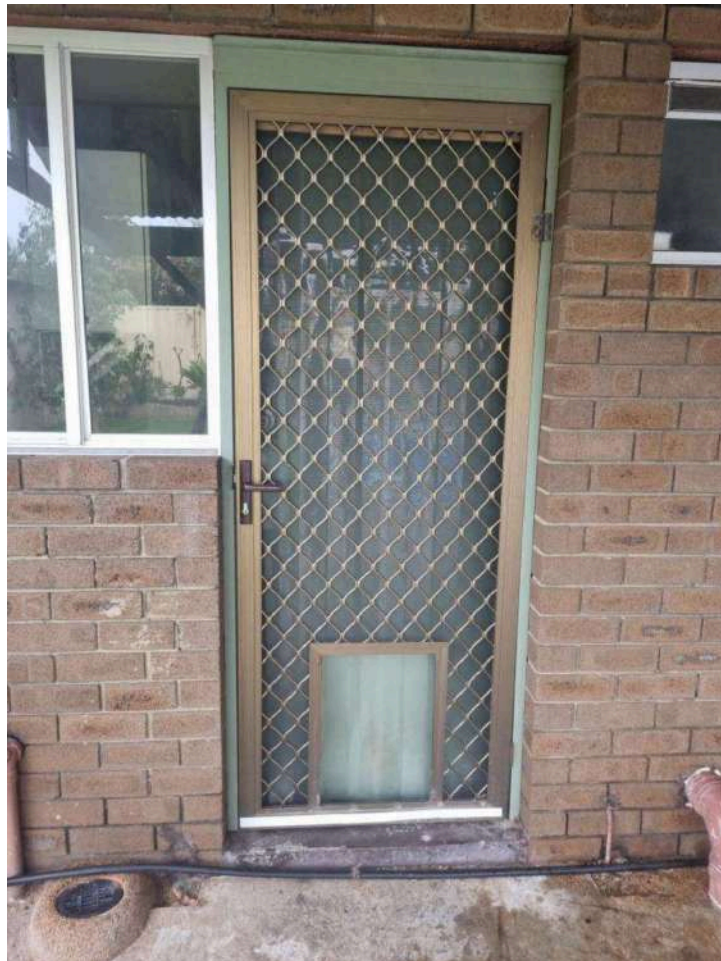
Door/s Observations

Maintenance: Lintel rust observed above front entry door. Rust in lintels can cause cracking in the above brickwork. Recommendation: Engage a painter to polish out the rust and re-coat.

Maintenance: General age/damage has occurred to door frame, face or components. Recommendation: Engage a carpenter and/or painter for repairs.

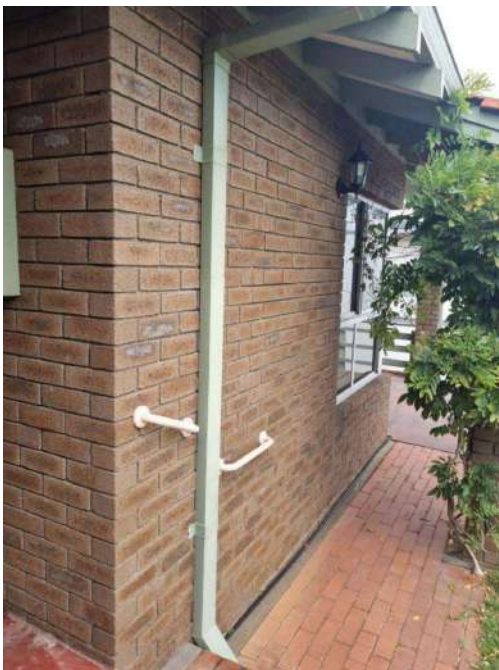
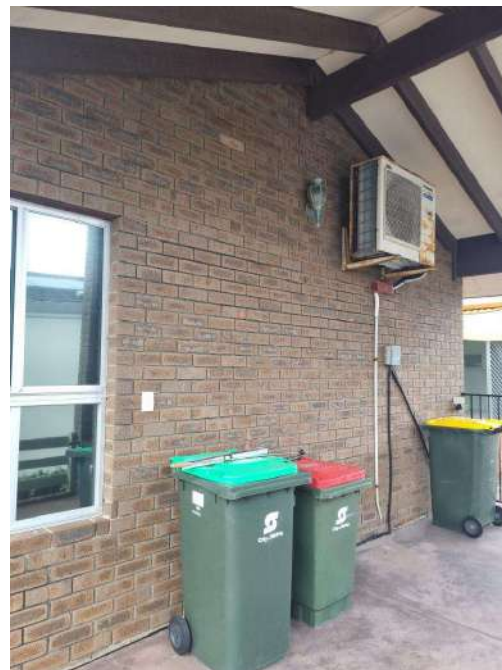
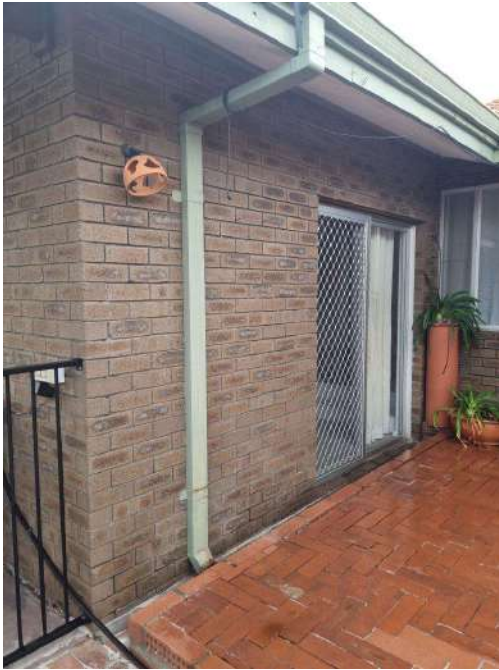
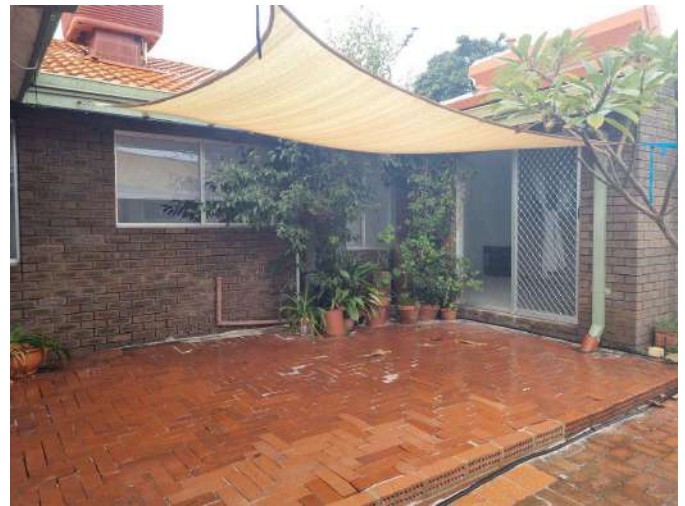
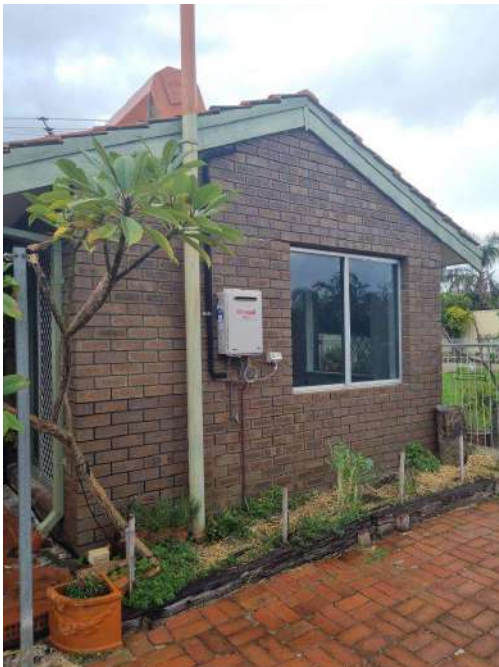
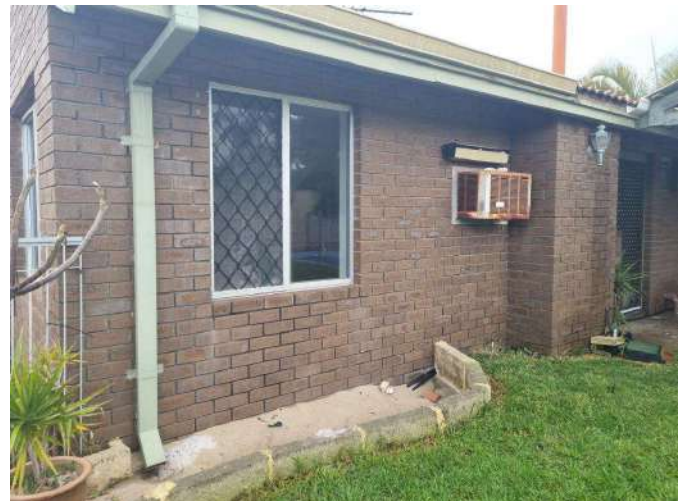
External Wall Observations

Structural Major: Cracks observed in damage Category 3 to 4. Possible causes may be

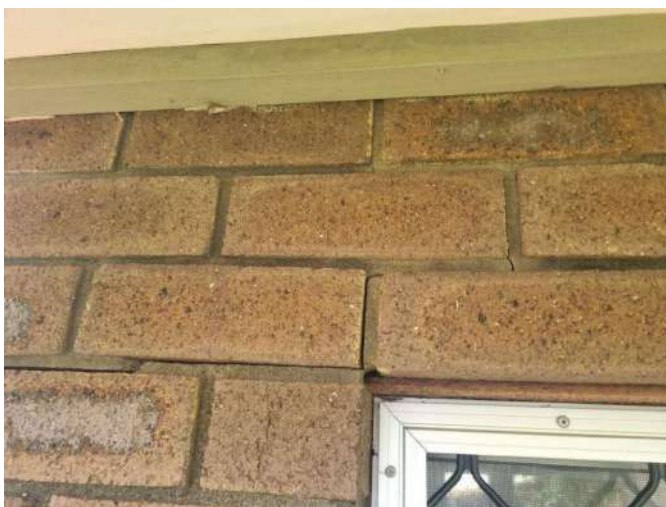
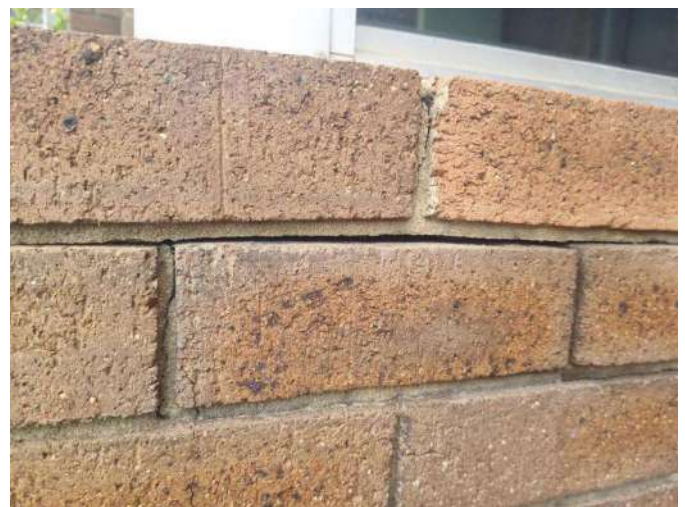
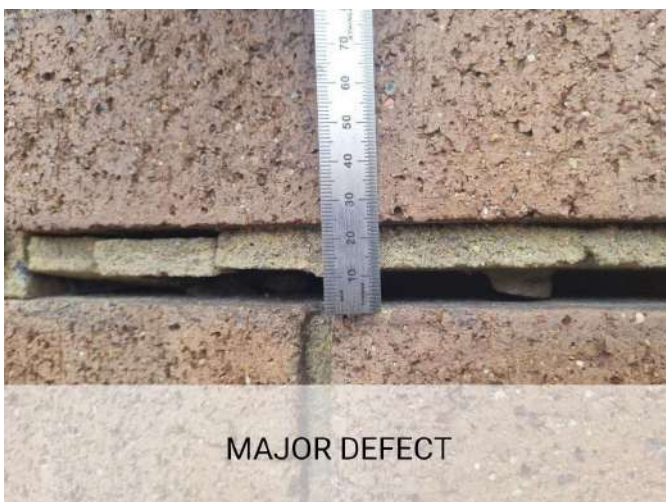
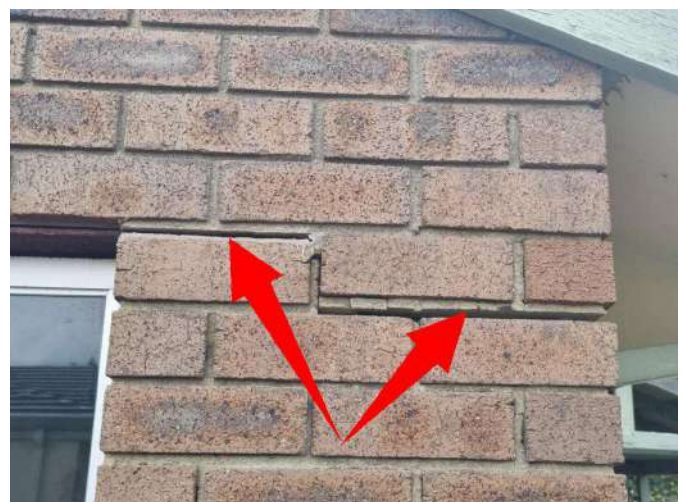
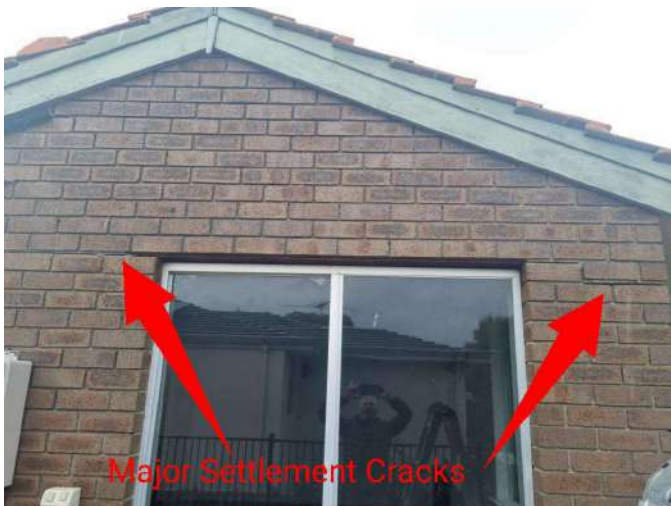
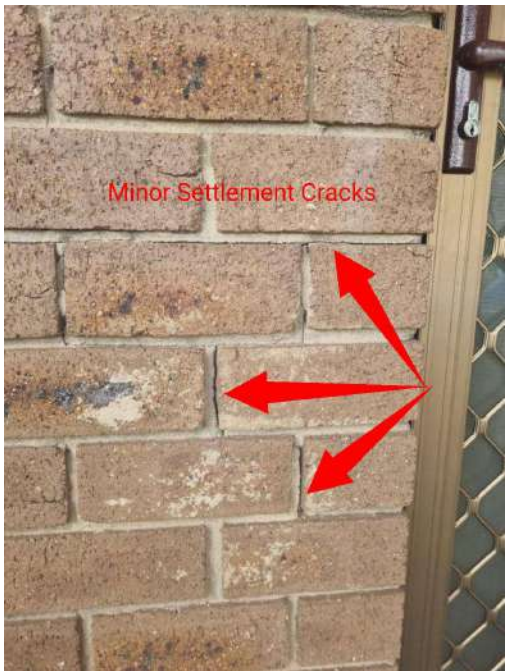
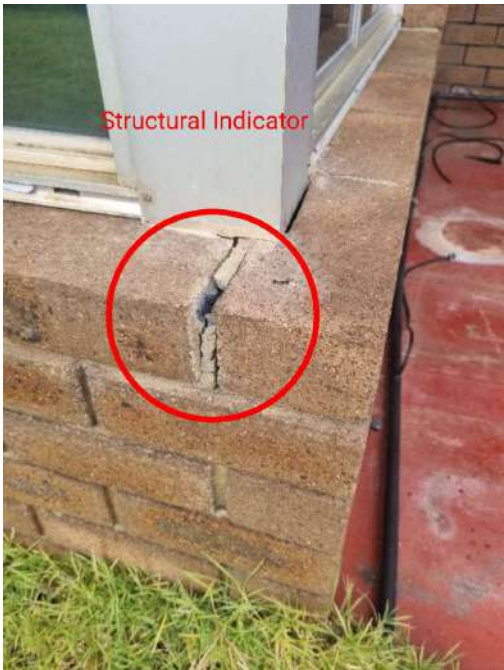
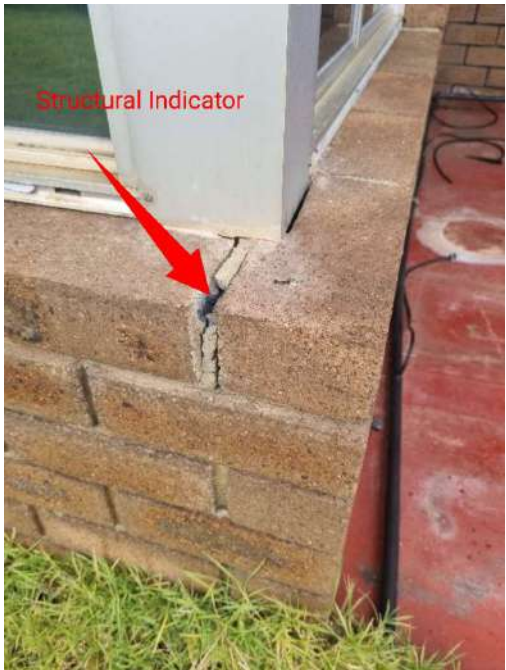
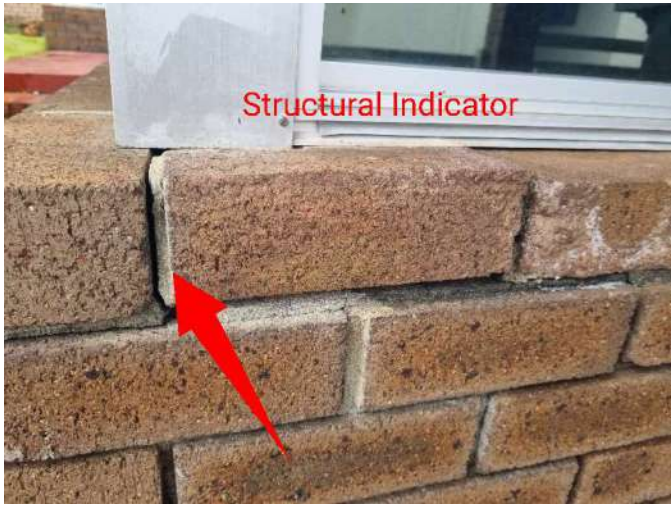
foundation movement, support structure deflection, thermal movement, moisture uptake or loss or failure under external loads. Recommendation: Engage a registered builder to complete repair works. A structural engineer should be consulted for further evaluation to determine scope of repair.

Structural Minor: There appears to have been some settlement in the building which has caused some cracking to the walls. These cracks are categorized as 0 to 2. This can also cause some doors to bind or be out of square. In the inspectors opinion these cracks are due to settlement, usually due to ground movement and subsequent movement to building materials can be expected. All cracks should be monitored and if cracks increase in size, further investigation should be carried out by a structural engineer. Engage a bricklayer to repair.

Structural Indication: Sections of the top course masonry brick wall/s have become loose around areas of the window frames with mortar cracking observed. Cracks and lifting of bricks have developed. This is an indication that frame movement may have occurred but is visually inaccessible due to the window frame components being situated in the cavity wall. Recommendation: Monitoring advised and if further opening occurs reassessment should be completed.

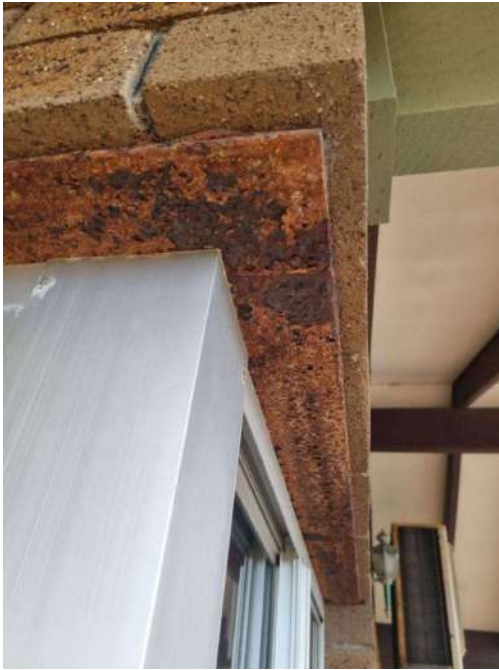
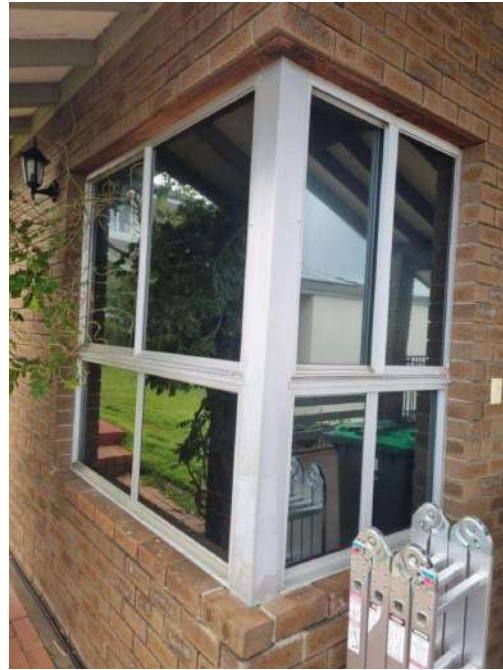
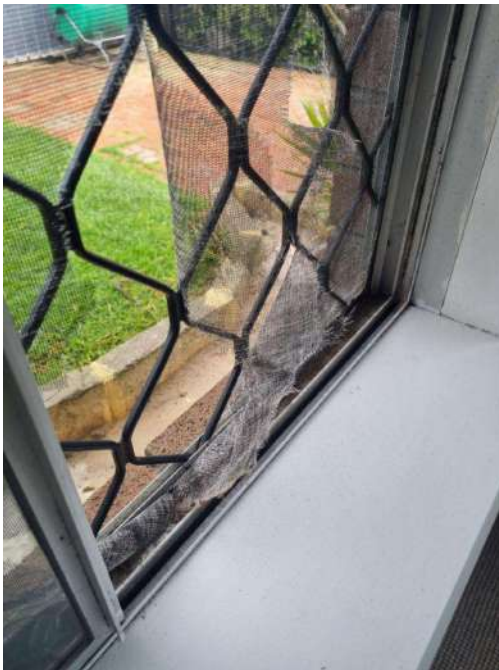
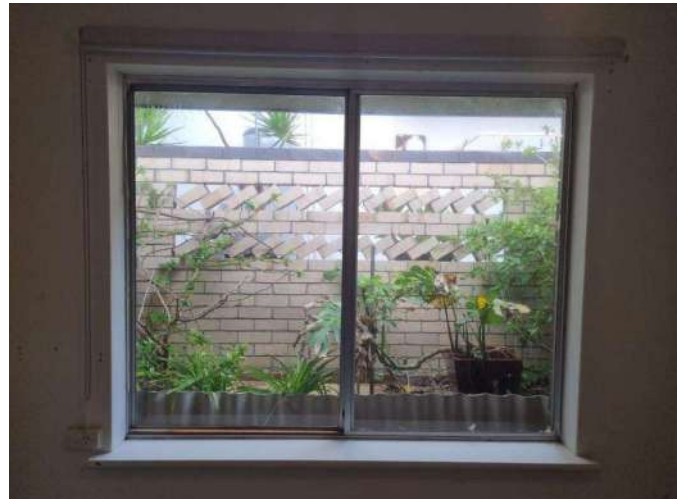
Maintenance: Lintel rust observed above door/s. Rust in lintels can cause cracking in the above brickwork. Recommendation: Engage a painter to polish out the rust and re-coat.

Maintenance: General age/damage has occurred to window components. Recommendation: Monitor condition and engage a glazer for restoration work and repairs as required.

Maintenance: Damaged fly screen/s observed. Recommendation: Engage a handyman to repair.

Maintenance: Missing fly screen/s observed. Recommendation. Engage a handyman to repair.

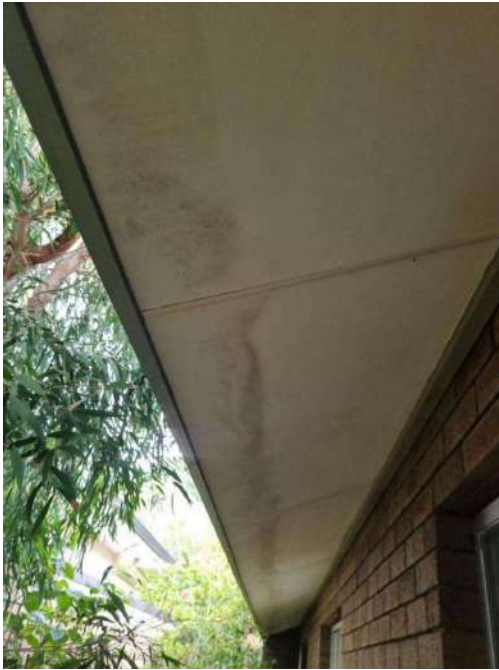
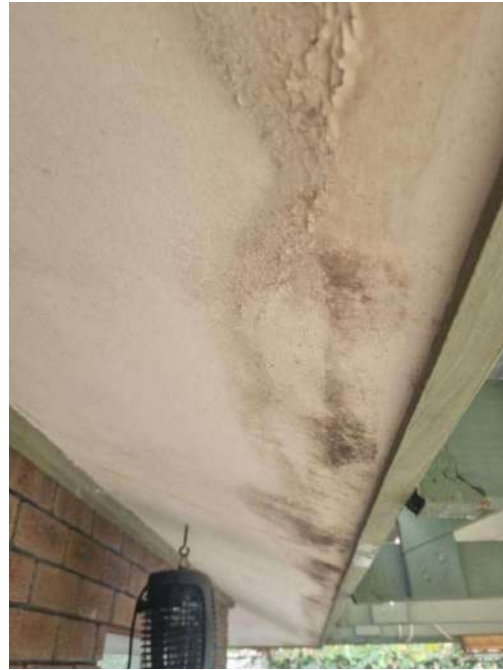
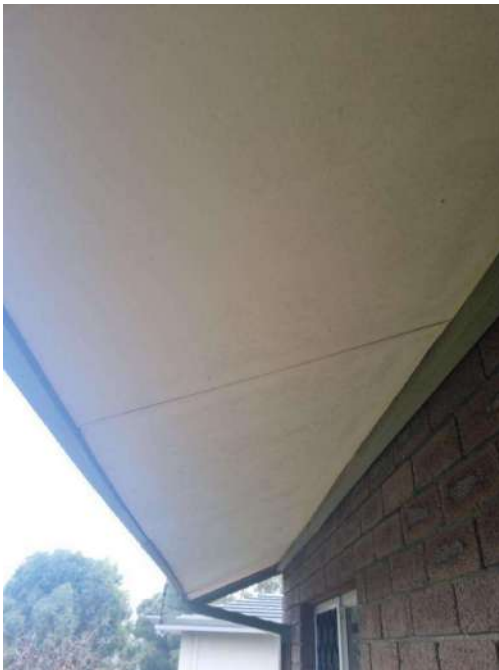
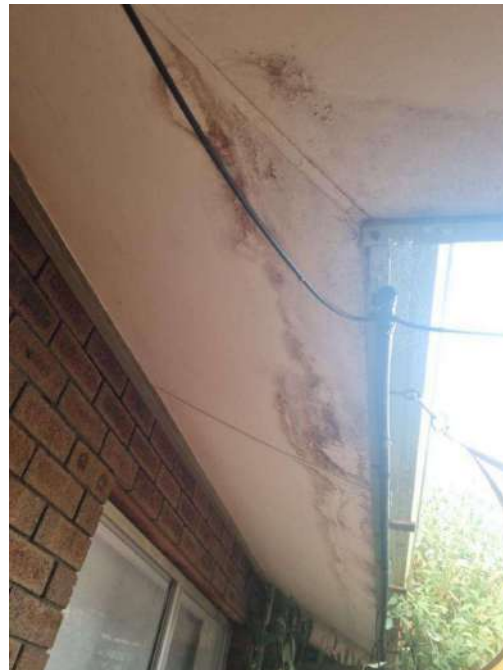
Maintenance: Eave lining stains observed. Normally this occurs due to overflow in blocked gutters. Recommendation: Ensure gutters are clear of debris, engage a painter to re-paint eave sections.

Maintenance: Paint flake/deterioration is evident. Normally due to overflowing/blocked or leakage guttering. Recommendation: Engage a painter for repairs.

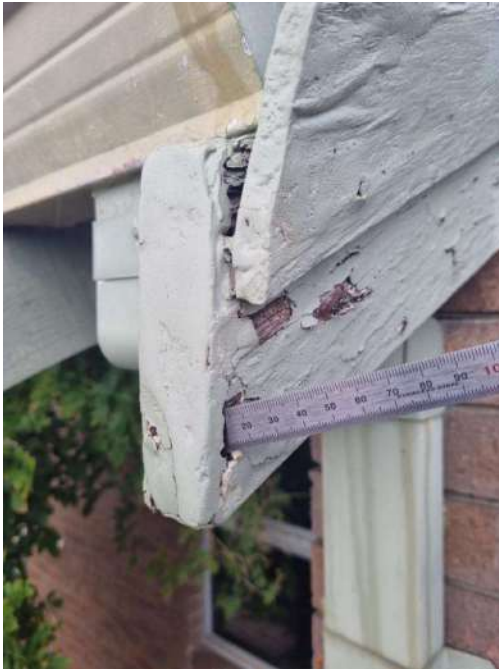
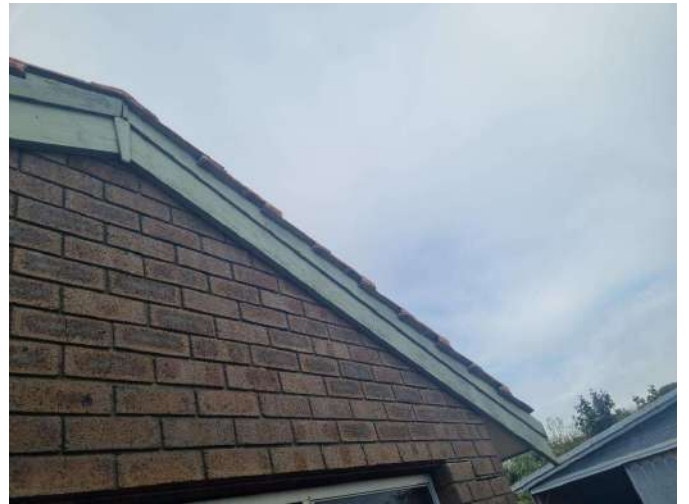
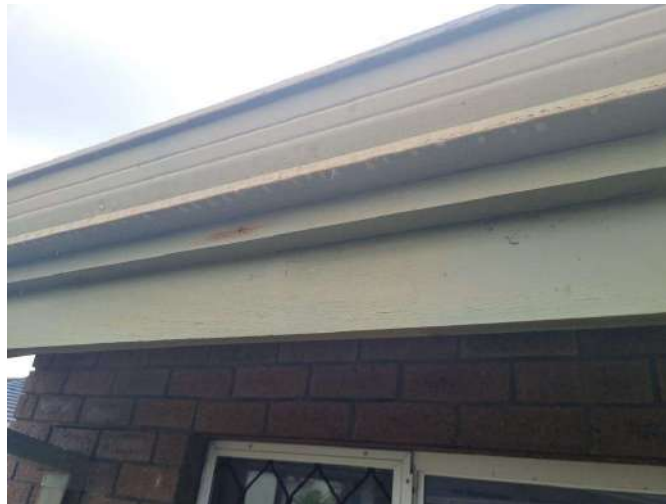
Maintenance: Paint deterioration observed in areas. Recommendation: Engage a painter for repairs.

Maintenance: Timber fungal decay (rot) observed. Recommendation: Engage a carpenter for repairs.

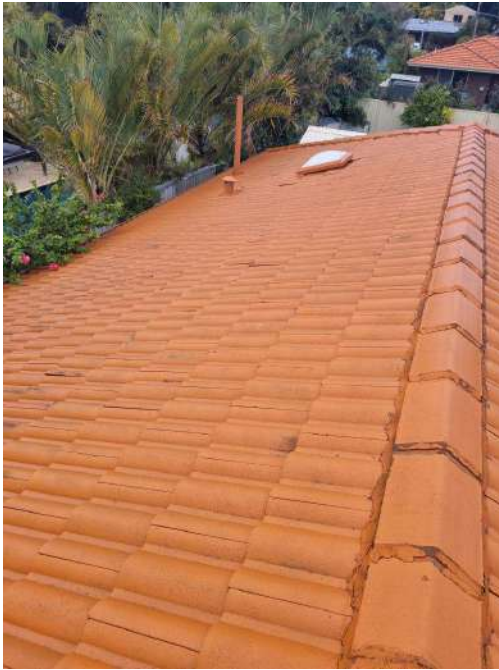
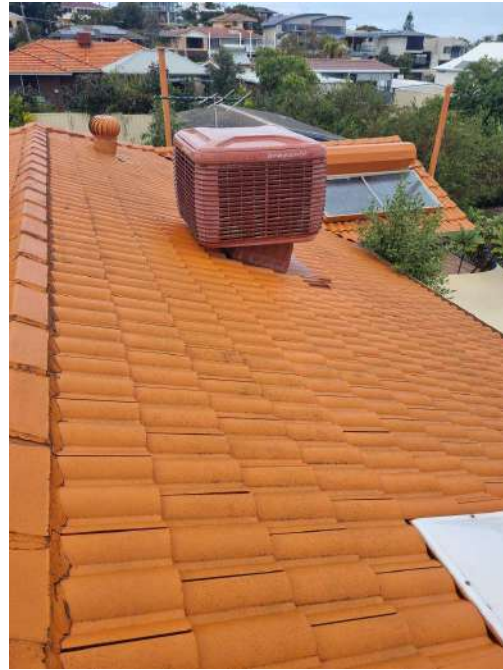
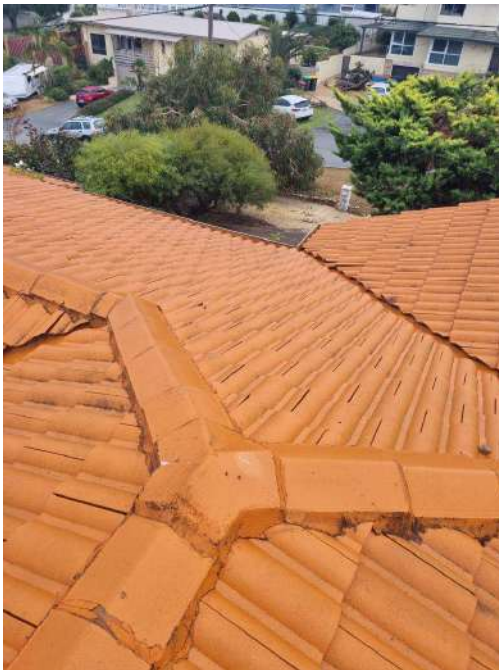
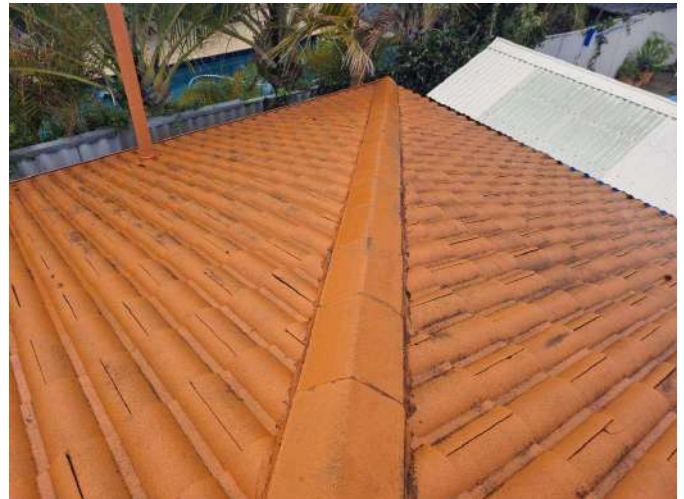
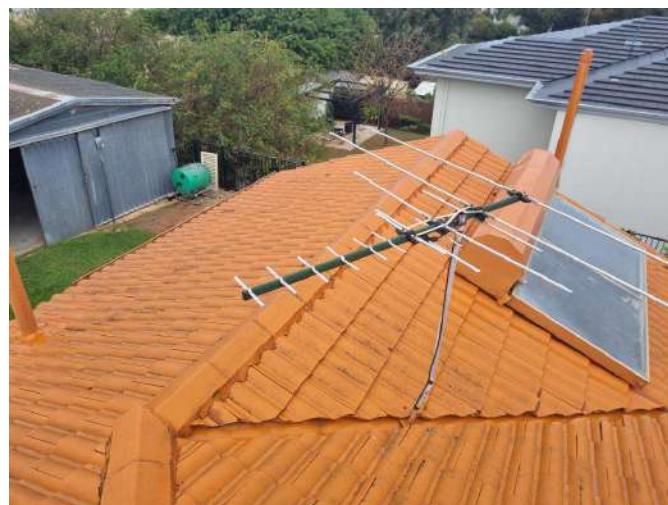
Structural Indication: Roof line unevenness observed. Refer to Roof Void section for frame

Maintenance: Cracked tile ends observed. Recommendation: Engage a qualified roofing contractor to repair.

Maintenance: Mortar cracks observed. Recommendation: Engage a roofing contractor to repoint affected sections as they may contribute to water ingress.

Maintenance: Moss has built up on the tiles over time. Recommendation: It is preferable to have removed / cleaned to prevent deterioration. Engage a roofing contractor for removal.

Maintenance: Tile lift/unevenness observed. Recommendation: Engage a roofing contractor to re-lay affected sections.

Maintenance: The roof mounted solar hot water system appears to be decommissioned. Recommendation: Confirm with seller. If decommissioned engage a plumber to remove the unit.
