Inspection Report

SURE Pty Ltd

Pest And Building Inspection

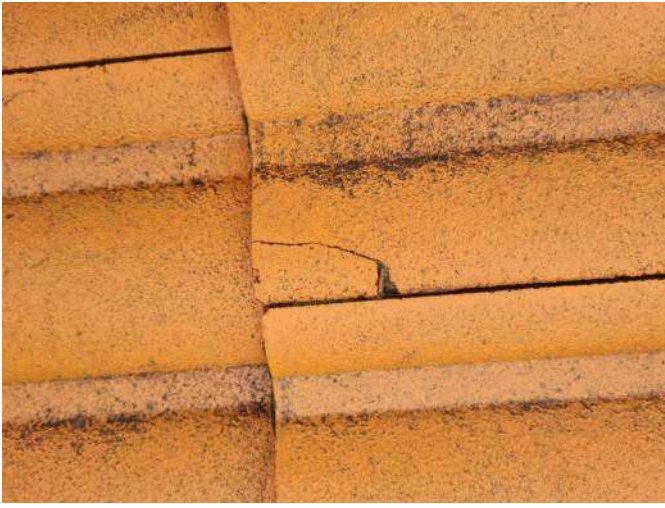
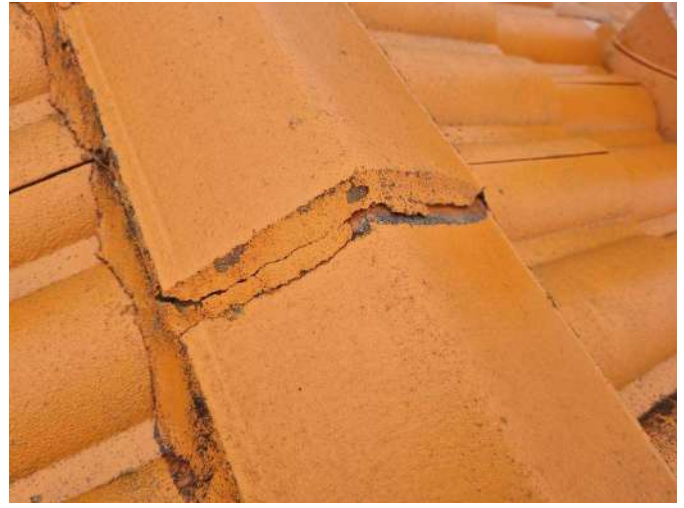
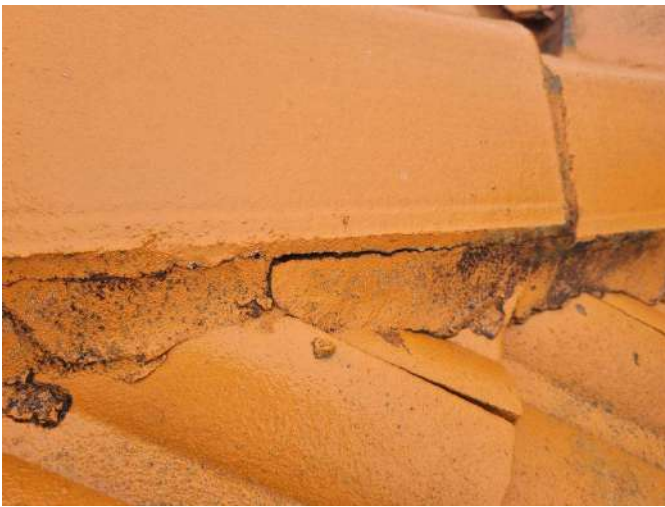
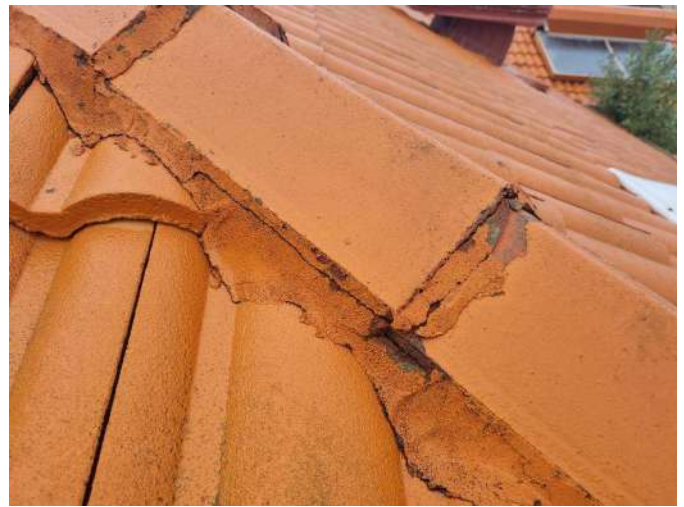
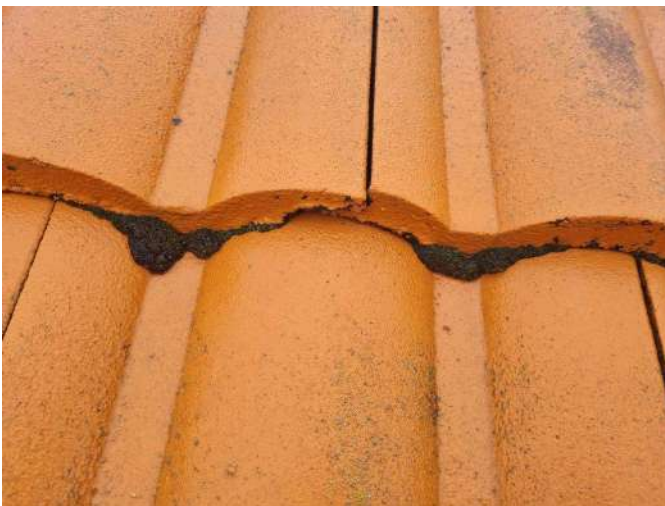
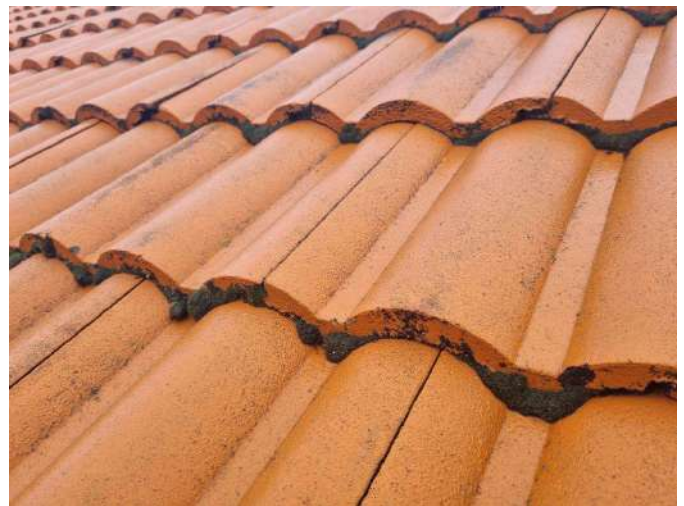
Maintenance: Cracked tile ends observed. Recommendation: Engage a qualified roofing contractor to repair.

Maintenance: Mortar cracks observed. Recommendation: Engage a roofing contractor to repoint affected sections as they may contribute to water ingress.

Maintenance: Moss has built up on the tiles over time. Recommendation: It is preferable to have removed / cleaned to prevent deterioration. Engage a roofing contractor for removal.

Maintenance: Tile lift/unevenness observed. Recommendation: Engage a roofing contractor to re-lay affected sections.

Maintenance: The roof mounted solar hot water system appears to be decommissioned. Recommendation: Confirm with seller. If decommissioned engage a plumber to remove the unit.

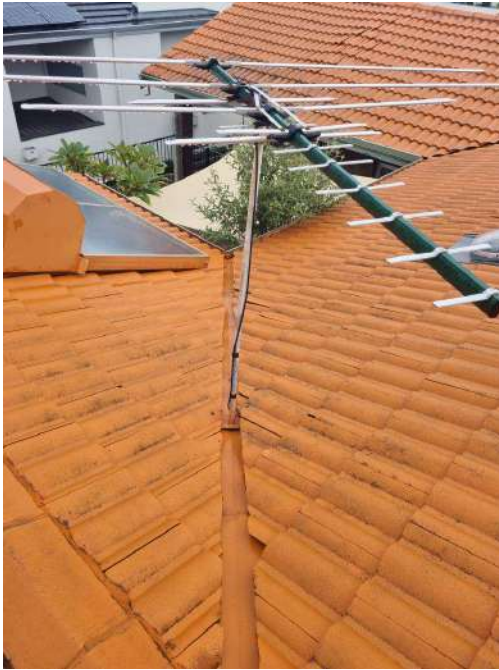
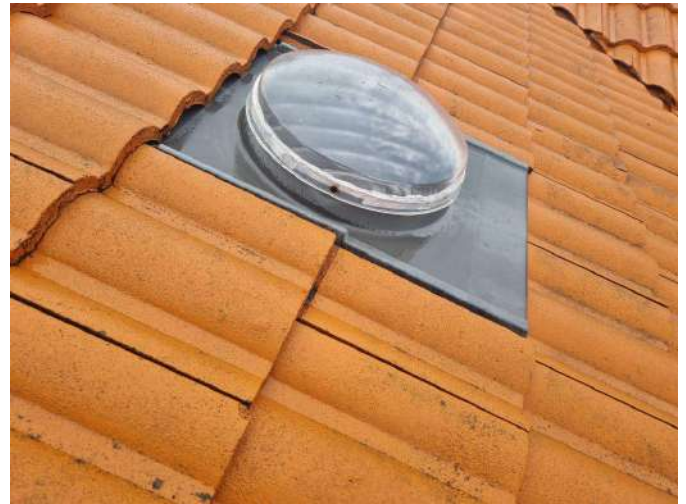
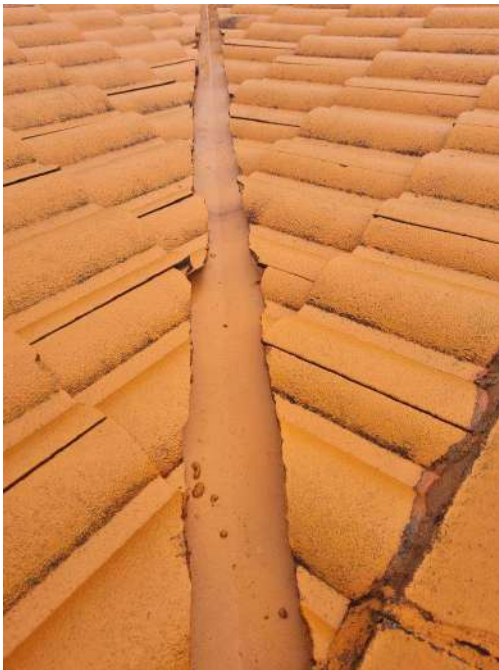
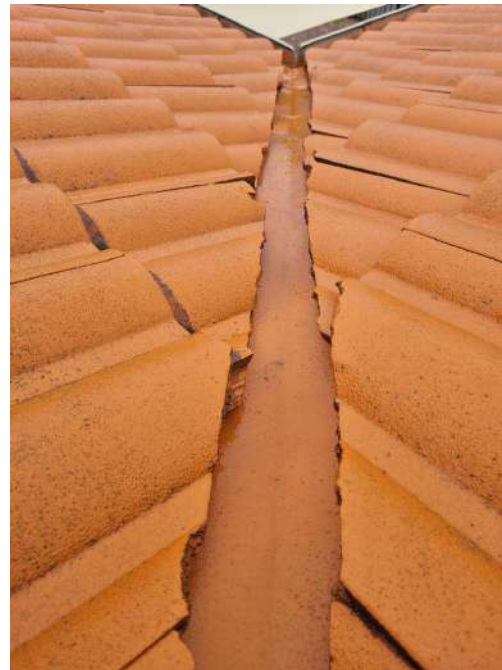
Maintenance: The antenna has been mounted in the valley. This creates disruption to water flow and could result in a leak. Recommendation: Engage an electrician to move.

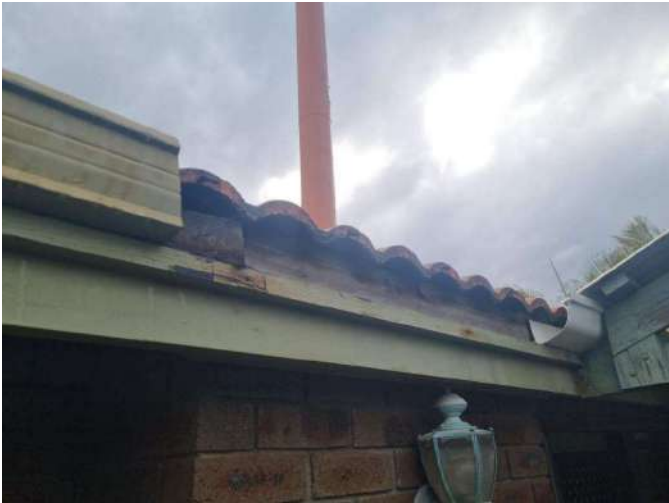
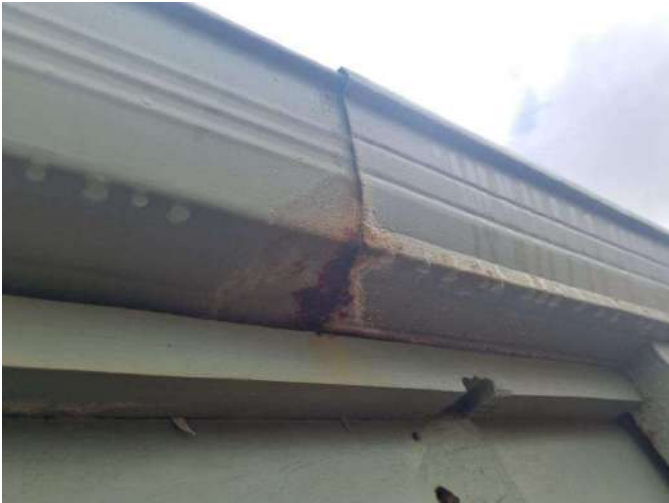
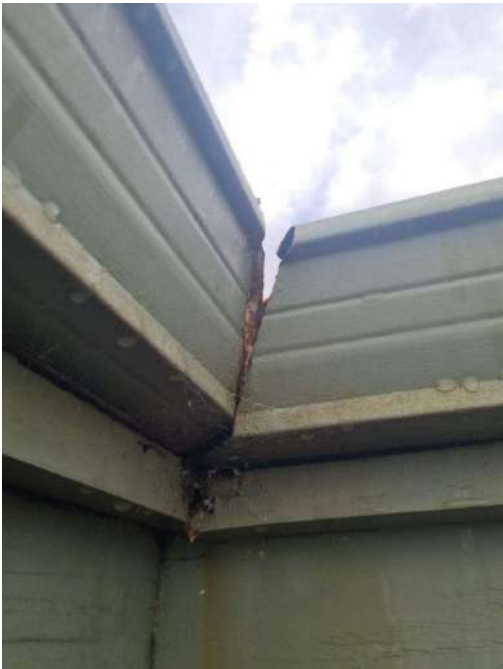
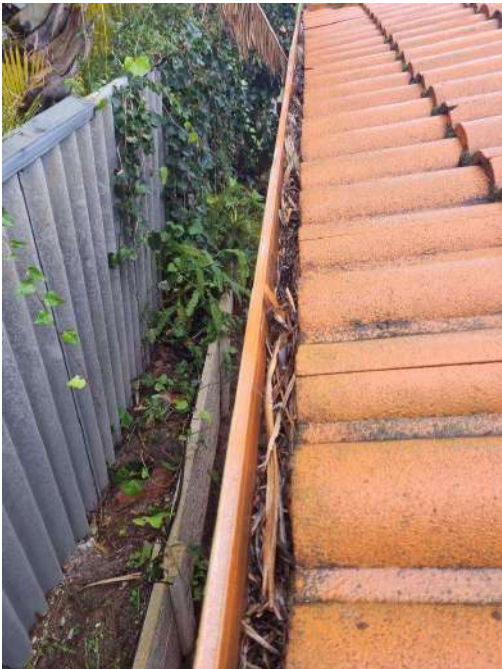
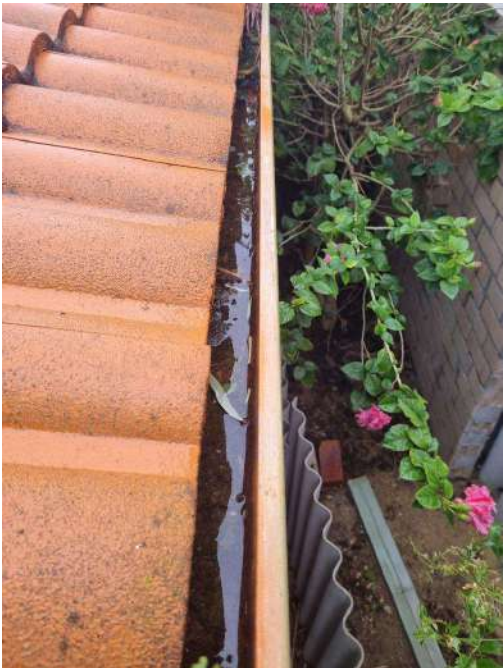
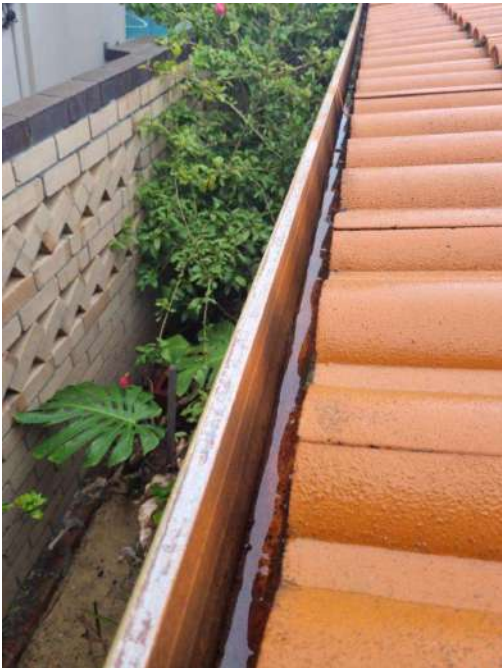
Maintenance: Debris observed in guttering area - this requires cleaning out to prevent blocking of downpipes and leaking into eaves and fascia. Recommendation: Engage a handyman to clean out. Regularly debris removal should be completed to prevent ponding. Ponding water will contribute to rust.

Maintenance: Standing water in gutter observed. This is likely due to debris build up in the affected areas, however it can also relate to poor fall, inadequate down pipes or a blocked down pipe. Recommendation: Engage a handyman to clean out debris and re-assess for any standing water. If condition continues to exist, engage a roofing contractor for repairs.

Maintenance: Surface rust observed to sections of the gutter. Recommendation: Engage a painter to clean and re-seal the guttering.

Maintenance: There is evidence of leaking gutters. Recommendation: Engage a roofing contractor for repair.

Maintenance: The gutter join/s have separated and will leak during rainfall. Recommendation: Engage a roofing contractor for repair.

Maintenance: Section/s of guttering missing.
Recommendations - Engage a licensed roof plumber for advice and repair.

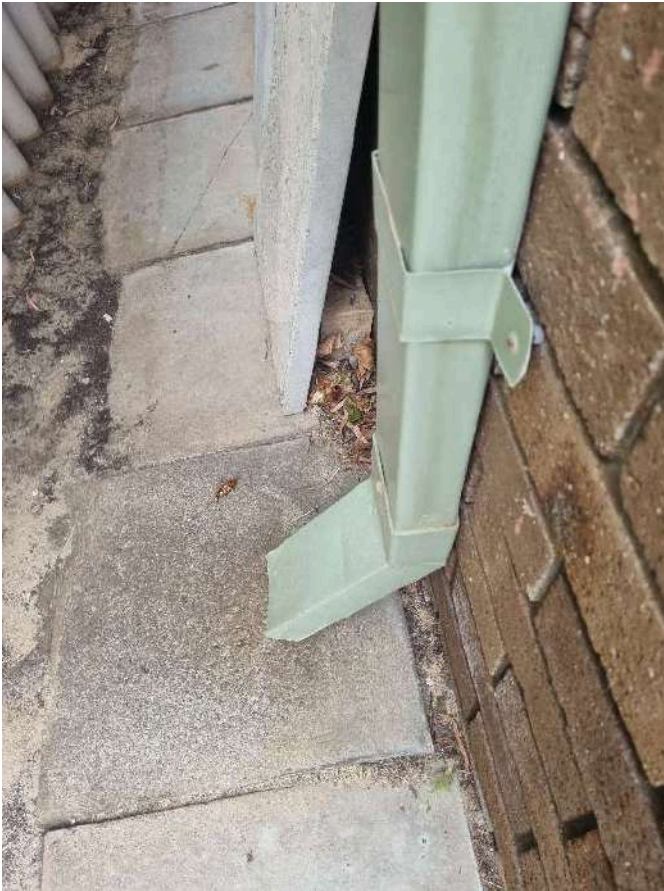
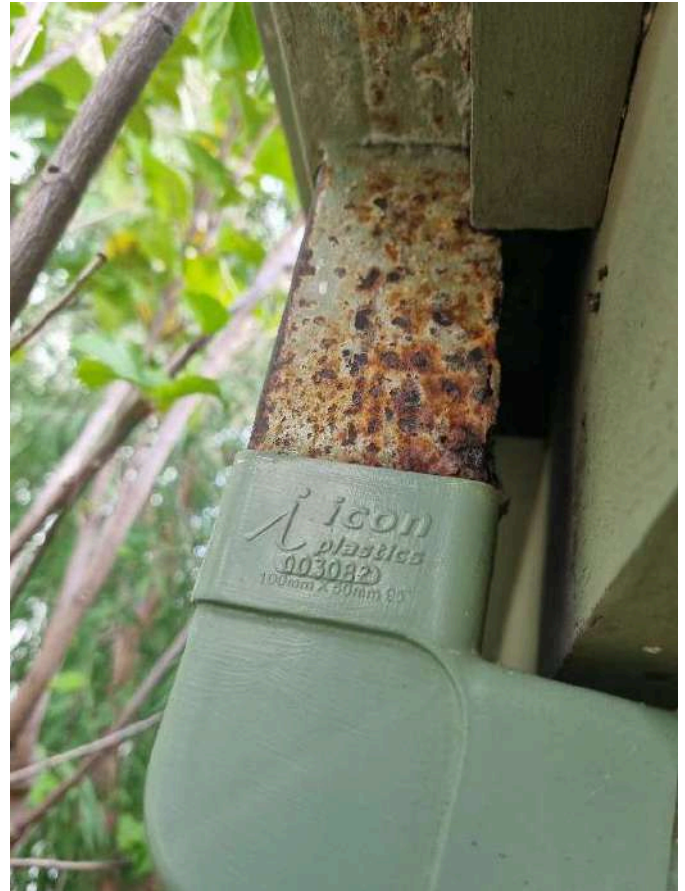
Maintenance: Downpipe/s not connected to storm water discharge - Downpipes not connected to storm water have the potential to cause differential settlement to the footings, cause rising damp and is also conducive to termite infestation. Recommendation: Engage a landscaper to install storm water drainage.

Maintenance: Rust penetrations observed to down pipe/s. Recommendation: Engage a roofing contractor to repair or replace affected down pipes.

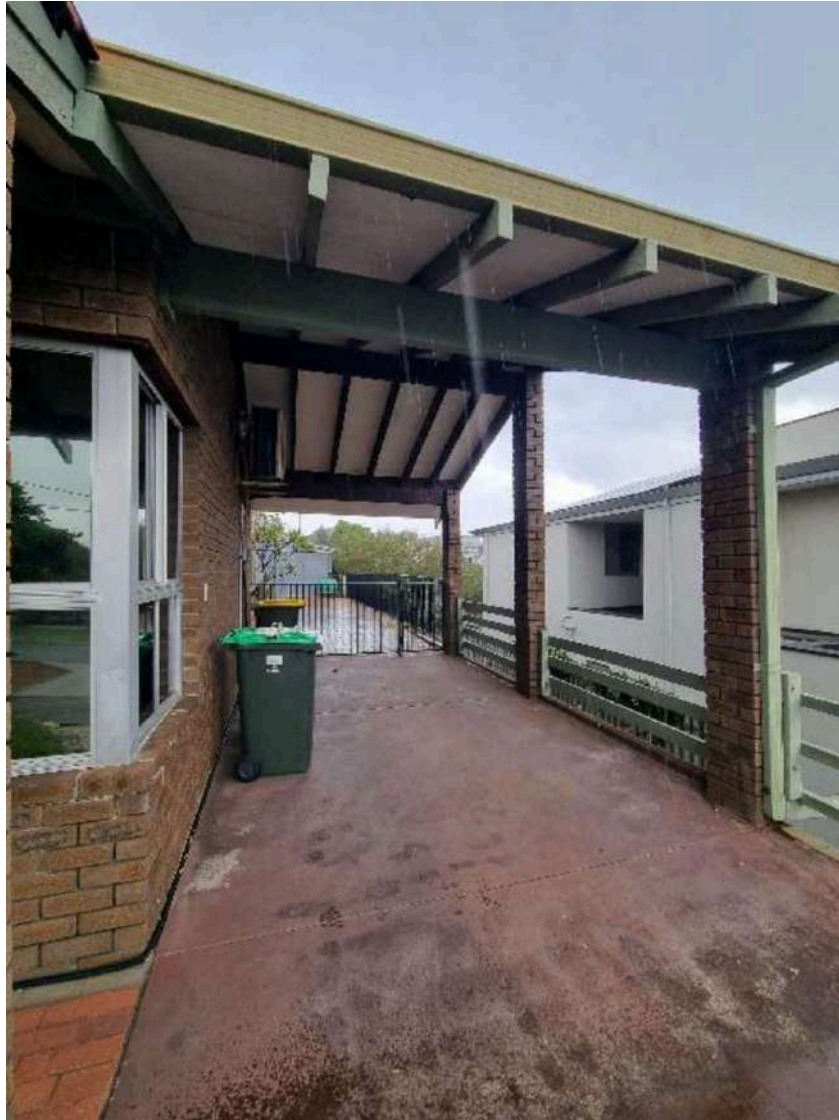
Structural Major: The footings of the brick post have settled with significant ground movement observed. The structural integrity of this supporting post/column has been compromised. In the inspectors opinion the stability of the load bearing post is of concern.

Recommendation: Engage a structural engineer for further assessment and advice regarding repairs.

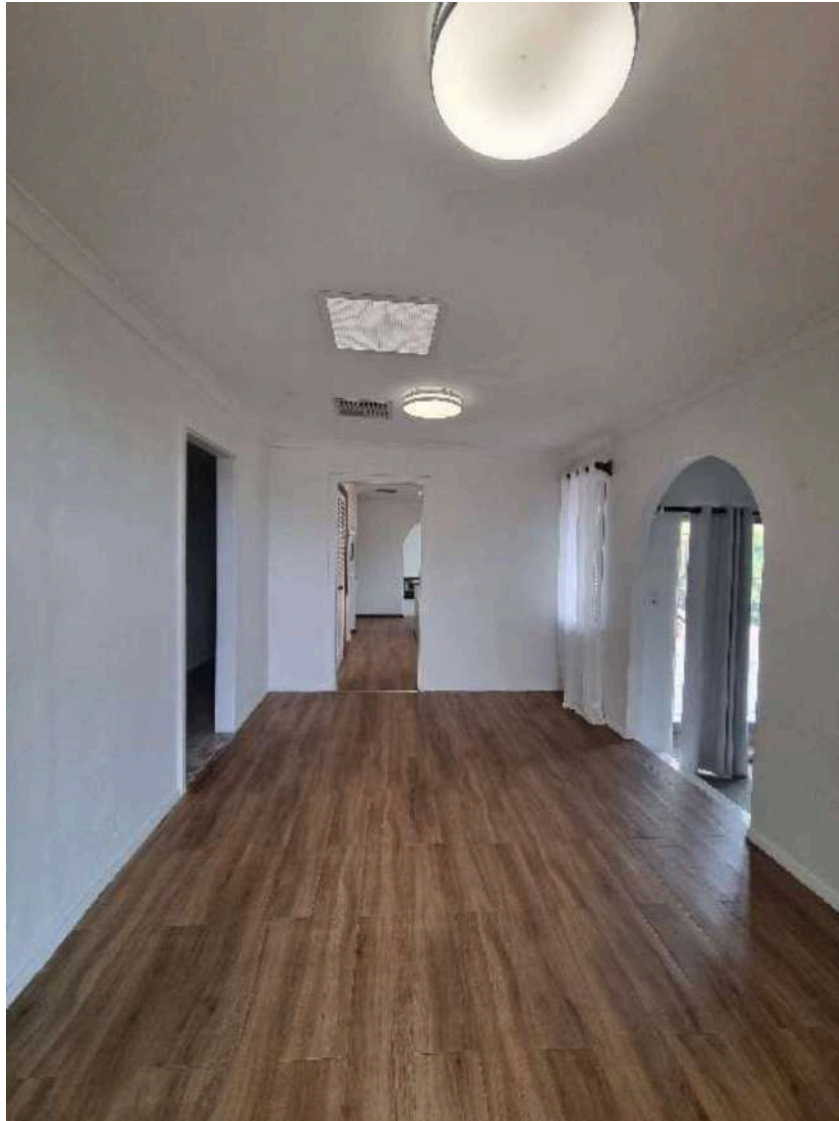
Maintenance: Ceiling deterioration & ageing evident. Recommendations: Maintenance works, general upkeep should be carried out.

Maintenance: Ceiling/cornice join crack/s observed. Recommendation: Engage a painter for repairs.

Maintenance: Ceiling stains with normal moisture readings obtained. The cause may have been repaired, however, you will need to monitor after a prolonged period of rainfall to confirm. Recommendation: Engage a painter for repairs. *Water damaged plaster has the potential for detachment or collapse, if required engage a plasterer for repairs.*

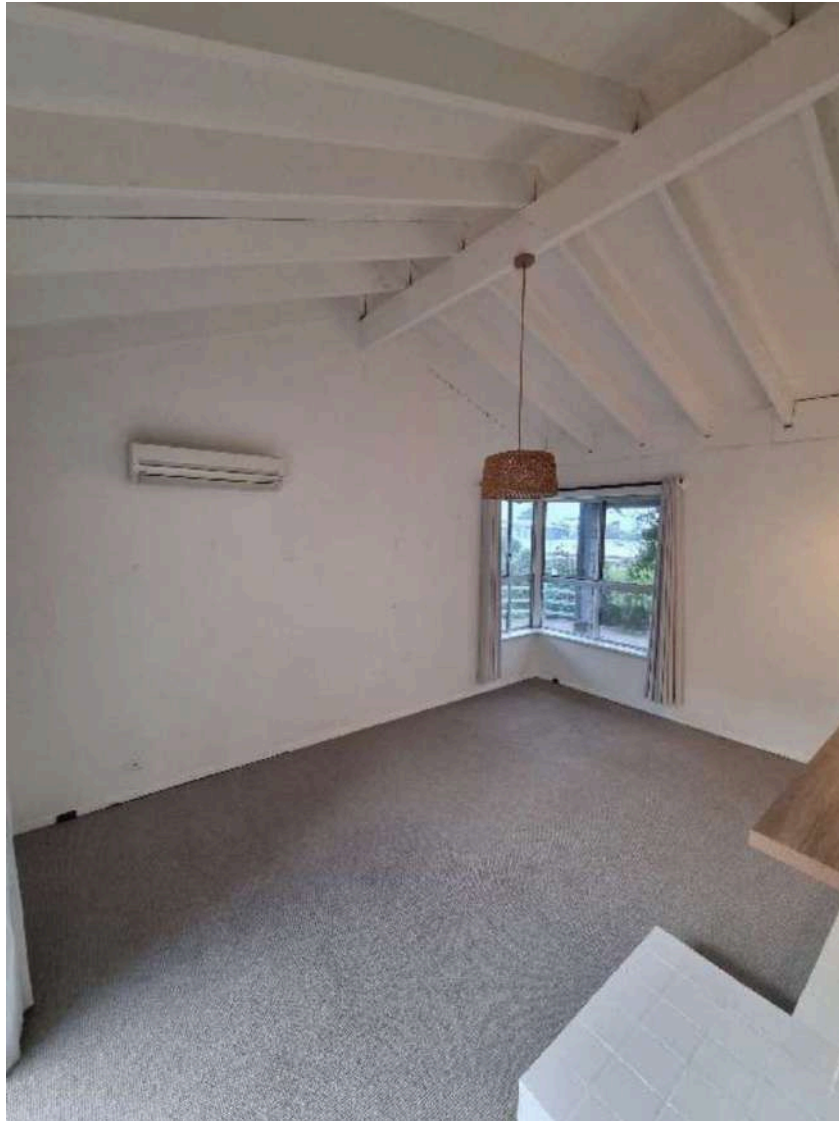
Maintenance: Ceiling/cornice joint crack/s observed. Recommendation: Engage a painter for repairs.

Maintenance: The light did not operate when tested. Recommendation: Replace bulb and retest. If failure continues to occur engage an electrician for repairs.

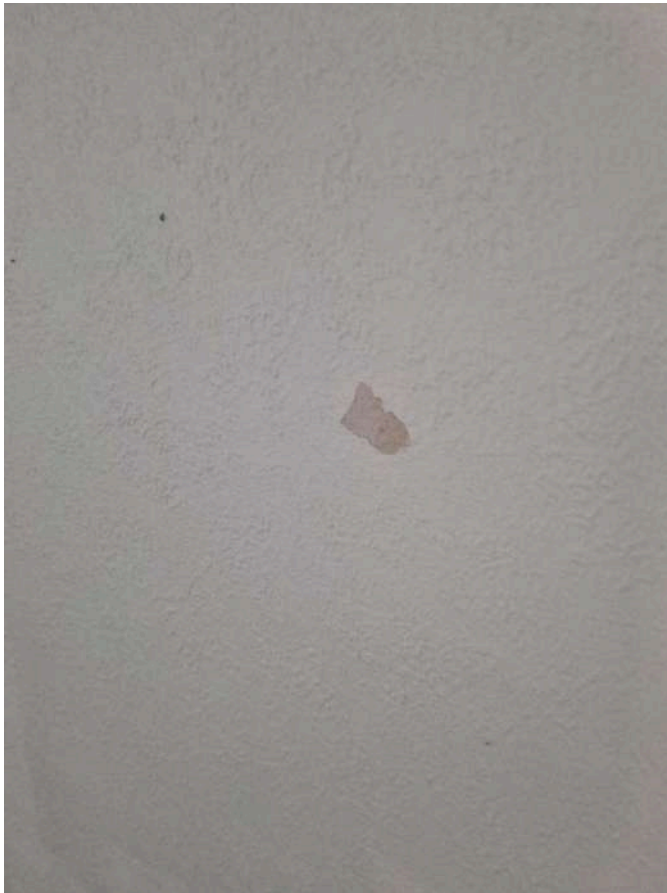
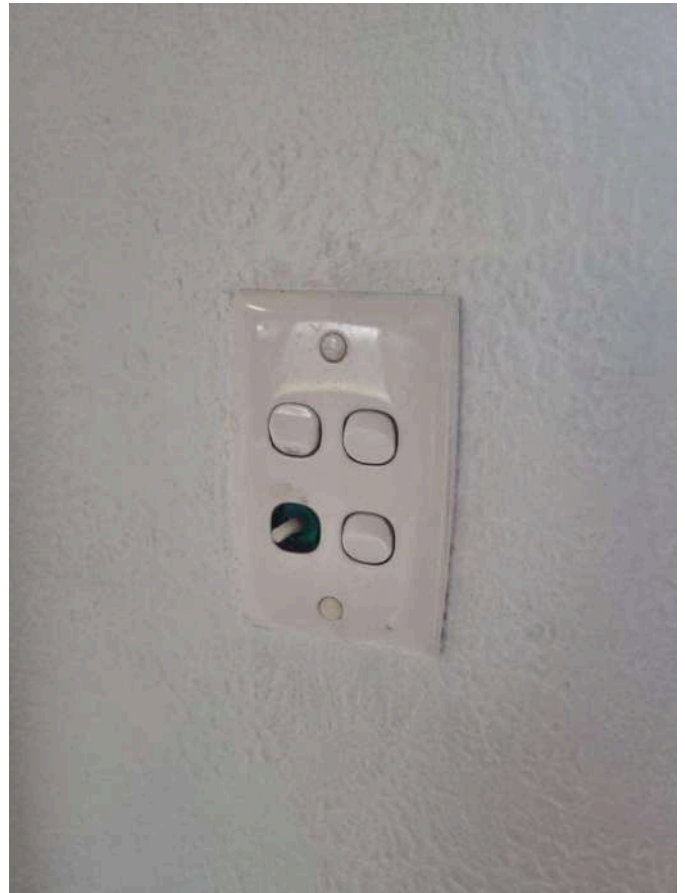
Maintenance: General scuffs and marks to walls. Recommendation: Engage a painter for repairs.

Maintenance: The light switch appears to be faulty (e.g. internally loose switch mechanism).
Recommendation: Engage an electrician to repair.

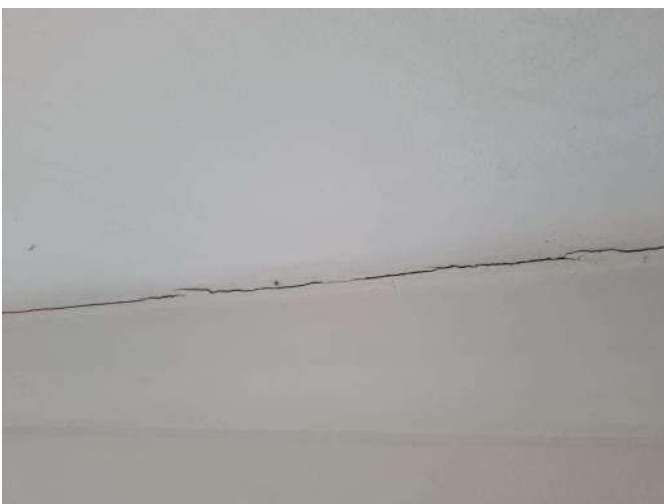
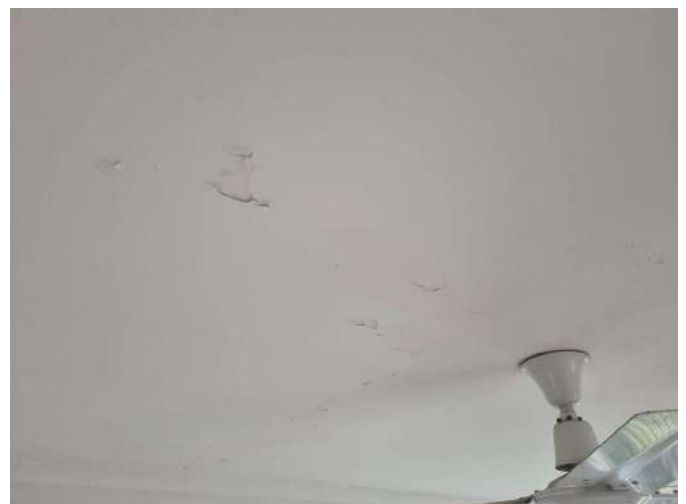
Maintenance: Ceiling/cornice joint crack/s observed. Recommendation: Engage a painter for repairs.

Maintenance: Paint deterioration observed. Recommendation: Engage a painter to repair.

Maintenance: Ceiling stains with normal moisture readings obtained. The cause may have been repaired, however, you will need to monitor after a prolonged period of rainfall to confirm. Recommendation: Engage a painter for repairs. *Water damaged plaster has the potential for detachment or collapse, if required engage a plasterer for repairs.*

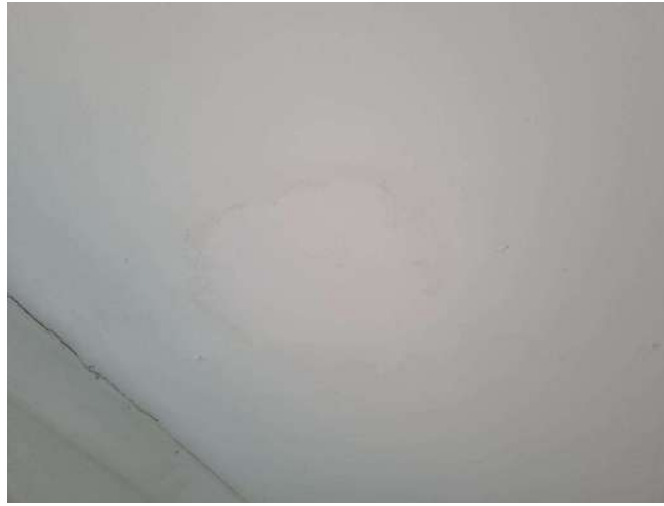
Structural Minor: There appears to have been some settlement in the building which has caused some cracking to the walls. These cracks are categorized as 0 to 2. This can also cause some doors to bind or be out of square. In the inspector's opinion, these cracks are due to settlement, usually due to ground movement and subsequent movement to building materials can be expected. All cracks should be monitored and if cracks increase in size, further investigation should be carried out by a structural engineer. Engage a painter to patch and paint.

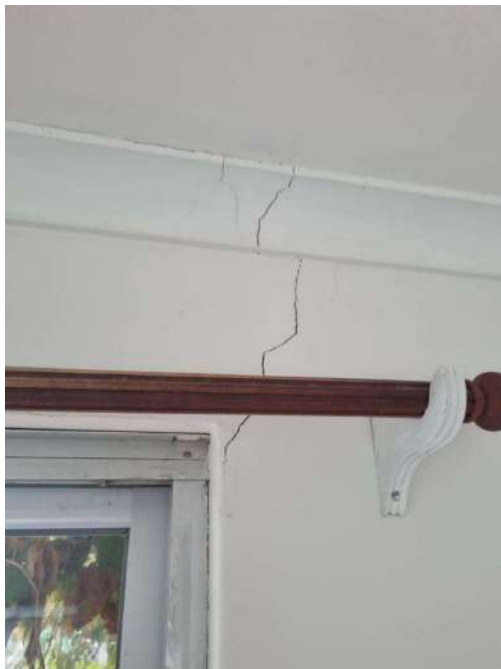
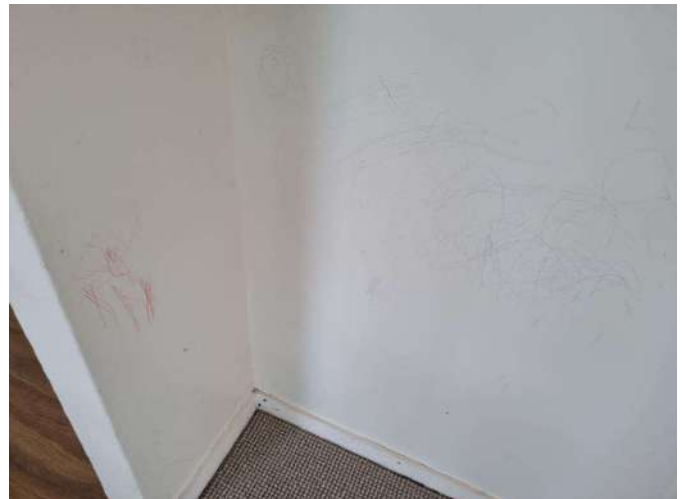
Maintenance: General scuffs and marks to walls. Recommendation: Engage a painter for repairs.

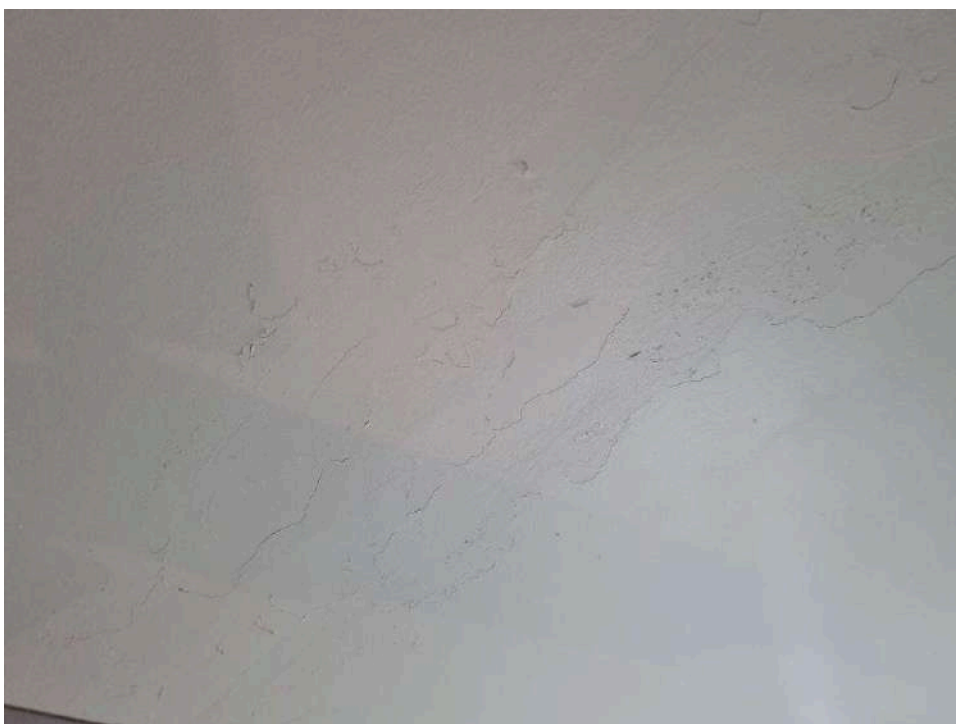
Maintenance: Paint deterioration observed. Recommendation: Engage a painter to repair.

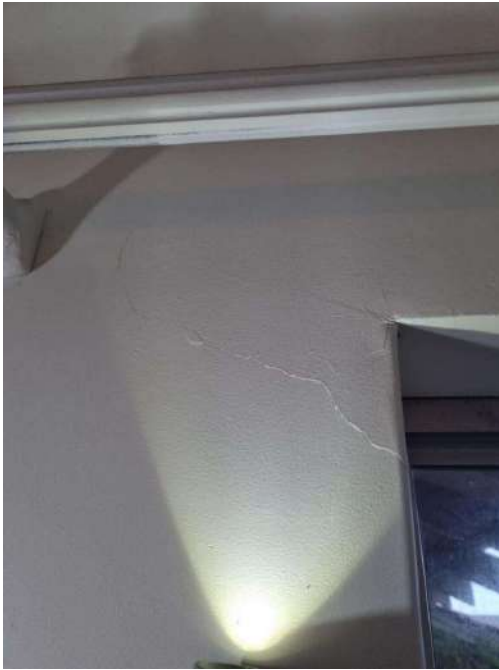
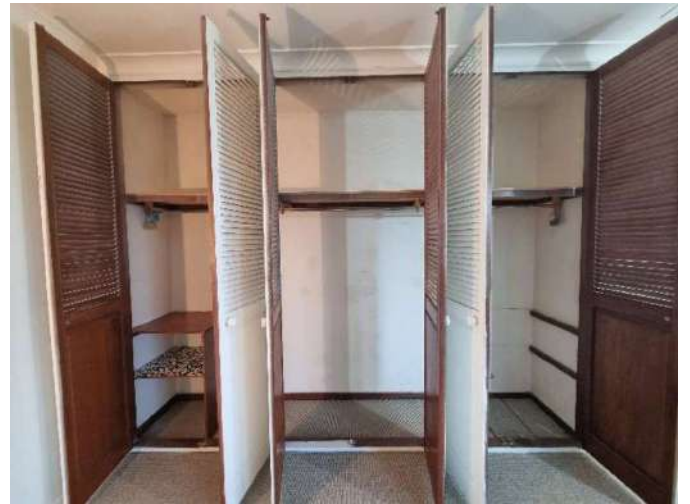
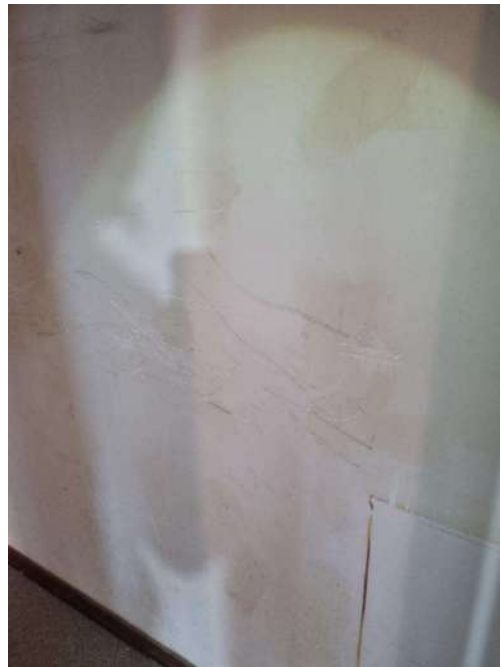
Structural Minor: There appears to have been some settlement in the building which has caused some cracking to the walls. These cracks are categorized as 0 to 2. This can also cause some doors to bind or be out of square. In the inspector's opinion, these cracks are due to settlement, usually due to ground movement and subsequent movement of building materials can be expected. All cracks should be monitored and if cracks increase in size, further investigation should be carried out by a structural engineer. Engage a painter to patch and paint.

Maintenance: The walls in the robe are aged and marked. Recommendation: Engage a painter to repair.

Maintenance: General scuffs and marks to walls. Recommendation: Engage a painter for repairs.

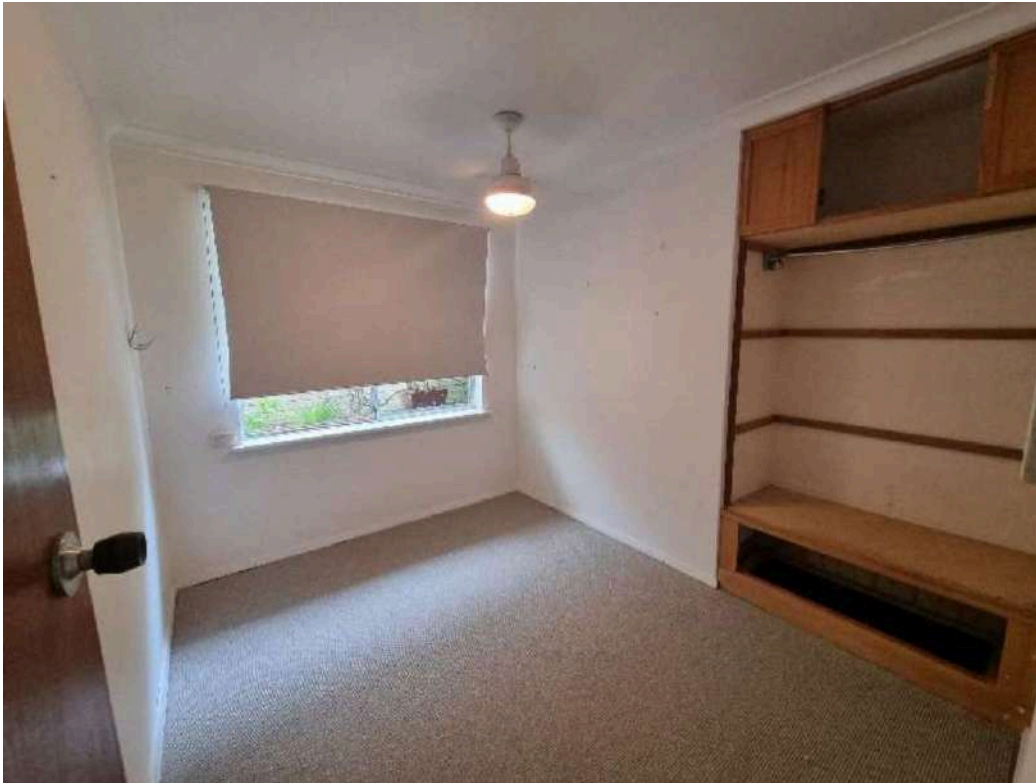
Bedroom 2

Maintenance: Ceiling/cornice joint crack/s observed. Recommendation: Engage a painter for repairs.

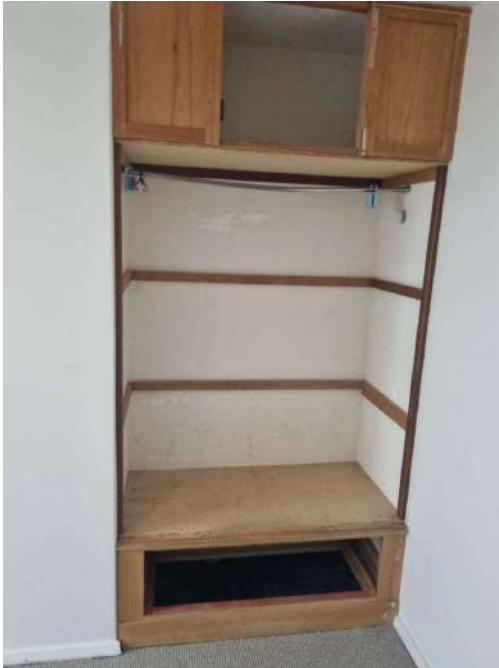
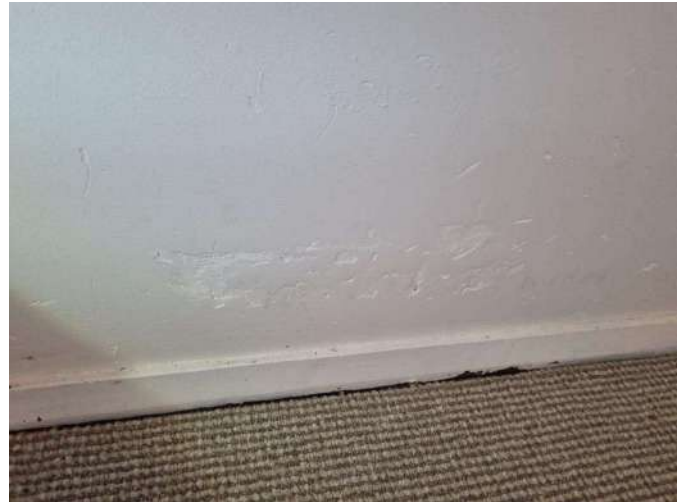
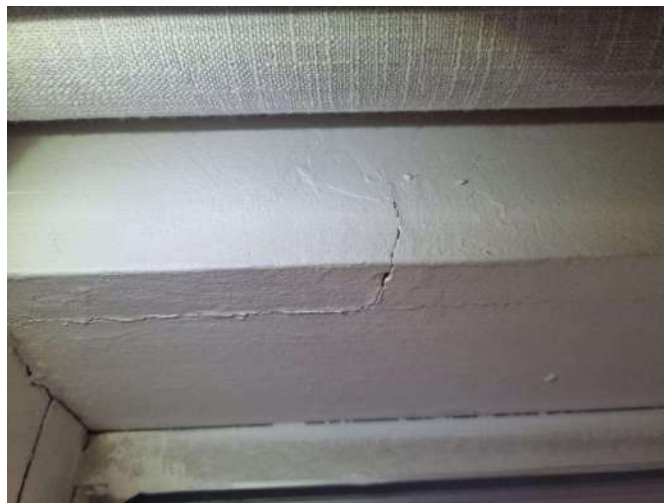
Structural Minor: There appears to have been some settlement in the building which has caused some cracking to the walls. These cracks are categorized as 0 to 2. This can also cause some doors to bind or be out of square. In the inspector's opinion these cracks are due to settlement, usually due to ground movement and subsequent movement to building materials can be expected. All cracks should be monitored and if cracks increase in size, further investigation

Maintenance: The walls in the robe are aged and marked. Recommendation: Engage a painter to repair.

Maintenance: General scuffs and marks to walls. Recommendation: Engage a painter for repairs.

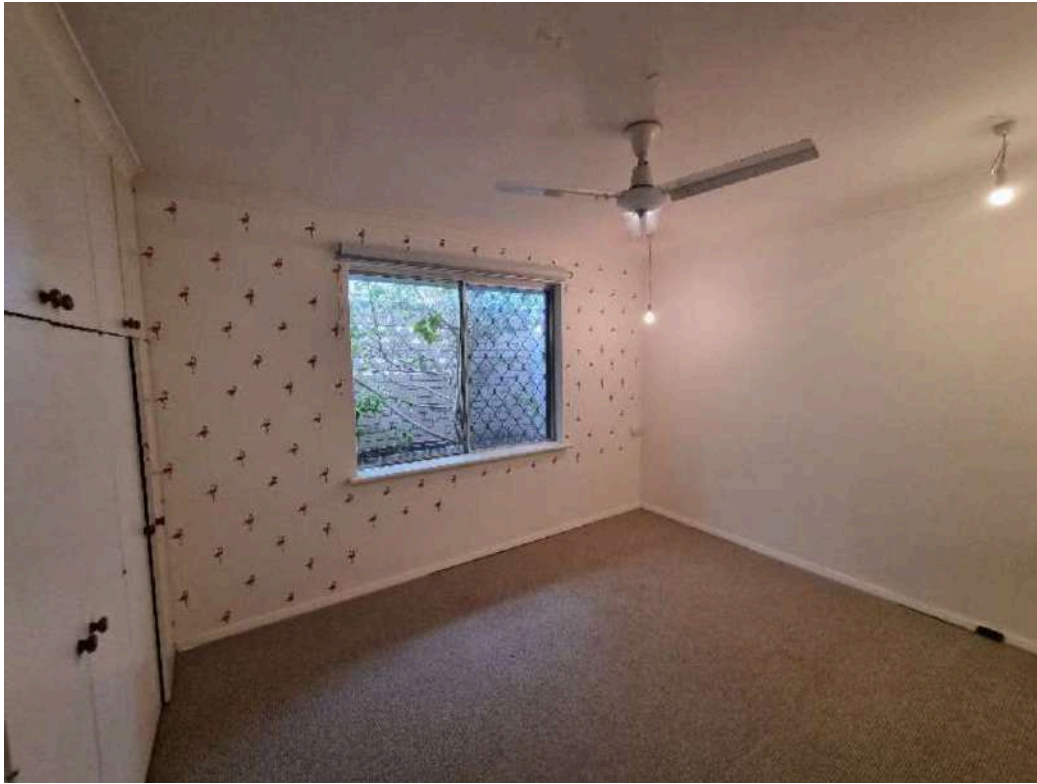
Bedroom 3

Maintenance: Paint deterioration observed. Recommendation: Engage a painter to repair.

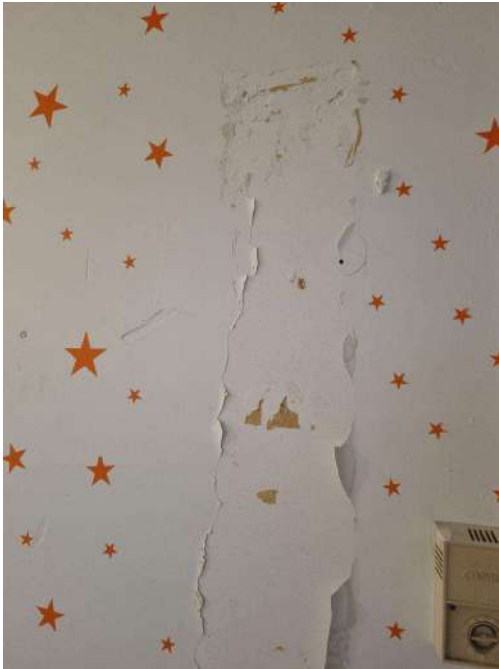
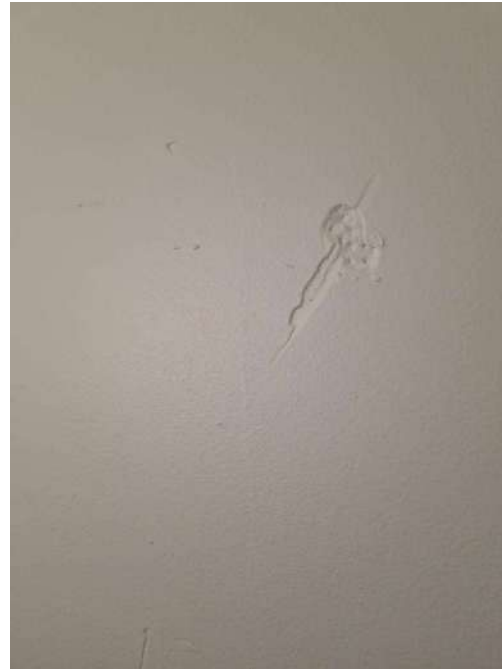
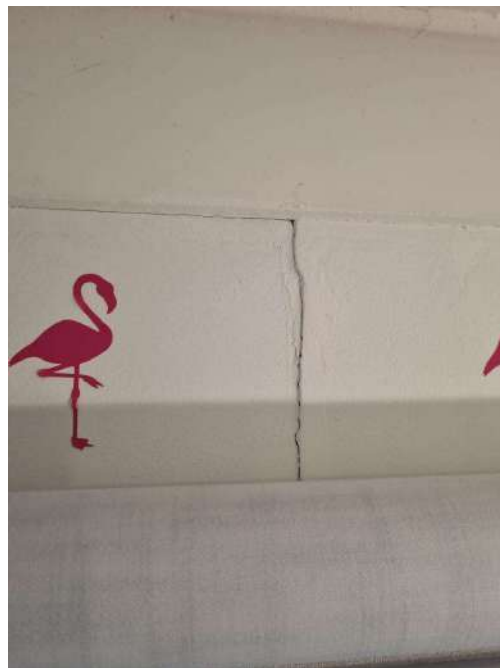
Structural Minor: There appears to have been some settlement in the building which has caused some cracking to the walls. These cracks are categorized as 0 to 2. This can also cause some doors to bind or be out of square. In the inspectors opinion these cracks are due to settlement, usually due to ground movement and subsequent movement to building materials can be expected. All cracks should be monitored and if cracks increase in size, further investigation should be carried out by a structural engineer. Engage a painter to patch and paint.

Maintenance: General ageing and/or denting and the like is evident on wall linings.
Recommendation: Engage a painter for repairs.

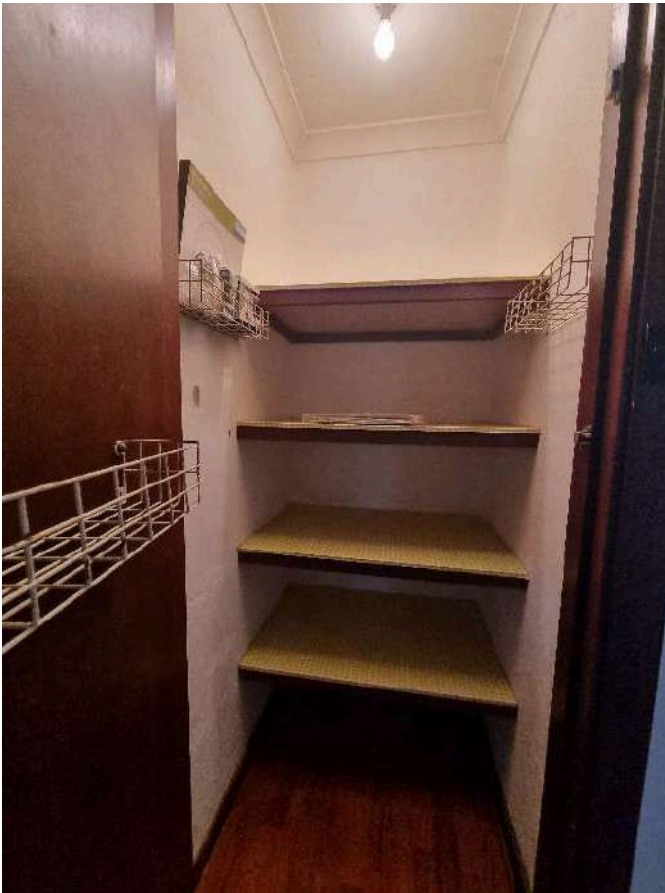
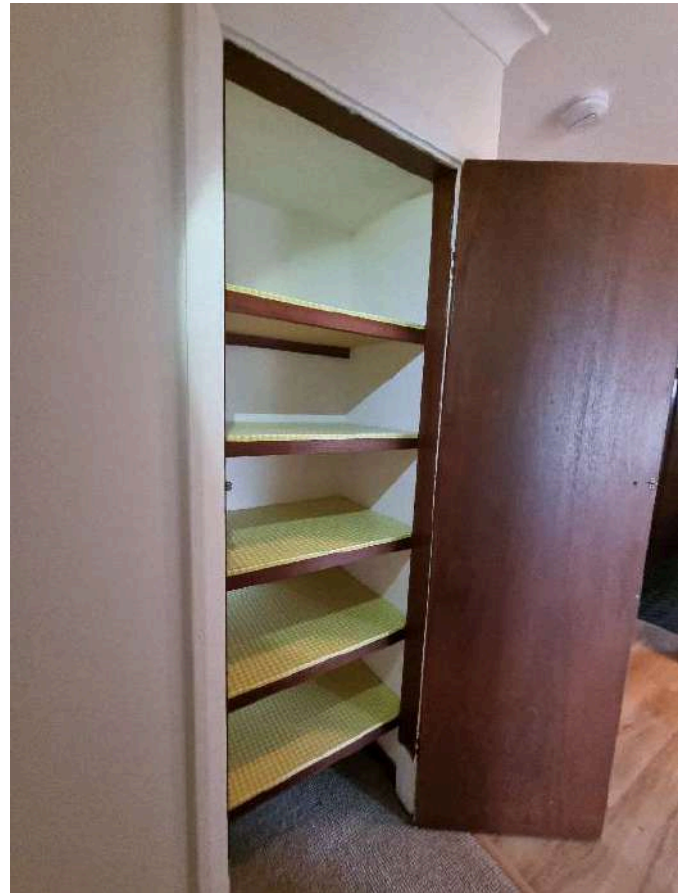
Maintenance: General ageing and/or denting and the like is evident on wall linings.

Recommendation: Engage a painter for repairs.

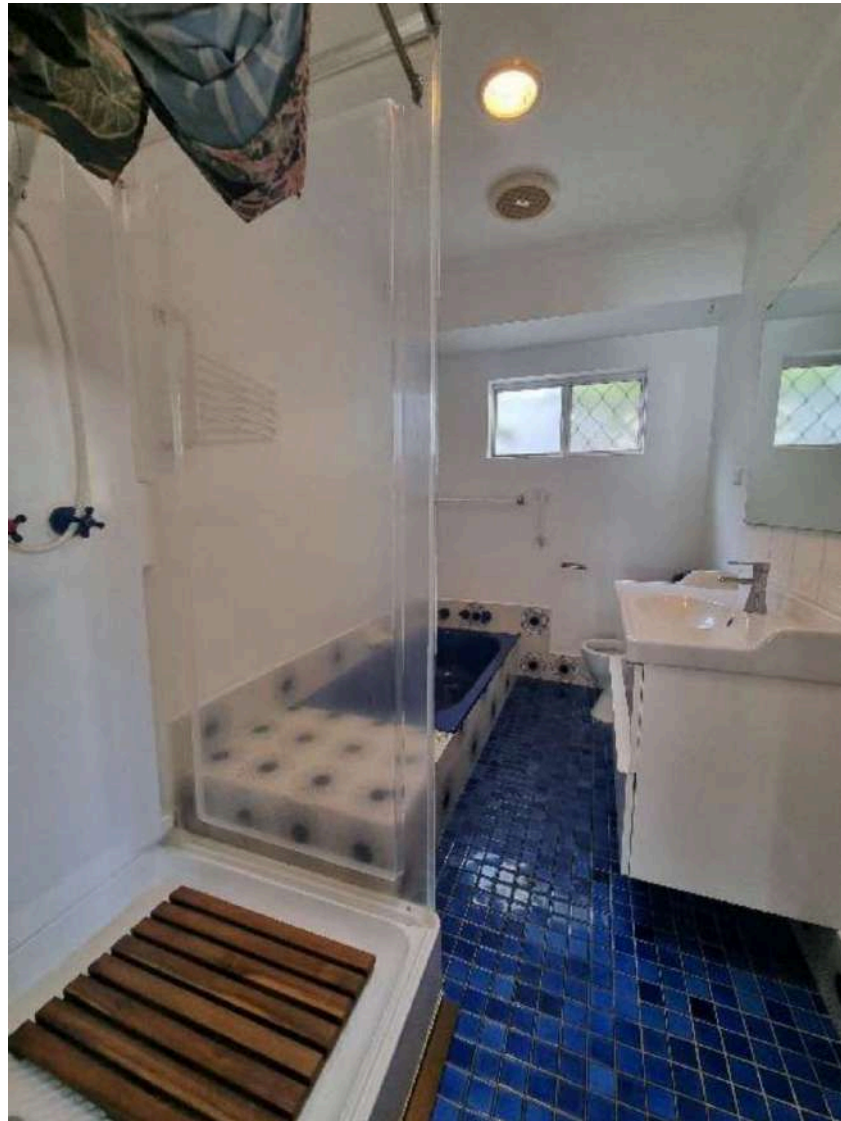
Maintenance: General age/damage has occurred to door frame, face or components.
Recommendation: Engage a carpenter and/or painter for repairs.

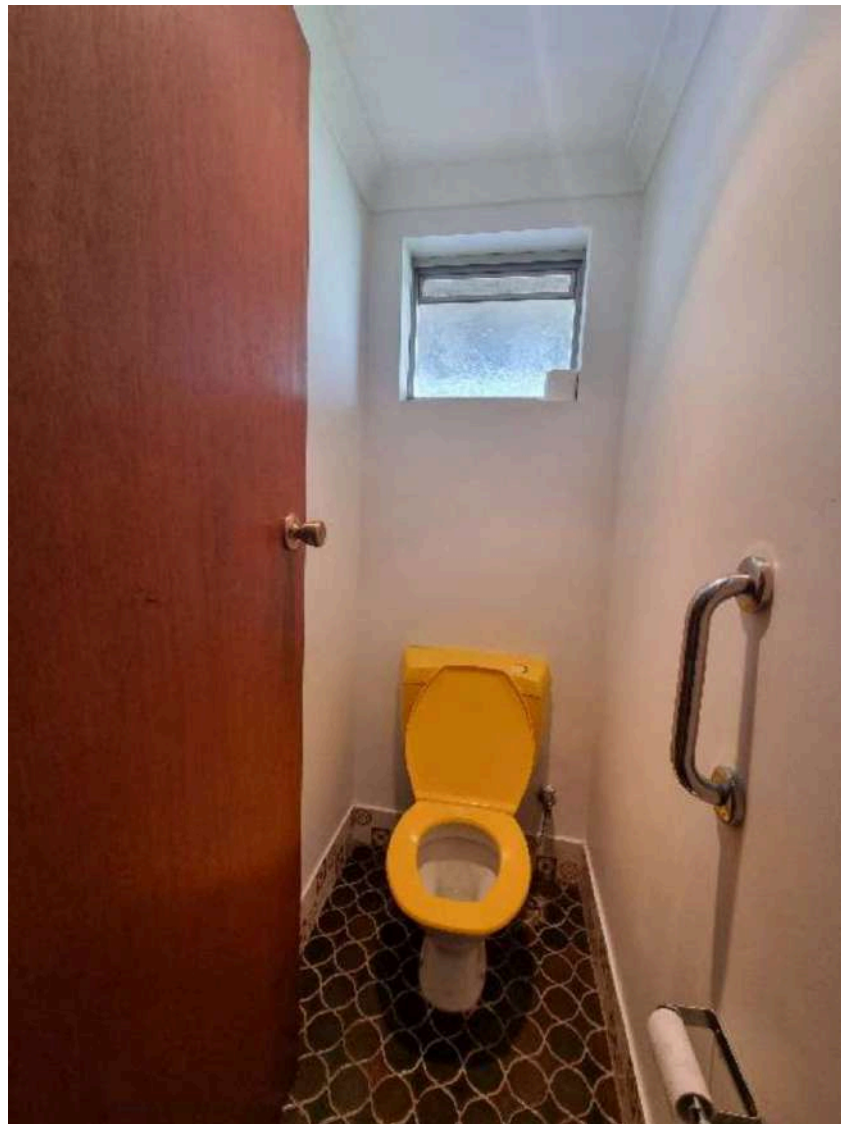
Maintenance: There is no ventilation installed to the bathroom. Recommendation: Engage an electrician to install an exhaust fan.
