Inspection Report

SURE Pty Ltd

Pest And Building Inspection

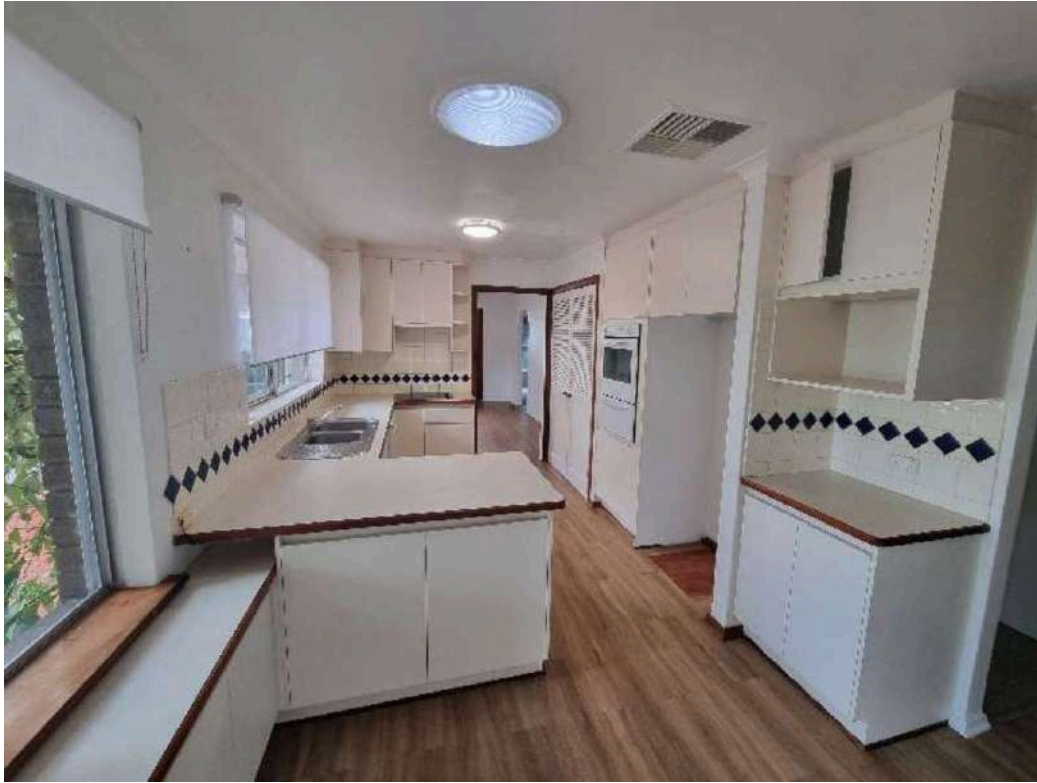
Maintenance: Paint deterioration observed. Recommendation: Engage a painter to repair.

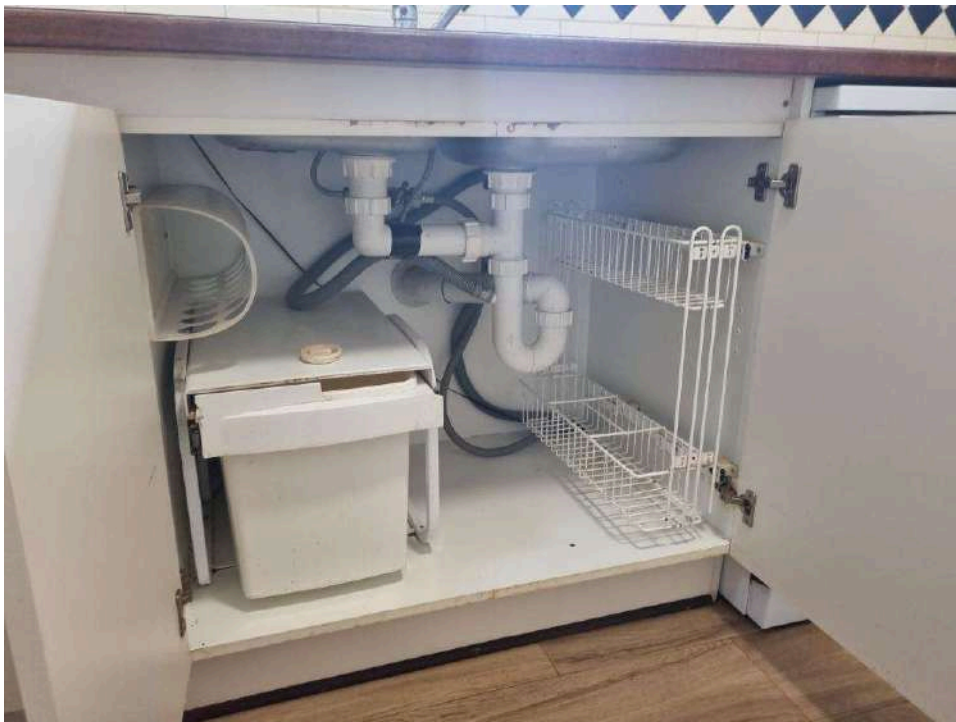
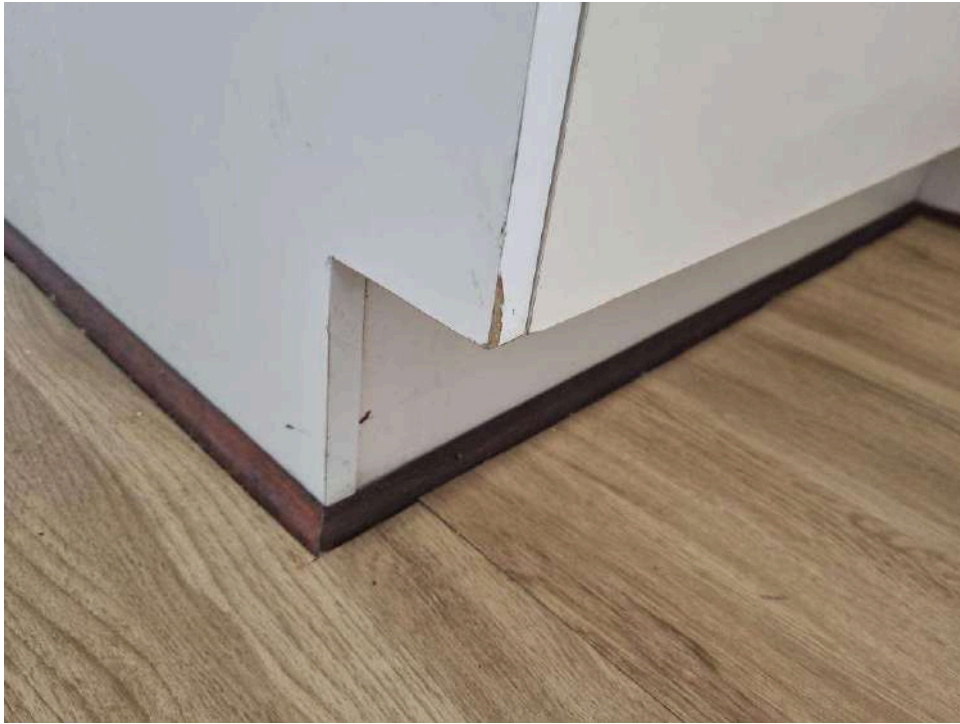
Maintenance: General wear and tear to cupboards and benches. Recommendation: Engage a cabinet maker for refurbishment if desired.

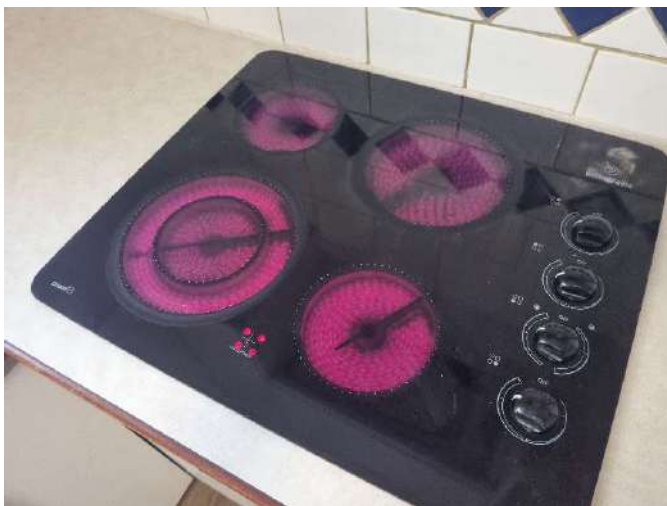
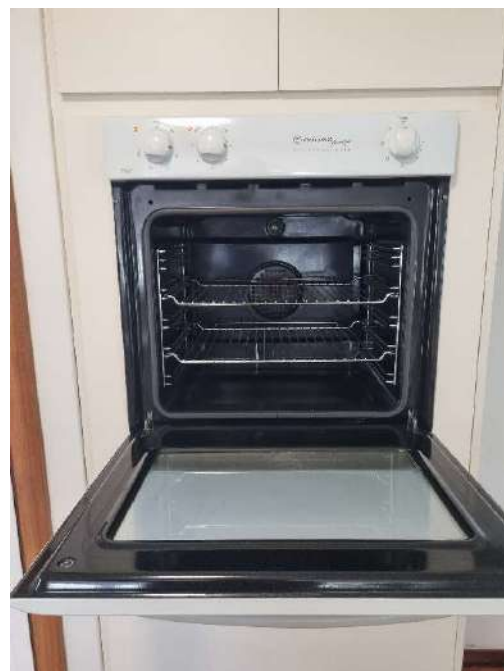
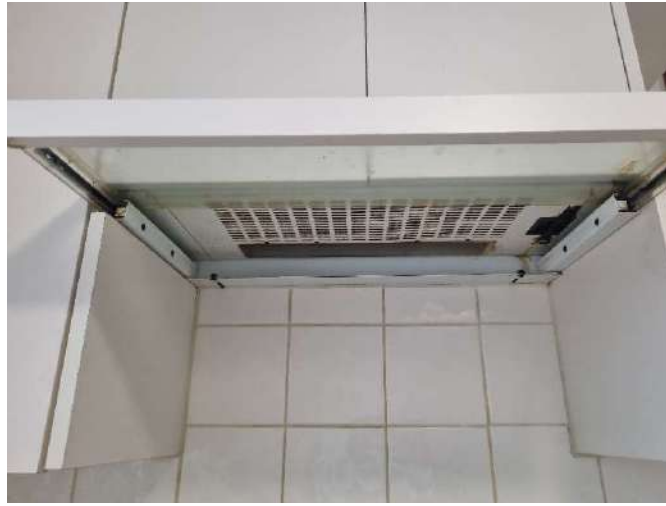
Maintenance: The oven light did not operate as expected. Recommendation: Replacement bulb required.

Maintenance: The exhaust fan light is not operating. Recommendation: Engage an appliance technician to replace bulb/s.

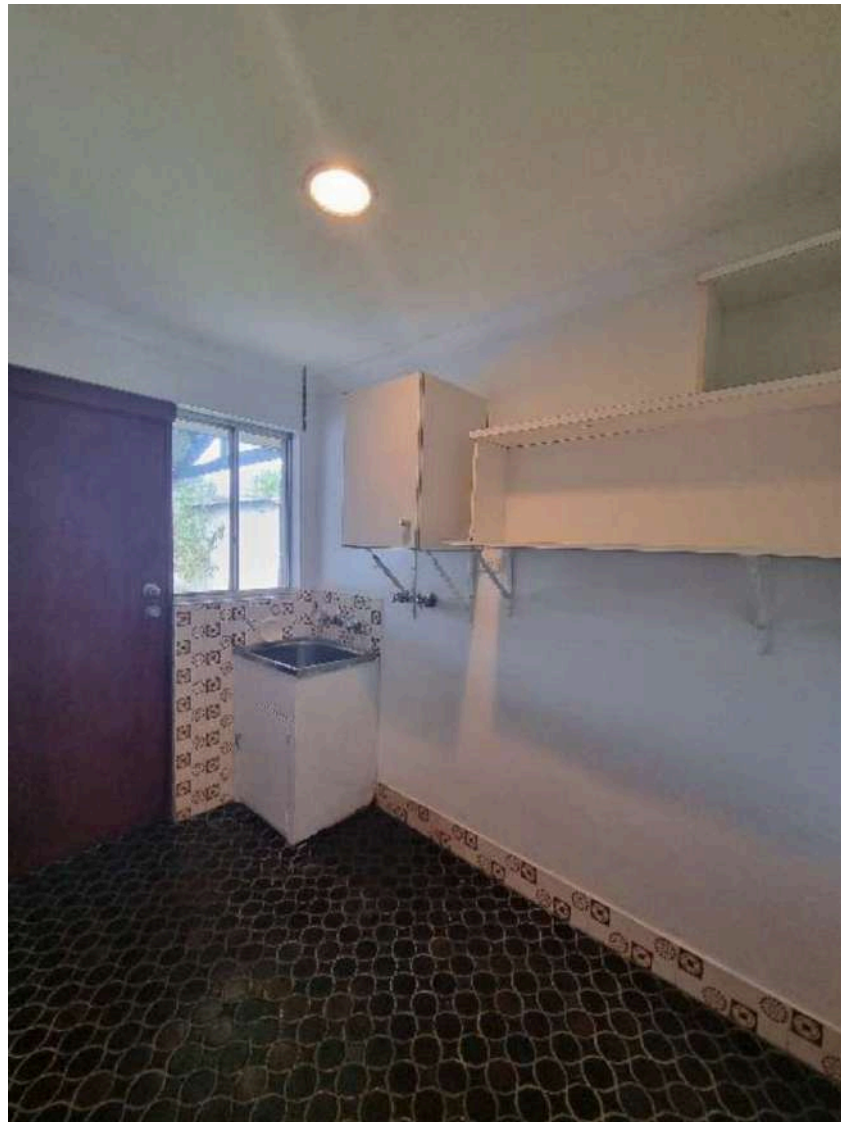
Laundry

Maintenance: Paint deterioration observed. Recommendation: Engage a painter to repair.

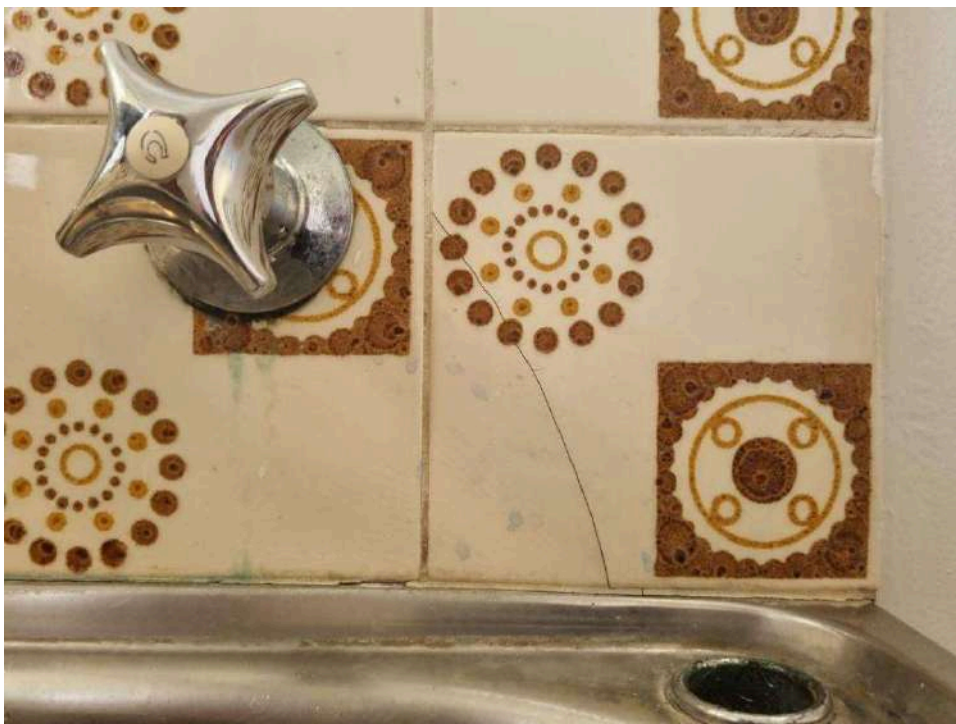
Maintenance: Cracked wall tiles noted. Recommendation: Engage a tiler for repairs.

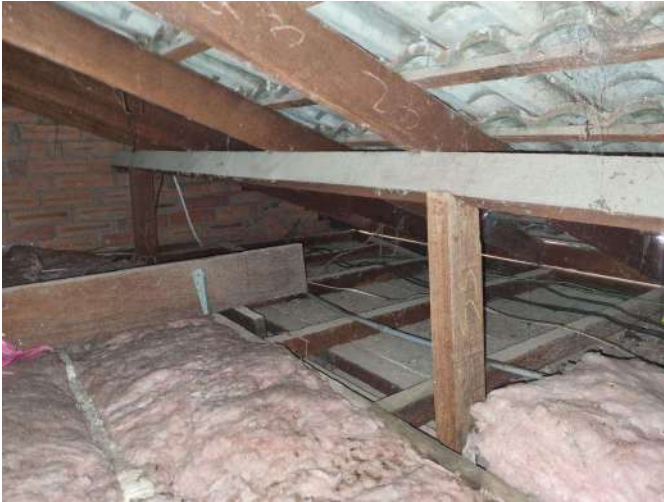
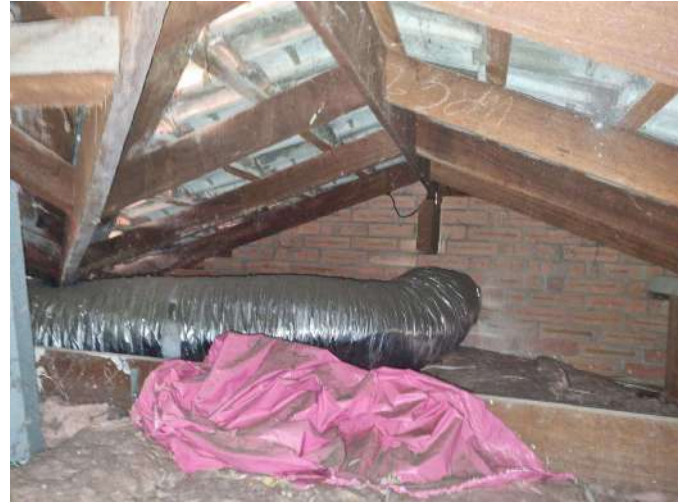
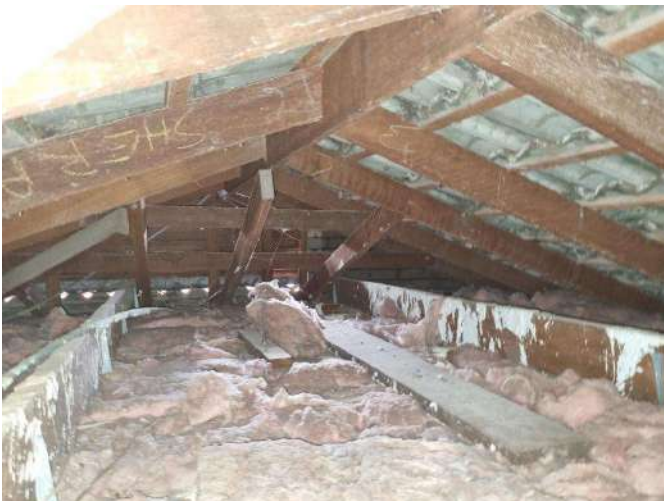
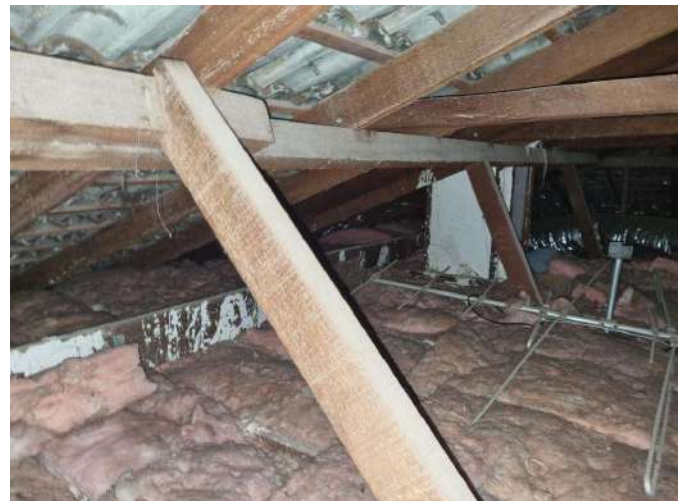
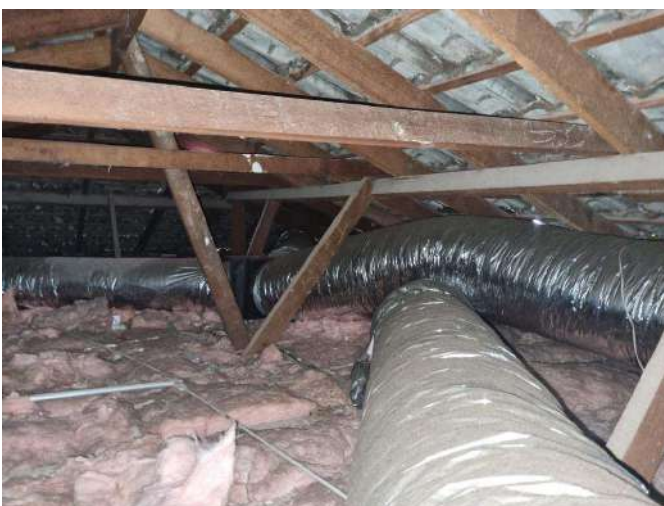
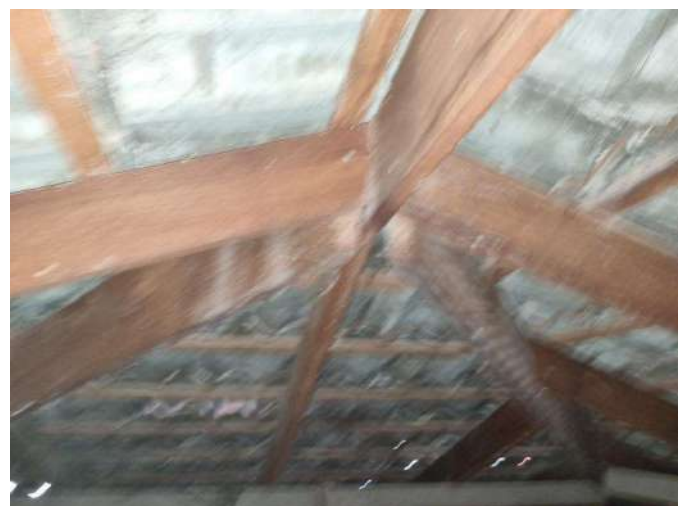
Structural Major: Unevenness in underpurlin - insufficient load support contributing to sagging / unevenness in roof line. Recommendation: Engage a carpenter for installation of additional strut components to adequately support the load of the roof frame/covering.

Maintenance: Framing timbers are aged. Recommendation: Maintain a regular inspection routine and engage a carpenter to complete maintenance as required.

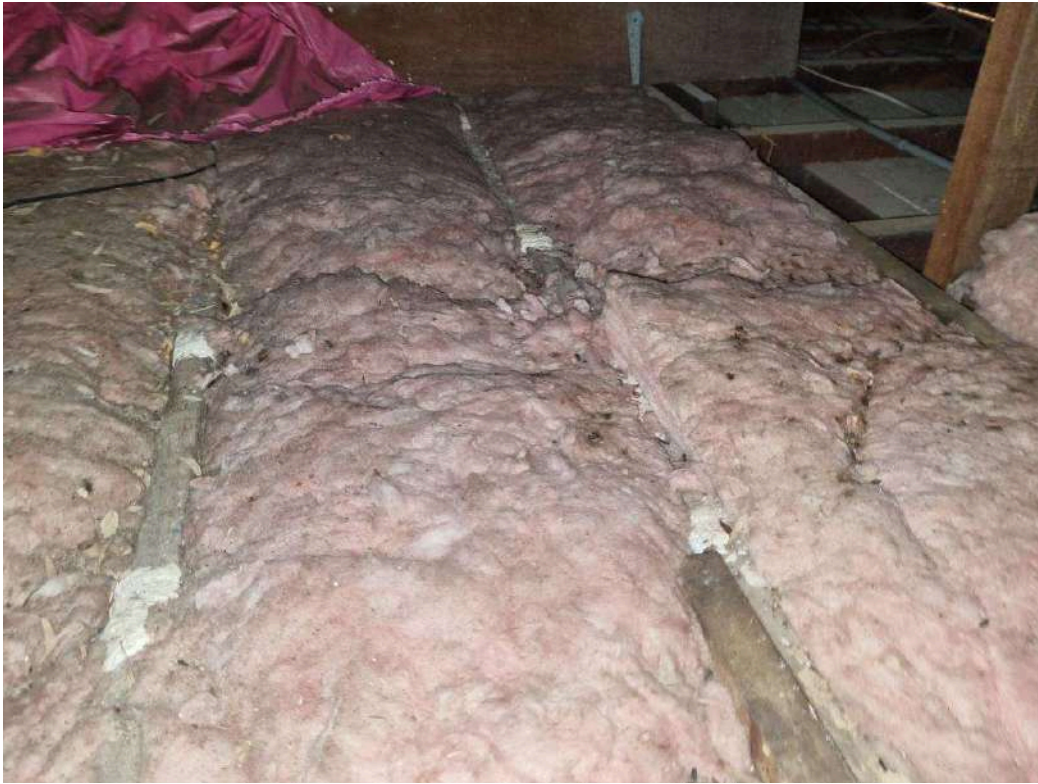
From the visible and accessible areas, the general condition of the roof void insulation is serviceable for the age of the building.

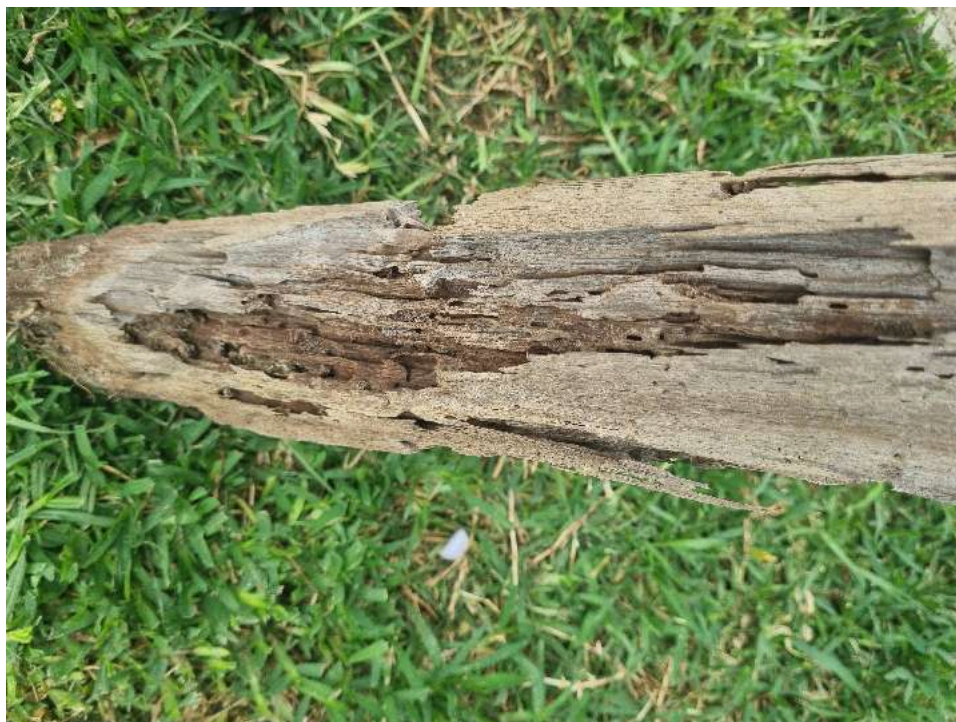
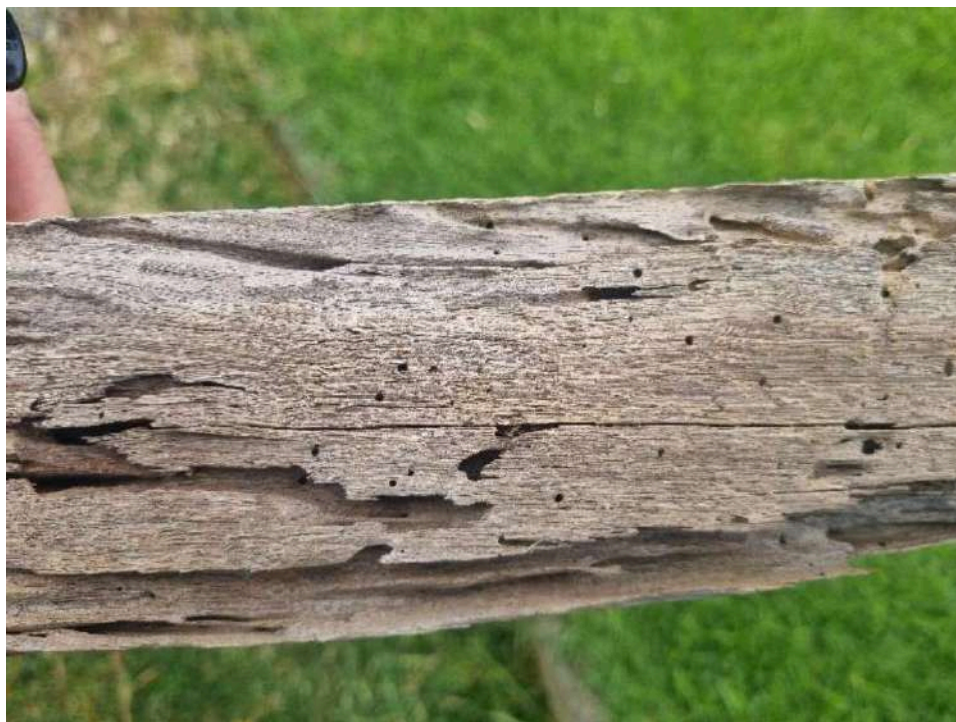
Garden timbers.

Where evidence of termite activity was found in the grounds then the risk to buildings is extremely high. A treatment to eradicate the termites and to protect the building(s) should be carried out in the first instance.

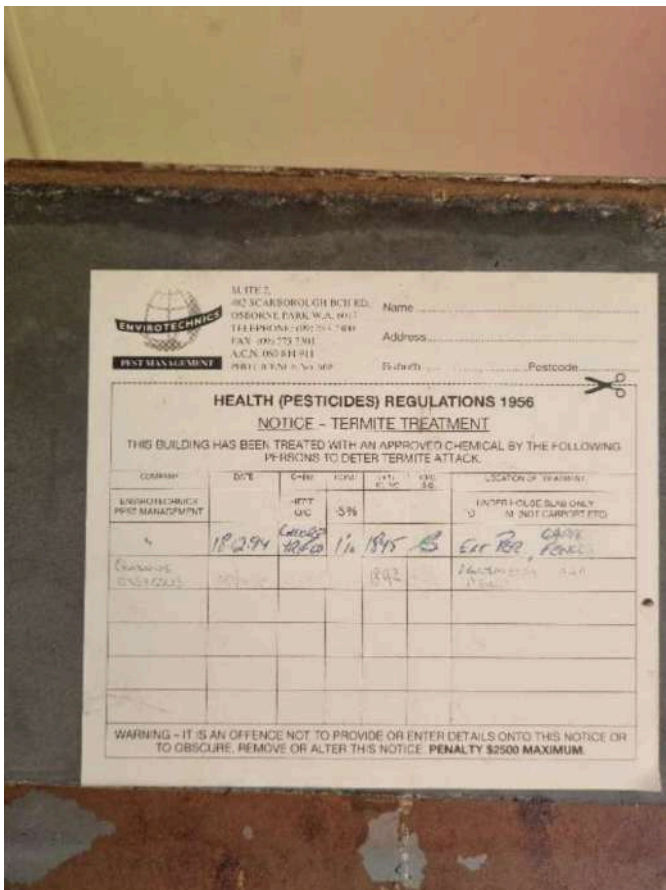
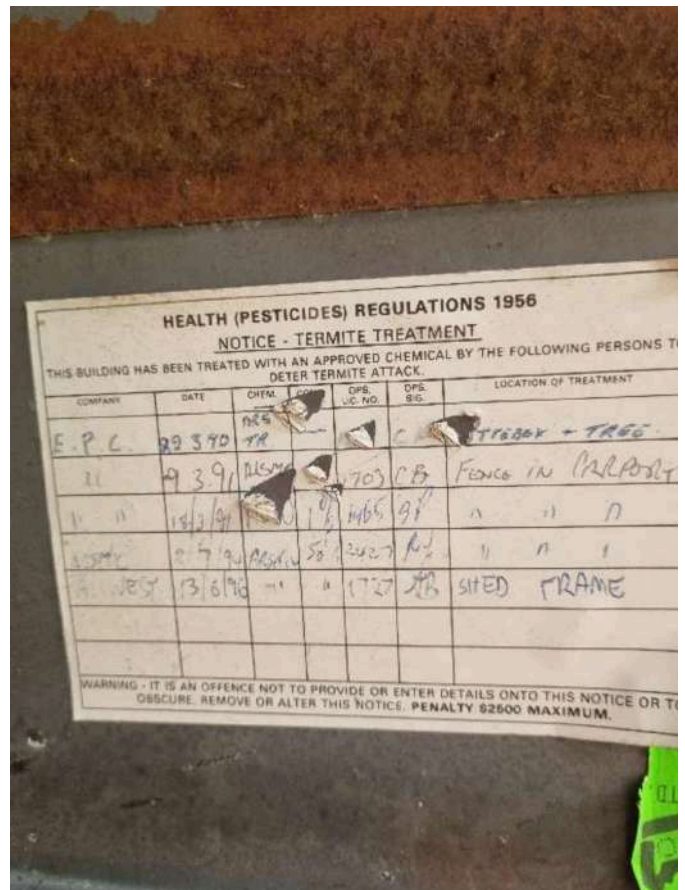
Yes, a durable notice was found in the meter-box during the inspection.

This firm can give no assurances with regard to work that may have been previously performed by other firms. You should obtain copies of all paperwork and make your own inquiries as to the quality of the treatment, when it was carried out and warranty information. In most cases you should arrange for a treatment in accord with Australian Standard 3660 be carried out to reduce the risk of further attack.

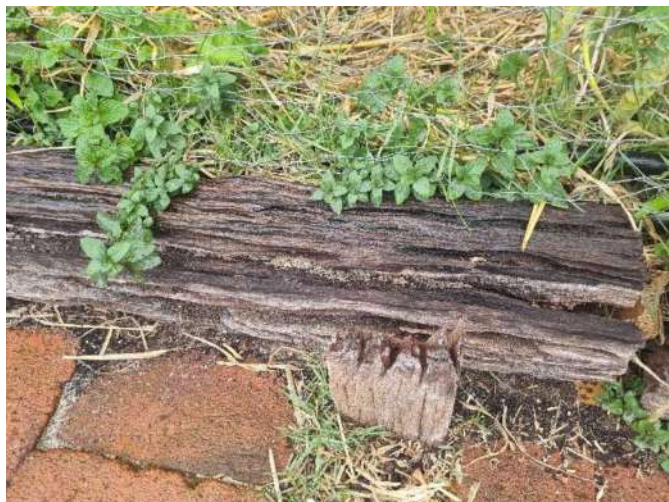
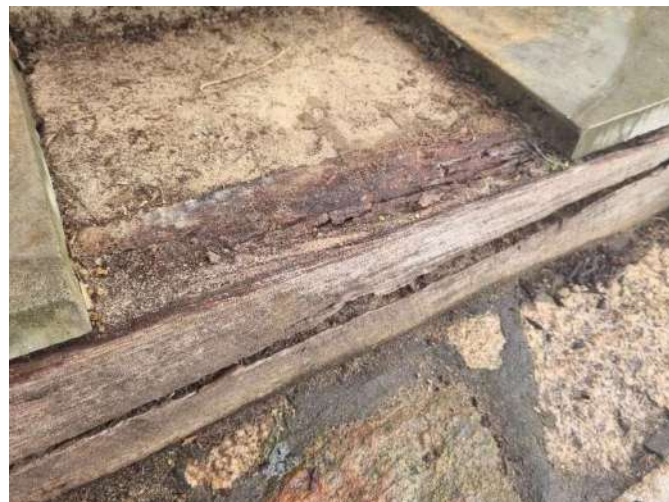
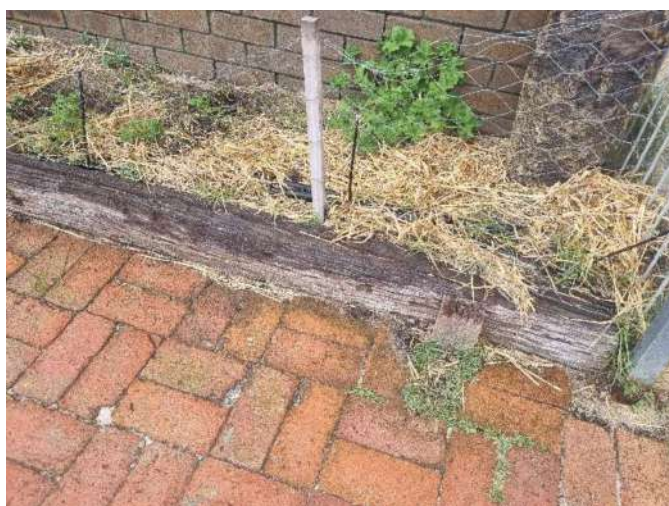
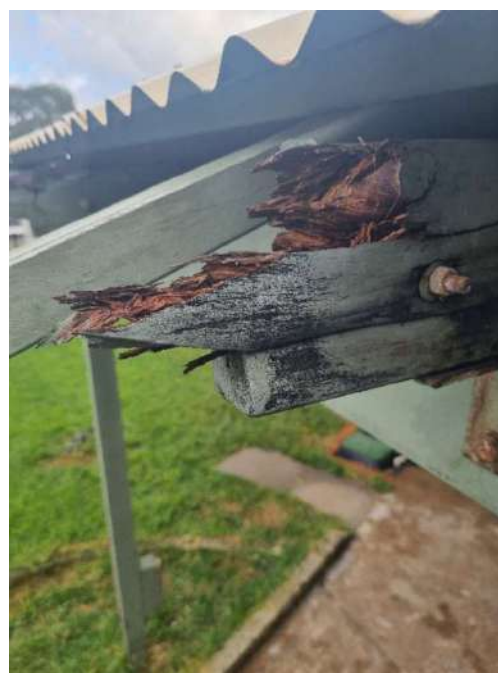
Yes, in the following areas ,
Garden landscaping sleepers/timbers.
Pergola framing timbers.

The extent of rot damage is considered to be high.

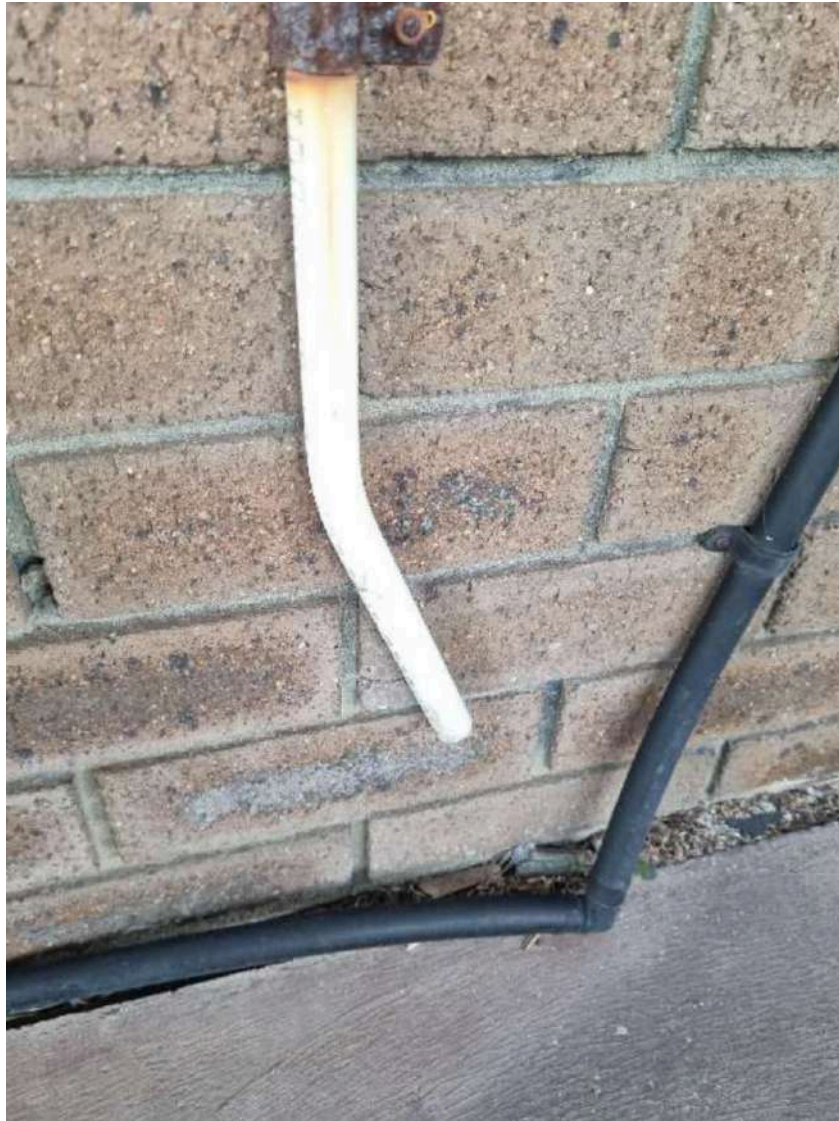
No. Divert hot water overflow away from the building perimeter.

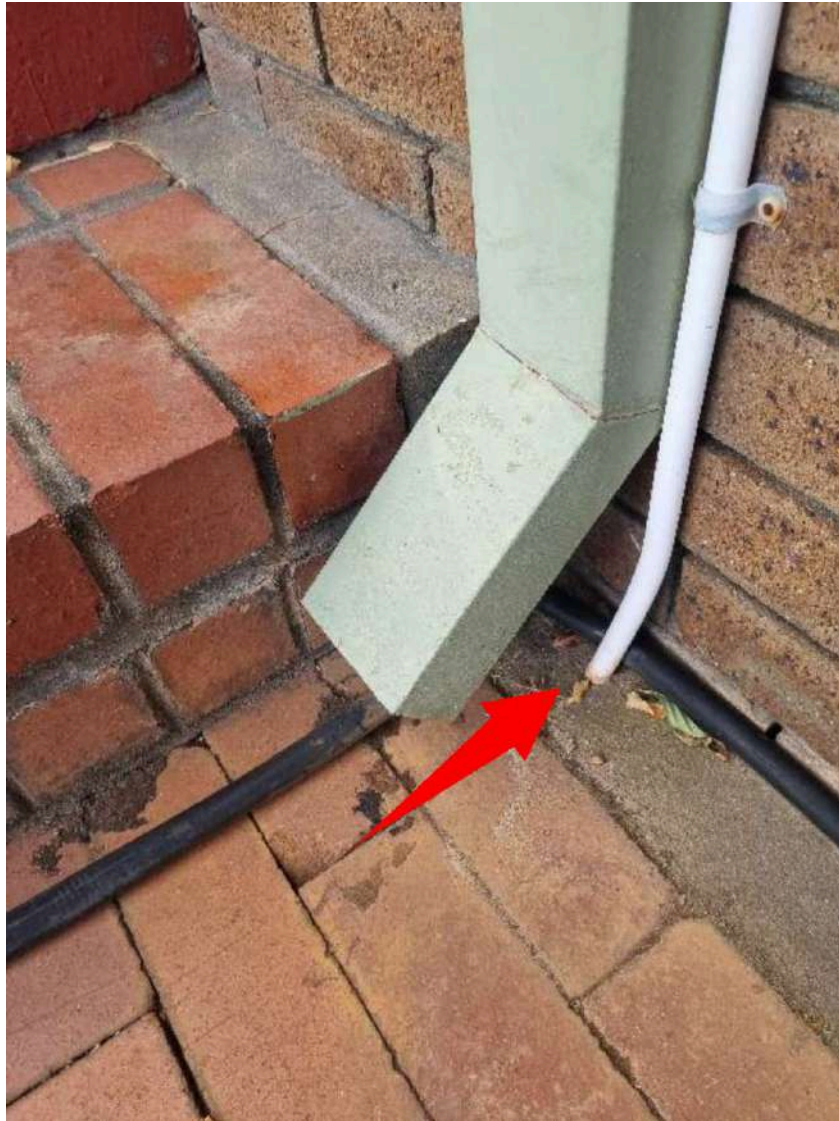
No - Divert A/C overflow away from the building perimeter.

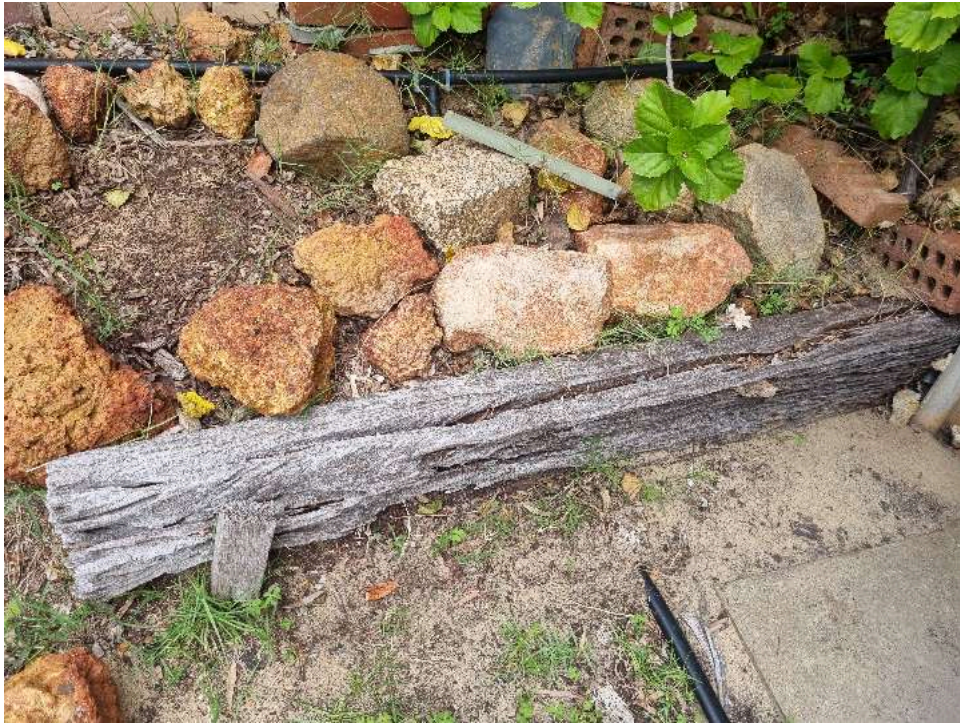
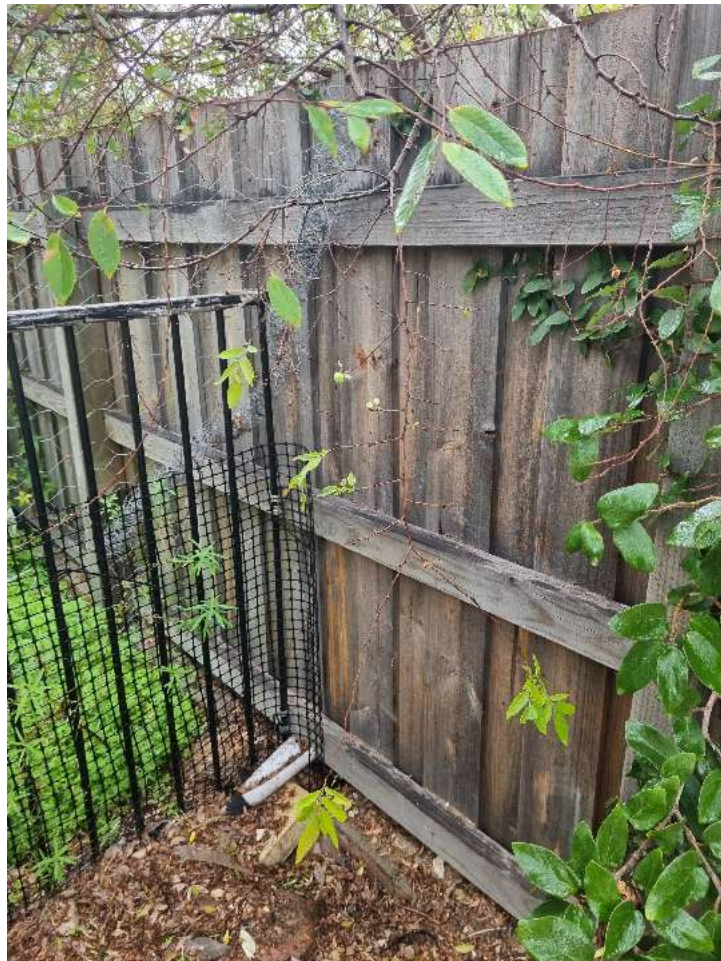
Tree stump/s are located at the site. These need to be removed by a suitably qualified tradesperson as they are conducive conditions for a termite nest.

Tree/leafy environment: This property is located in a suburb which is high risk due to the environmental surrounds. It is close to large trees and parkland. A termite management plan/treatment is strongly advised.

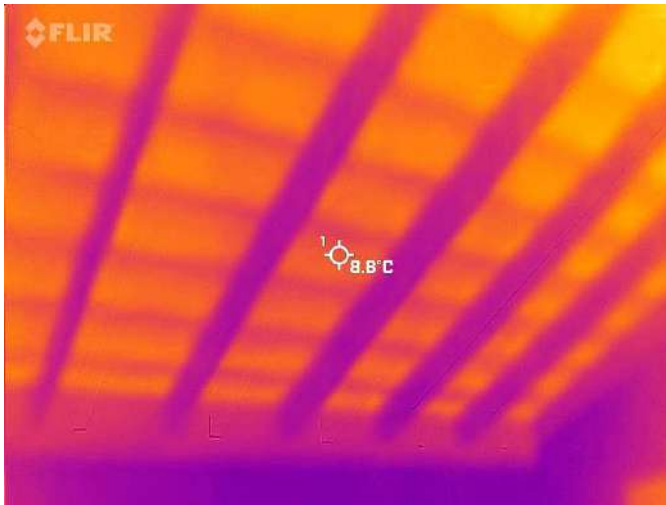
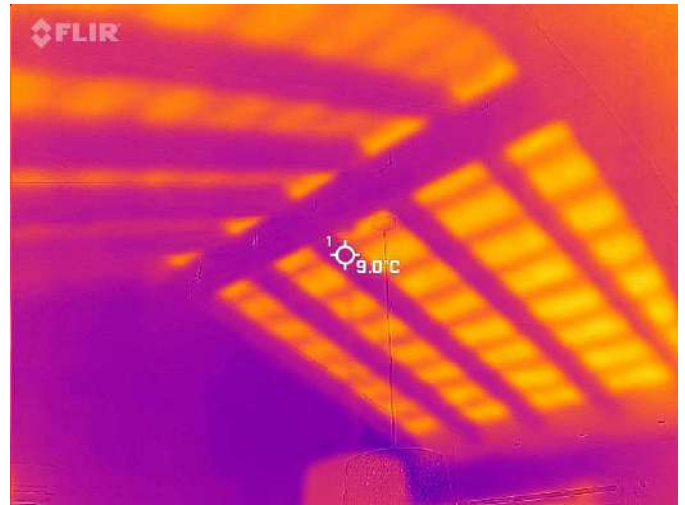
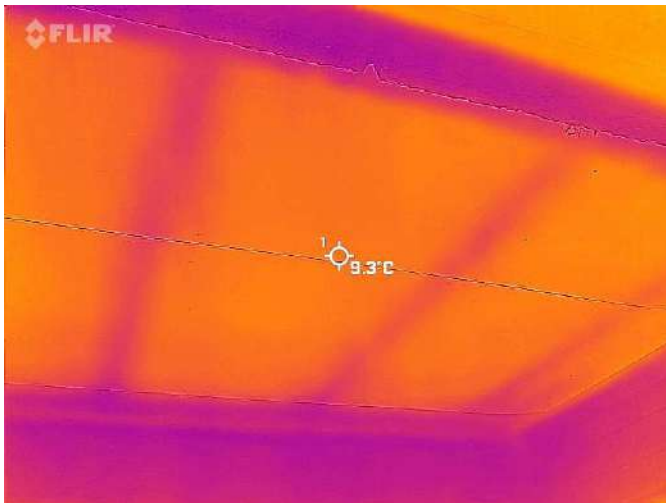
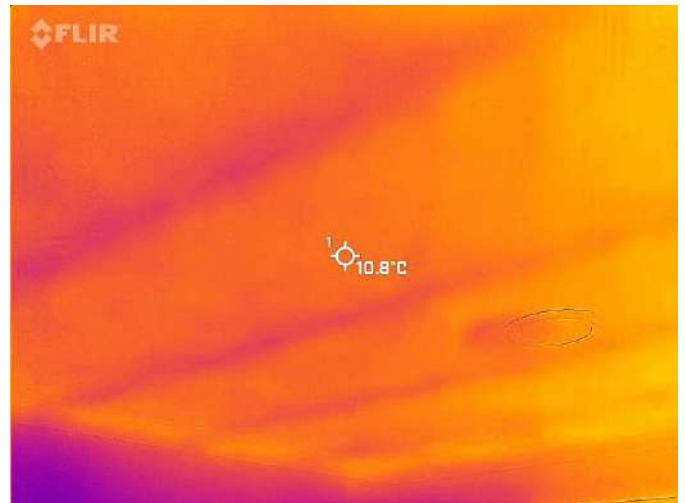
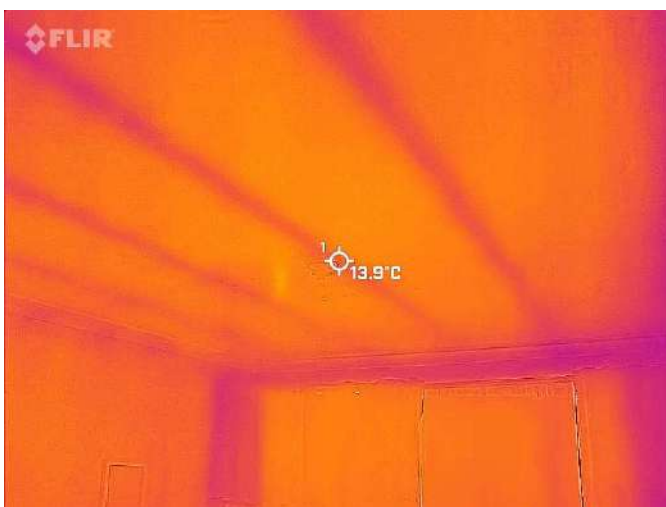
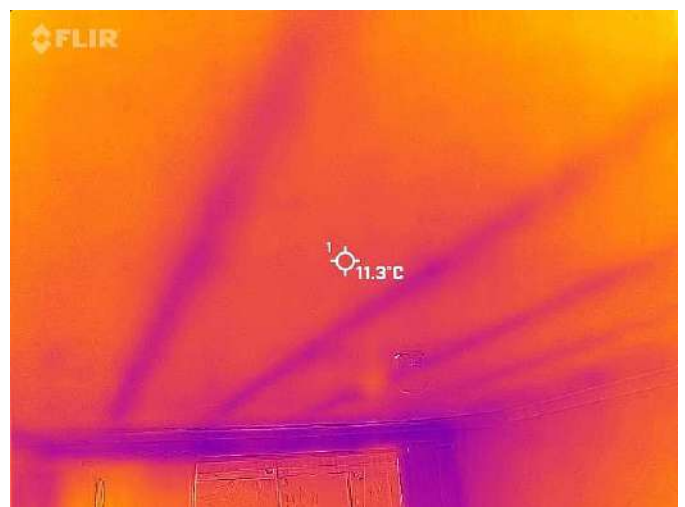
An infrared thermal imager was utilised during the inspection. No thermal anomalies were detected during this inspection, however various factors must be taken into effect which may hamper or impede the reading obtainable by the imager. These factors include obstructions, ambient temperature, wall material and thickness etc. If any surface is restricted visually or otherwise, a proper thermal reading is not possible and is not within the scope of this inspection. Any findings or otherwise is reported on at the time of the inspection only.
